EL12-064c ITB12-062c November 12, 2013

WITHOUT NAVIGATION SYSTEM HANDS-FREE PHONE POOR SOUND QUALITY

APPLIED VEHICLES: 2011 – 2013 M37, M56 and M Hybrid (Y51 & HY51)

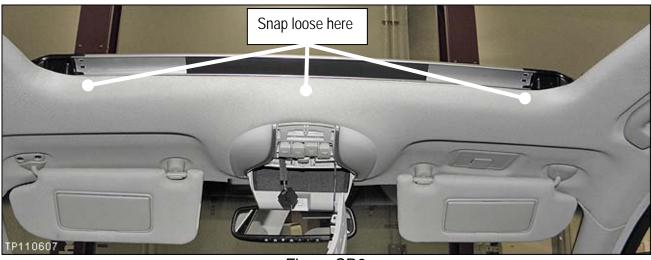
Figure SR3

- 4. Fully open (slide back) the sunroof.
- 5. Carefully snap loose the headlining along the front of the sunroof opening at the 3 spots shown in Figure SR3.

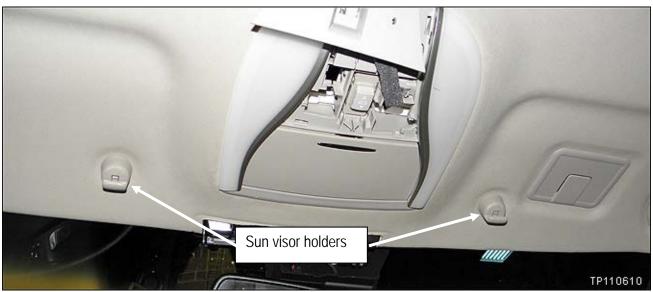
Figure SR5

7. Remove both sun visor holders – twist ¼ turn to remove.

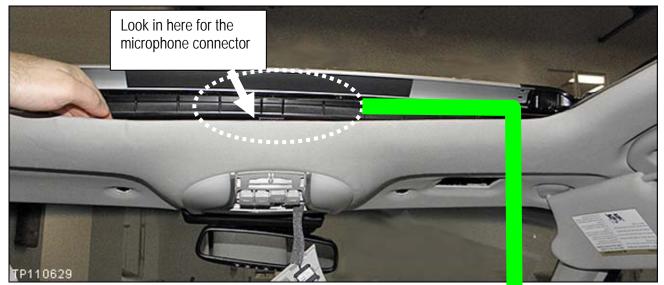
Figure SR6

8. Carefully pull the headlining down just enough to look in and locate the microphone connector.

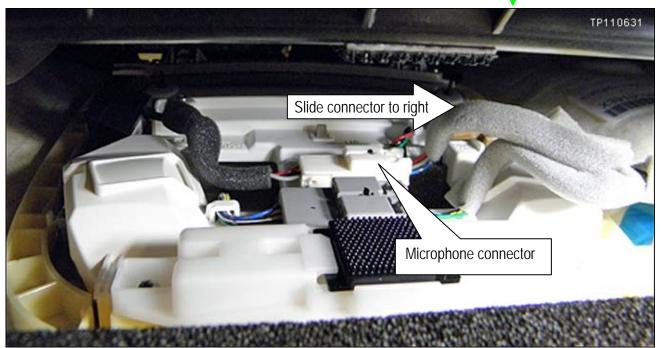
Figure SR7

- 9. Carefully slide the connector to the right (towards the passenger side) to disengage it from its mount.
 - It may be tight on the mount, but it just slides to the right to disengage.

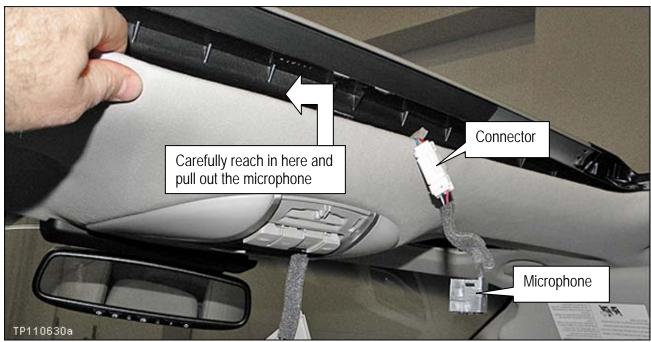
Figure SR8

10. Carefully reach in above the headlining and pull out the microphone.

11. Disconnect the old microphone and discard.
