EL12-062c

WITH NAVIGATION SYSTEM HANDS-FREE PHONE POOR SOUND QUALITY

APPLIED VEHICLES: 2011 – 2013 M37, M56, and M Hybrid (Y51 & HY51)
 2013 JX35 (L50)
 2010 – 2012 FX35 and FX50 (S51)
 2010 – 2012 EX35 (J50)
 2011 – 2012 QX56 (Z62)
 2010 – 2012 G37 Sedan, Coupe, and Convertible
 (V36, CV36, & HV36)

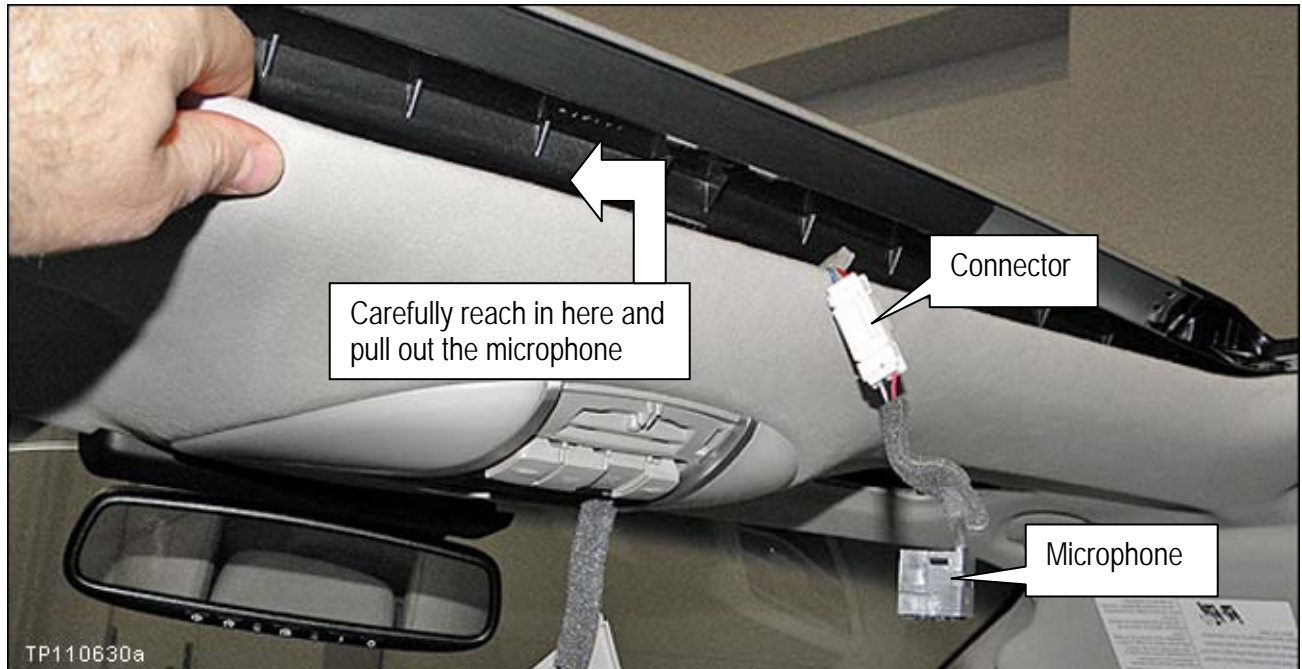
Figure M9

IMPORTANT: Make sure the microphone is firmly snapped into place. If the microphone is loose, it could pick up extra noise from an unintended source.

11. Disconnect the old microphone and discard.

12. Install the new microphone in reverse order.

- Make sure to use the new microphone listed in the Parts Information.
- Make sure to use the new map lamp finisher listed in the Parts Information.
