EL13-051

ITB13-052

## INTELLIGENT KEY NOT DETECTED / ENGINE WILL NOT START

**APPLIED VEHICLES:** 2013 JX35 (L50)  
2014 QX60 (L50)  
2011 - 2013 QX56 (Z62)  
2014 QX80 (Z62)  
2011 - 2013 M37 / M56 (Y51)  
2012 - 2013 M35h Hybrid (HY51)  
2014 Q70 / Q70 Hybrid (H/Y51)

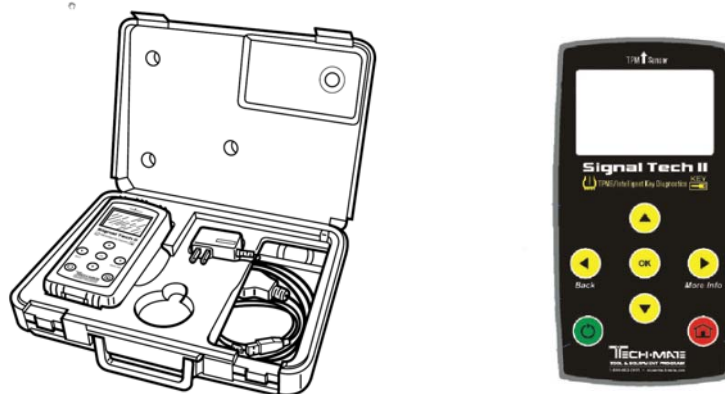
Signal Tech-II will detect the presence of RF signals that may be interfering with I-Key signals.

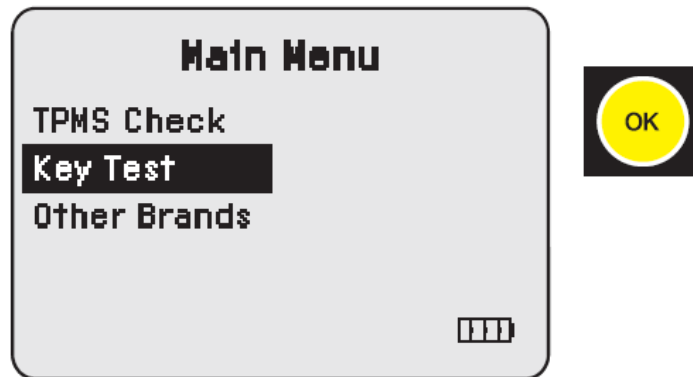
Figure 1

1. Place the Signal Tech-II inside the vehicle.
2. Set the ignition to "Key ON Engine OFF" (KOEO).
3. Get all of the vehicle's I-Keys out of range of the vehicle (place them at least 25 feet away from the vehicle).
4. With Signal Tech-II, select **Key Test**, and then select **OK**.

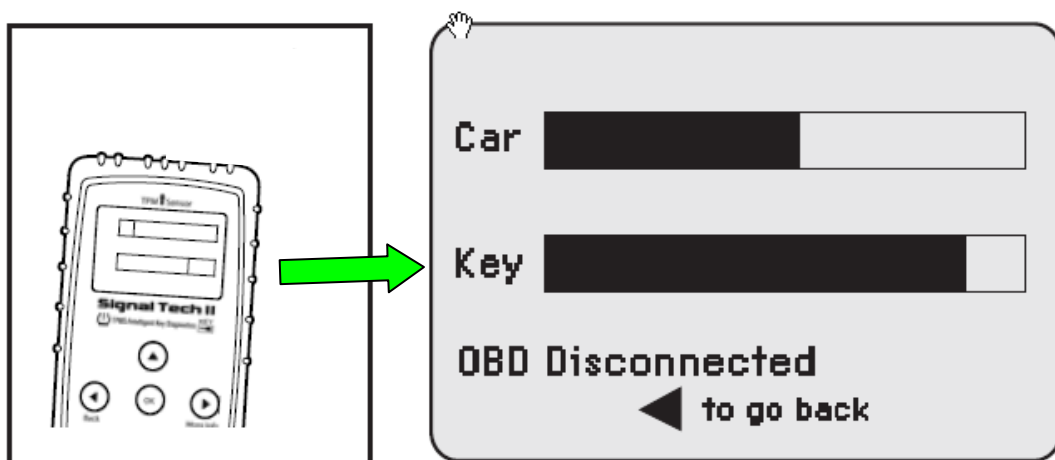
Figure 2

5. Observe the bar graph for **Key**.
  - Ignore the bar graph for **Car**.
  - If a signal is detected in the **Key** bar graph, this may indicate an interference issue. In this case, the source of the interference must be isolated / eliminated.
