SERVICE BULLETIN

| Classification: EC13-021 | Reference: NTB13-110 | Date: December 17, 2013 |

2014 TITAN AND ARMADA; MIL “ON” WITH P117A AND/OR P117B STORED

APPLIED VEHICLES: 2014 Titan (A60)
2014 Armada (TA60)

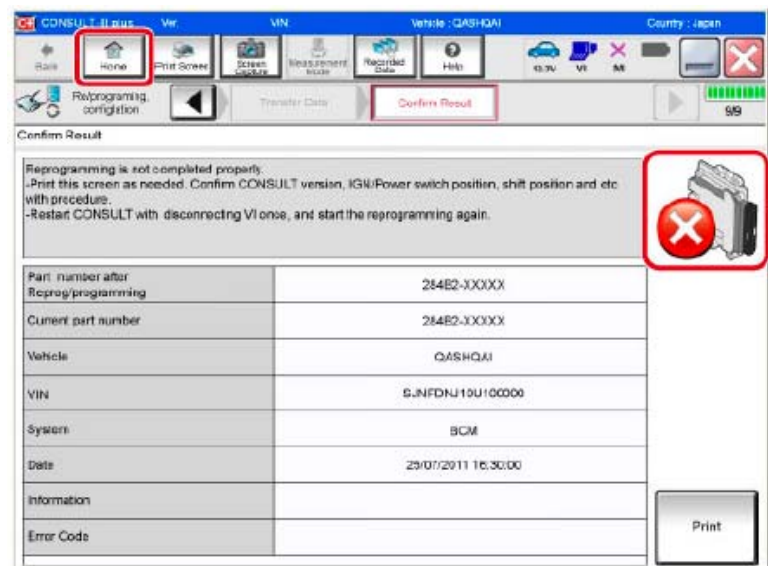
Figure 6

If reprogramming does not complete and the “X” icon displays as shown in Figure 6:

- Check battery voltage (12.0 - V).
- CONSULT A/C adapter is plugged in.
- Ignition is ON, engine OFF.
- Transmission is in Park.
- All C-III plus / VI cables are securely connected.
- All C-III plus updates are installed.
- **Select Home, and restart the reprogram procedure from the beginning.**
