NISSAN BULLETIN

2014 Nissan Altima and Maxima Floor Support Weld Dealer Inventory Inspection

Reference: PC256
Date: December 19, 2013

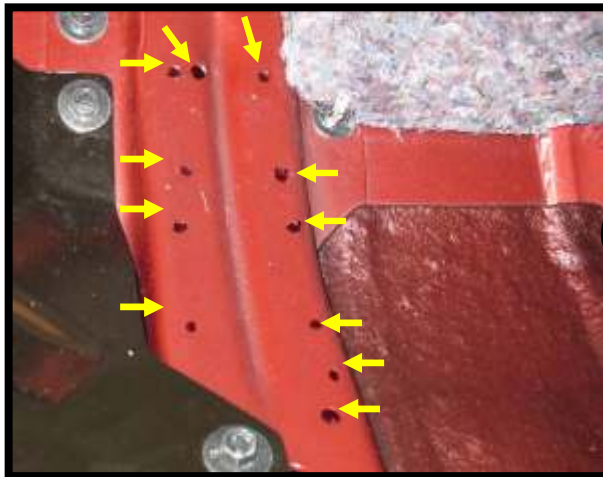
Figure 10

11. Inspect driver side metal floor support bracket welds.

- Count each visible weld to ensure a minimum of 21 welds are present on the top of the metal floor support bracket.
- Refer to arrows identifying black highlighted spot welds in Figures 10, 11 and 12.
- Location of welds will vary from vehicle to vehicle.

12. If **21 or more** spot welds are confirmed present:

- Reassemble vehicle.
- Submit warranty claim using PC2560. (see claims info)
- Release the vehicle.

13. If **less than 21** welds are confirmed or unable to confirm number of welds:

- Continue to hold the vehicle.
- Send E-mail to the below address and carbon copy (CC) your FOM:
