2014 Altima, Pathfinder, Rogue CVT Rev Sensor  
Dealer Inspection

Reference: PC260

Date: January 15, 2014

**\*\*\*\*\* Dealer Announcement \*\*\*\*\***

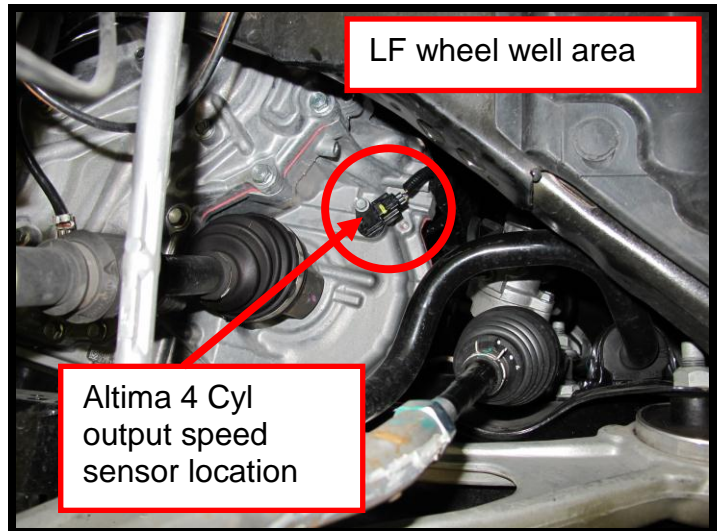
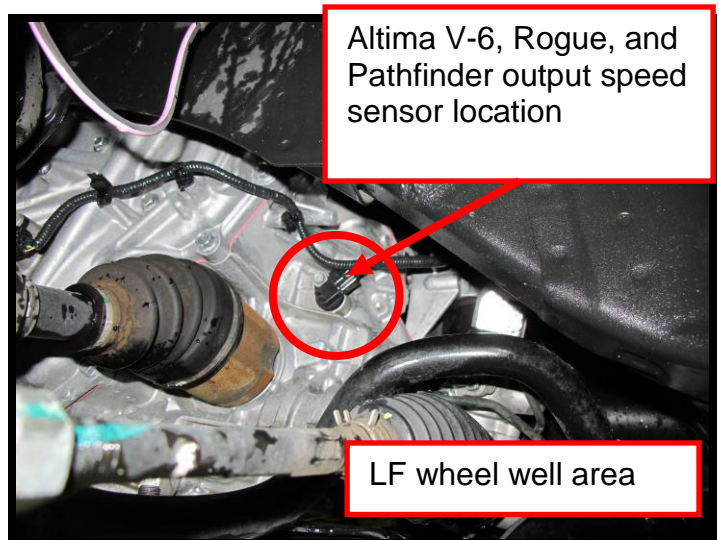
2. Raise the vehicle on the hoist.
3. Look into driver side (LF) wheel well to locate the output speed sensor, see Figures 1 & 2.
4. Disconnect harness from output speed sensor and remove sensor from transmission.
5. Inspect output speed sensor terminals and harness connector for corrosion or evidence of moisture intrusion.
  - Is corrosion found on output speed sensor terminals? (see Figure 3)
  - Is moisture intrusion found in output speed sensor harness connector?
6. If YES to any of the questions in Step 5:
  - Replace output speed sensor with a new sensor assembly.
  - Torque output speed sensor bolt to 5.9 N•m (52 in-lb).
  - Dry harness connector with low pressure shop air and apply electric cleaner (CRC® QD® Electric Cleaner PN 05103 or equivalent).
