# SERVICE BULLETIN

BT14-003

February 25, 2014

## ALTIMA SEDAN; HISS AND / OR WHINE TYPE NOISE FROM LOWER INSTRUMENT PANEL AREA

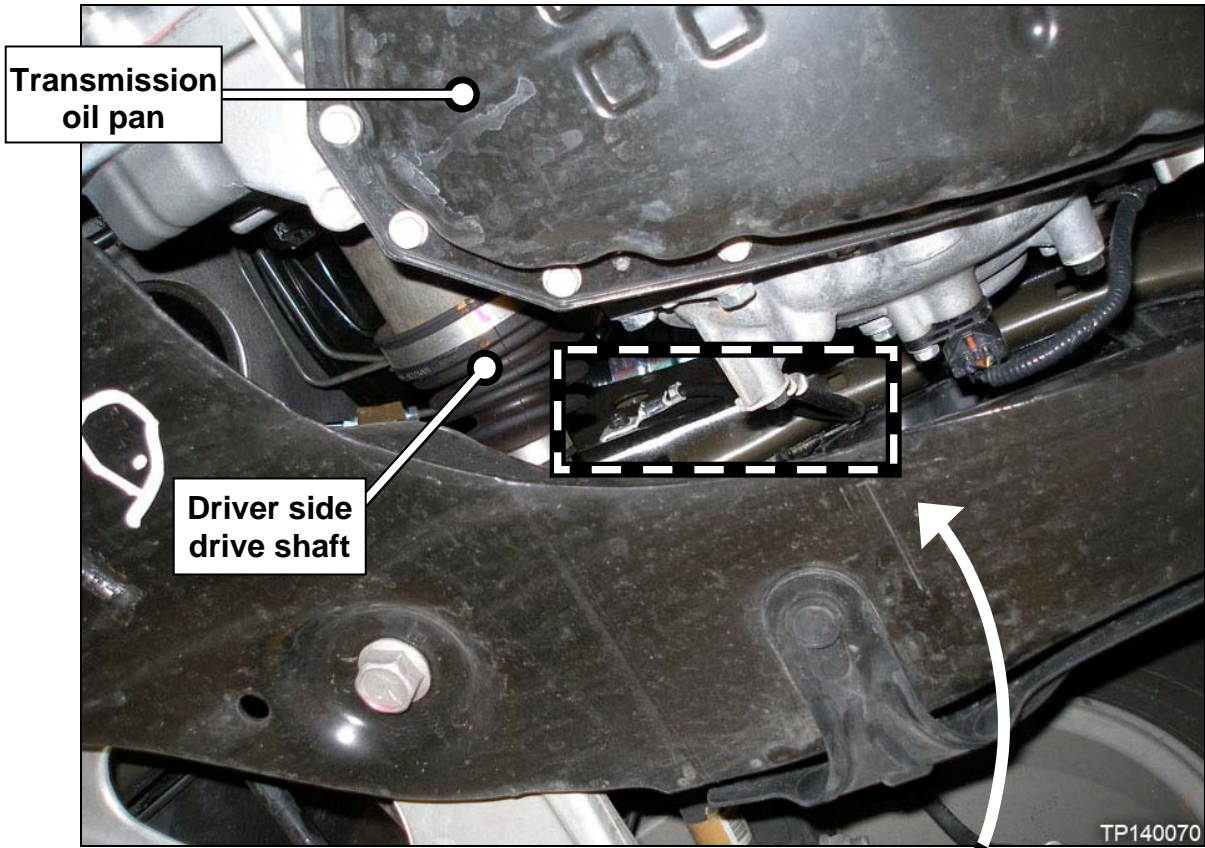
Figure 1: Ground wire.

1. Remove the ground wire connected between the transmission and driver side frame rail.
2. If the noise stops after removing the ground wire in Step 1 above and repeating the procedure under **IF YOU CONFIRM**, replace the ground wire with the one listed in **PARTS INFORMATION**.
  - See page 2, Figure 1 for ground wire location.
  - Before installing, flatten the tabs on both eyelets of the new ground wire (see page 2, Figure 3).
  - Bolts torque: 10 N•m (1.02 kg-m, **88.5 in lbs**)
  - Make sure the ground wire does not twist at either end when securing the bolts.
3. If the noise does not stop after removing the ground wire in step 1 in the **ACTION** section and repeating the procedure under **IF YOU CONFIRM**, this bulletin does not apply. Go back to ASIST and the Electronic Service Manual (ESM) for further diagnostic assistance.

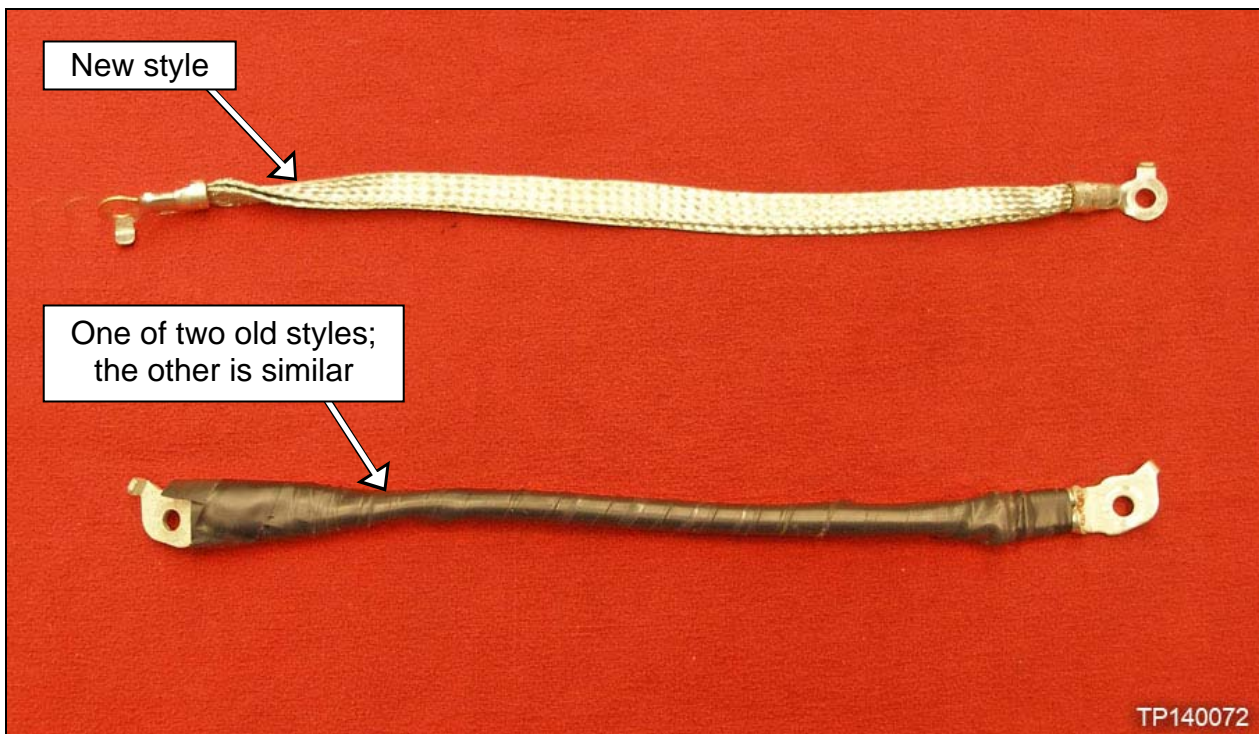
Figure 4: Ground wires.
