# SERVICE BULLETIN

Classification: FE14-001	Reference: NTB14-018	Date: March 20, 2014
-----------------------------	-------------------------	-------------------------

## 2008 – 2014 ROGUE; EXHAUST CENTER TUBE HEAT SHIELD RATTLE

**APPLIED VEHICLES:** 2008 – 2013 Rogue (S35)  
2014 Rogue Select (S35)

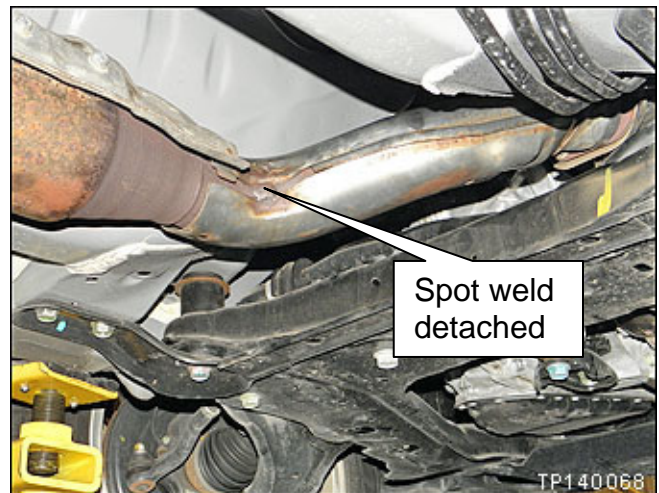
Figure 1

A rattle coming from the exhaust center tube heat shield,

The heat shield spot weld is detached at the location shown in Figure 1.

Install a band clamp around the heat shield and over the detached spot weld.
