# SERVICE BULLETIN

ST14-009

June 6, 2014

## 2014 ALTIMA; HYDRAULIC ELECTRIC POWER STEERING SERVICE INFORMATION

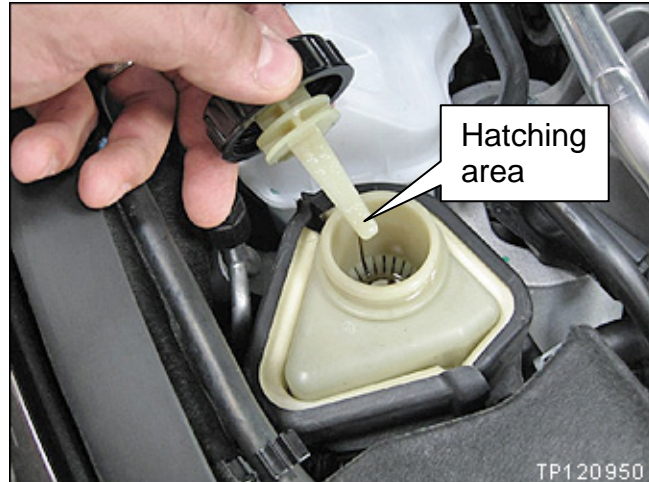
Figure 1

Check the fluid level of the Hydraulic Electric Power Steering (H-EPS) system.

- Check fluid level with the ignition OFF and fluid temperature between 0 – 30°C (32 – 86°F).
- Power steering fluid level should be within the hatching area of the indicator on the power steering reservoir tank cap.
- If fluid is needed, use only genuine NISSAN E-PSF or equivalent.

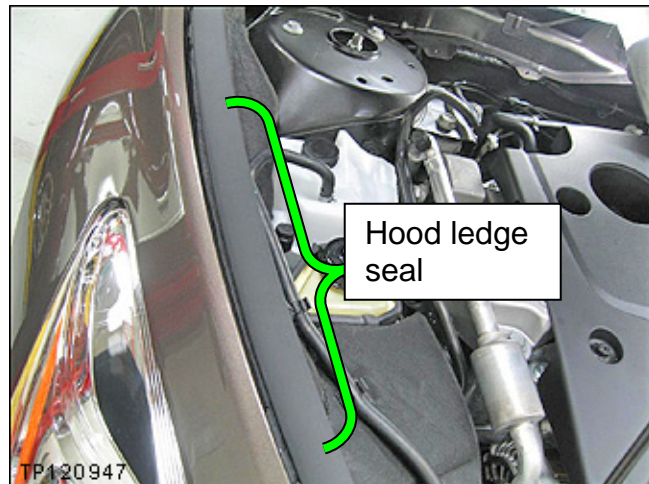
Figure 2

Make sure the right front hood ledge seal (passenger side) is installed correctly.

- Install the seal correctly
- or
- If damaged, replace the seal
- or
- If missing, install a seal.

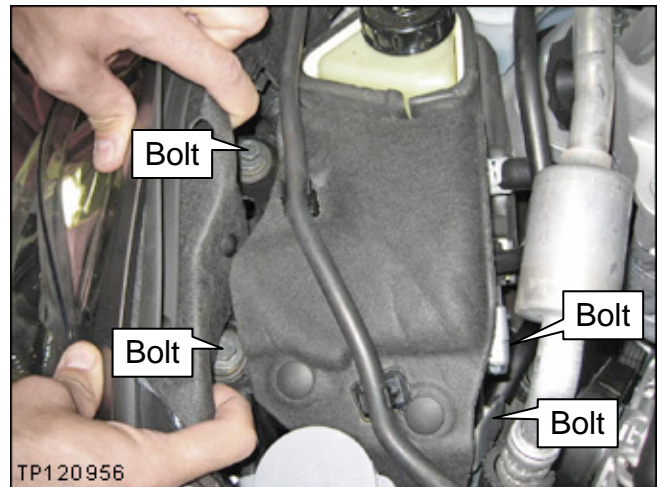
Figure 3

Make sure there is no binding on the H-EPS pump mounting isolator as follows:

- a. Loosen the four (4) H-EPS pump mounting bolts.
- b. Move the H-EPS pump a small amount from side to side.
- c. Tighten the mounting bolts.

13.5 N•m (1.4 kg-m, **10 ft-lb**)

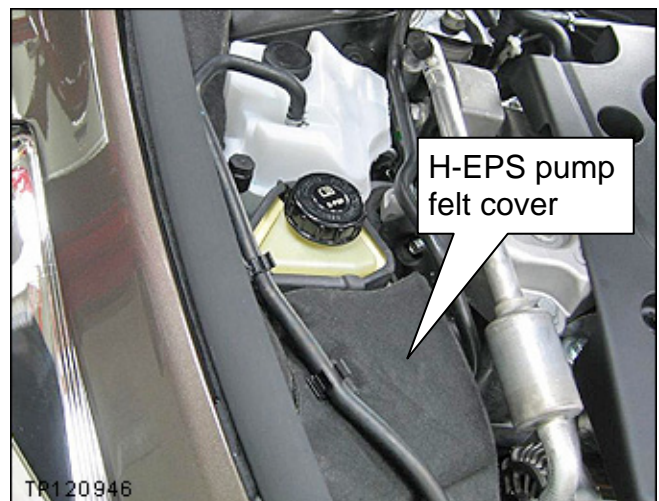
Figure 4

Make sure the H-EPS pump felt cover is installed correctly.

- Install the felt cover correctly
- or
- If damaged, replace the felt cover
- or
- If missing, install a felt cover.

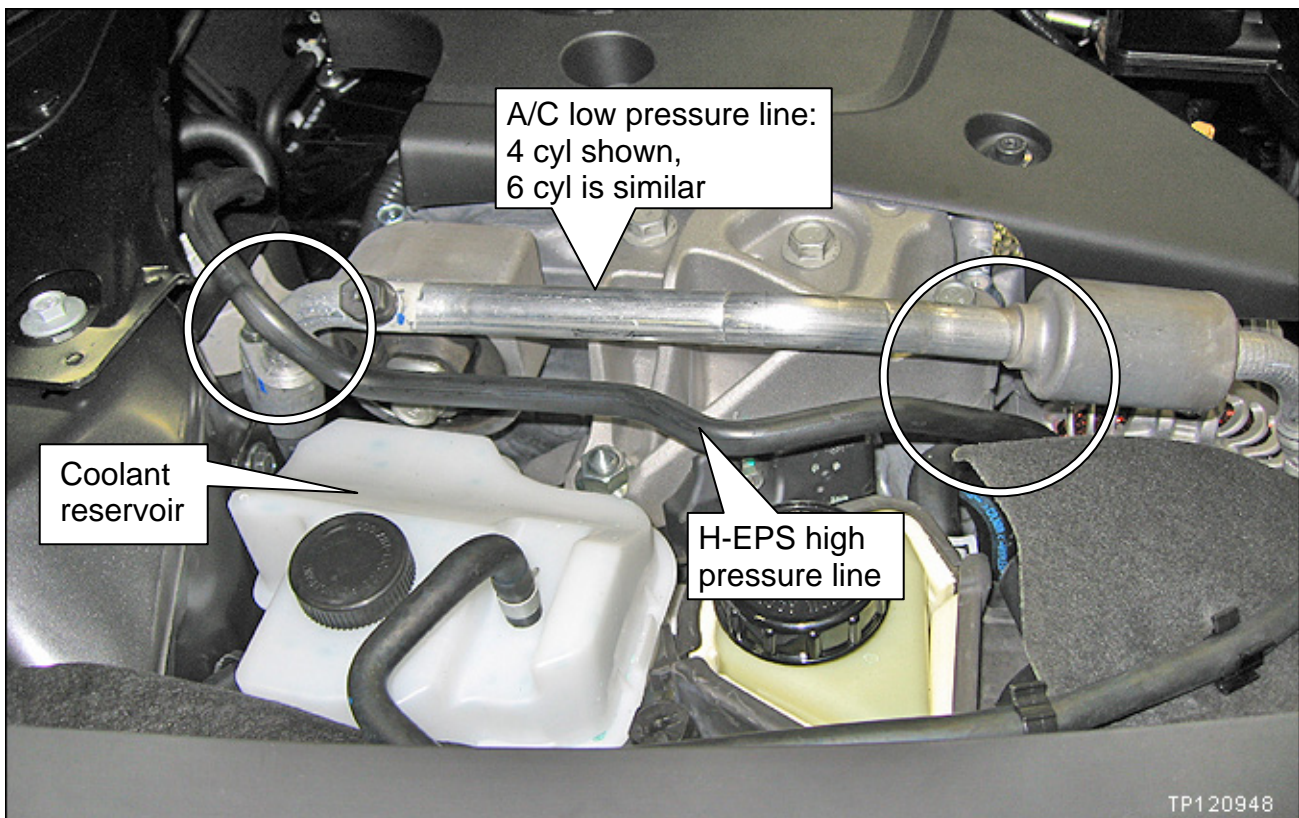
Figure 5

Check the H-EPS high pressure line and the A/C low pressure line. Make sure they are **not** touching each other (see Figure 5).

Check the H-EPS high pressure line and coolant reservoir. Make sure they are **not** touching each other (see Figure 5).

- a. Check the two locations circled in Figure 5.
- b. If the lines are touching, reposition the lines so they are **not** touching.

- a. Make sure the coolant reservoir is mounted correctly; its locator boss must be seated in the mounting hole.
- b. If needed, reposition the H-EPS line so it is **not** touching the reservoir.

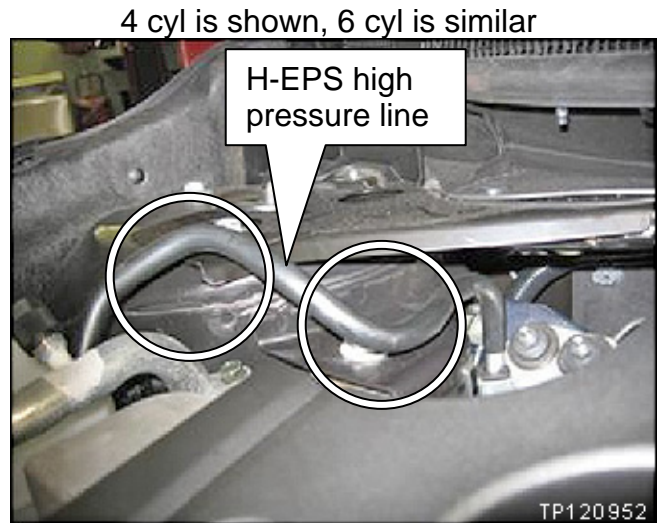
Figure 6

Make sure the H-EPS high pressure line is **not** touching the strut tower brace or the torque rod mounting bracket.

- a. Check the two locations circled in Figure 6.
- b. If needed, reposition the H-EPS high pressure line so it is **not** touching.

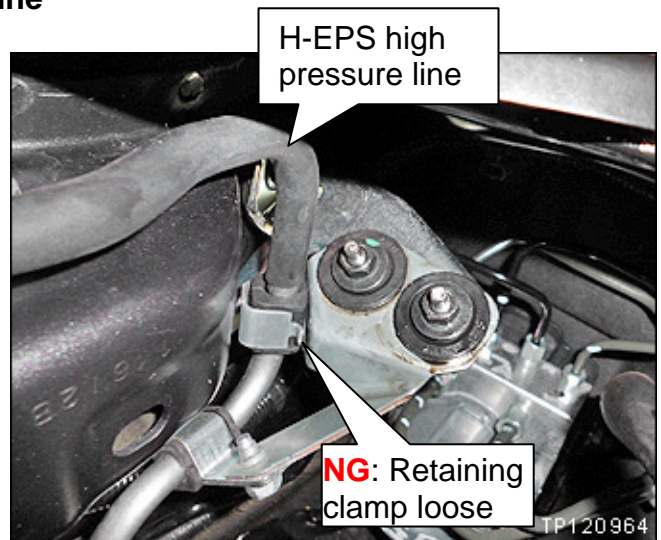
Check the H-EPS high pressure line retaining clamp shown in Figure 7.

- a. Make sure the clamp is secured correctly.
  - Figure 7 shows a clamp that **is not** secured correctly.
- b. If the clamp is loose like the one shown in Figure 7, replace the H-EPS high pressure line.
  - Refer to the Electronic Service Manual (ESM), section **ST-Steering System**, for replacement information.

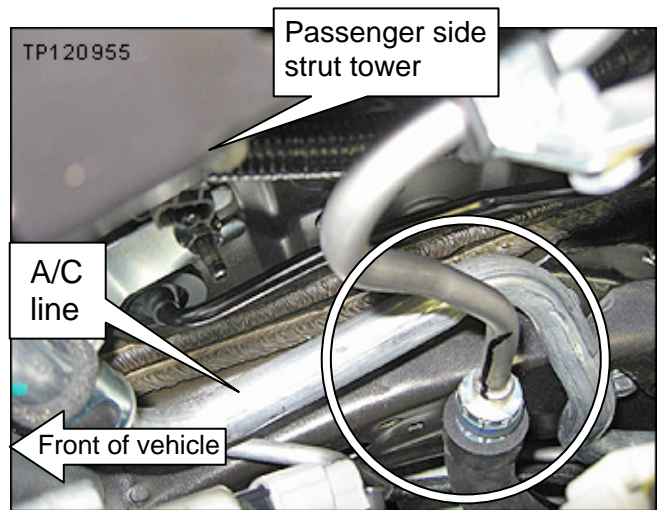
Make sure the H-EPS high pressure line is not touching the A/C line or vehicle body.

**NOTE:** The view in Figure 8 is downward from the inboard side of the passenger side strut tower.

- a. Check the area circled in Figure 10.
- b. If needed, reposition the lines so they are **not** touching.
- c. If needed, reposition the H-EPS line so it is **not** touching the vehicle body.

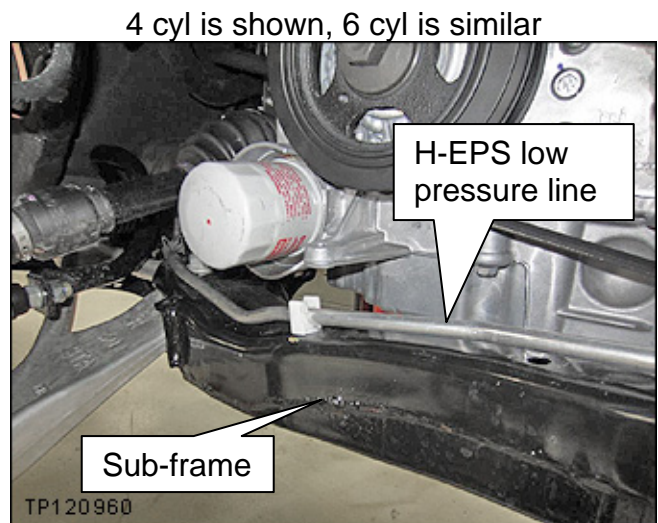
Figure 9

Make sure the H-EPS low pressure line is **not** touching the sub-frame near the front of the engine.

- a. If needed, reposition the H-EPS low pressure line so it does **not** touch the sub-frame.

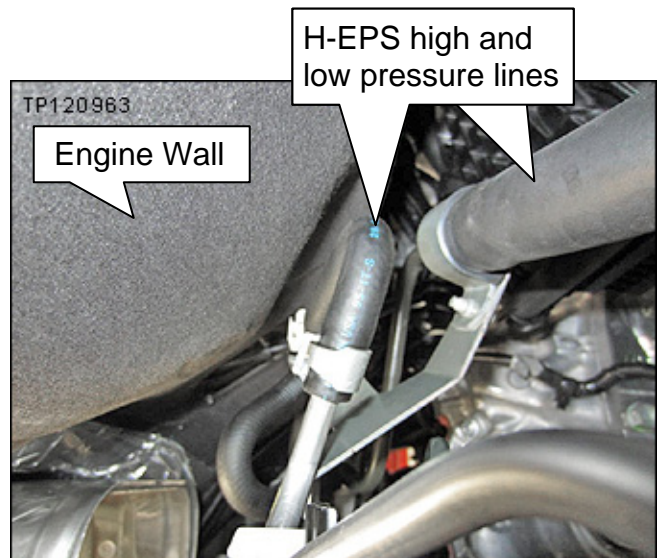
Figure 10

Make sure the H-EPS high and low pressure lines under the vehicle are **not** touching surrounding parts.

- a. Lift the vehicle.
- b. Visually check the routing of the under-vehicle H-EPS high and low pressure lines.
- c. If needed, reposition the H-EPS high and low pressure lines so they are **not** touching any surrounding parts.

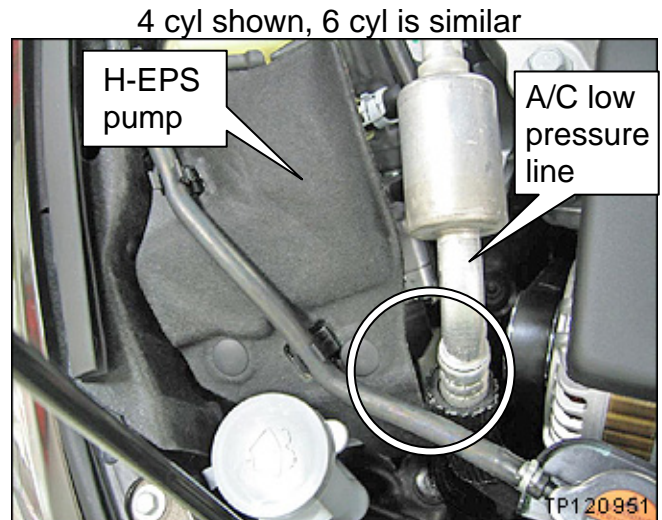
Figure 11

Make sure the A/C low pressure line is **not** touching the H-EPS pump.

- a. Check the location circled in Figure 8.
- b. If needed, reposition the A/C low pressure line so it is **not** touching the H-EPS pump.

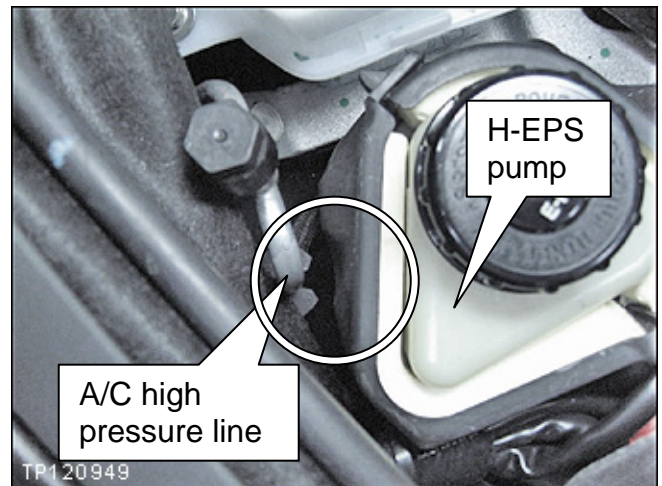
Figure 12

Make sure the A/C high pressure line is **not** touching the H-EPS pump.

- a. Check the location circled in Figure 9.
- b. Wiggle the H-EPS pump and observe the A/C high pressure line. If it moves, it is touching.
- c. If needed, reposition the A/C high pressure line so it is **not** touching the H-EPS pump.

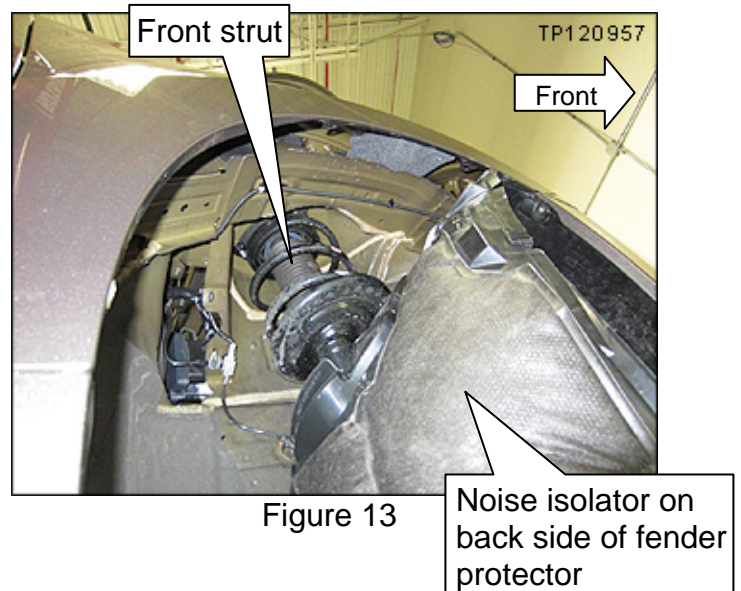
Figure 13

Make sure the noise insulator is installed inside the RH (passenger side) front fender protector:

- a. Remove the passenger side front wheel.
  - b. Partially remove the fender protector.
    - Refer to the ESM, section **EXT-Exterior**, as needed.
  - c. Confirm the insulator is in place.
    - Make sure the insulator is installed correctly
- or
- If damaged or missing, replace the fender protector with insulator.

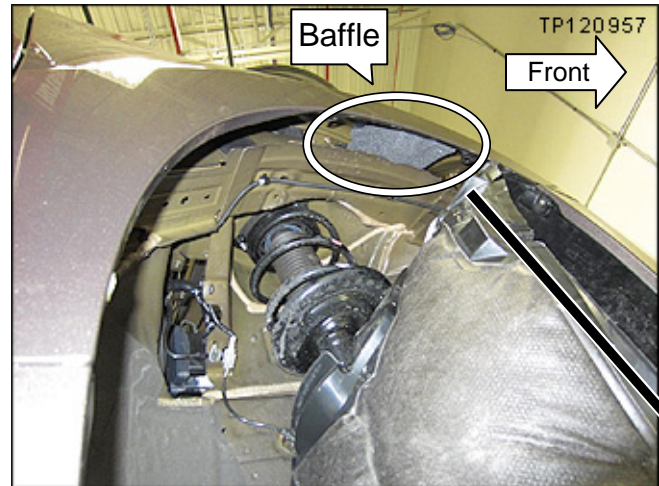
Figure 14

Make sure the baffle is positioned properly inside the RH (passenger side) front fender.

- a. Make sure the baffle is flush against the fender.
- b. There should be no gap between the fender protector and baffle when the fender protector is installed.
- c. If needed, reposition the baffle or install a new one.

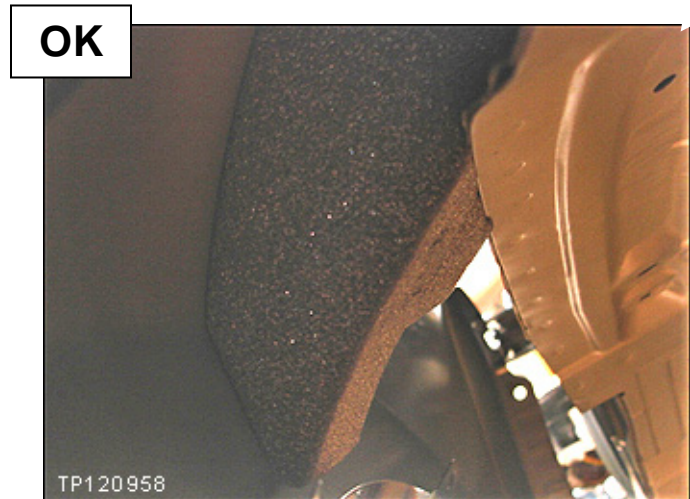
Figure 15 – baffle is **installed correctly**.

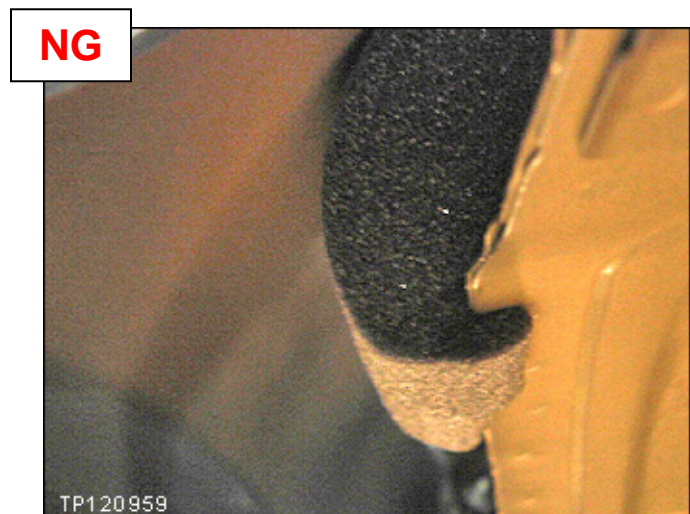
Figure 16 – example of a baffle **installed incorrectly**.

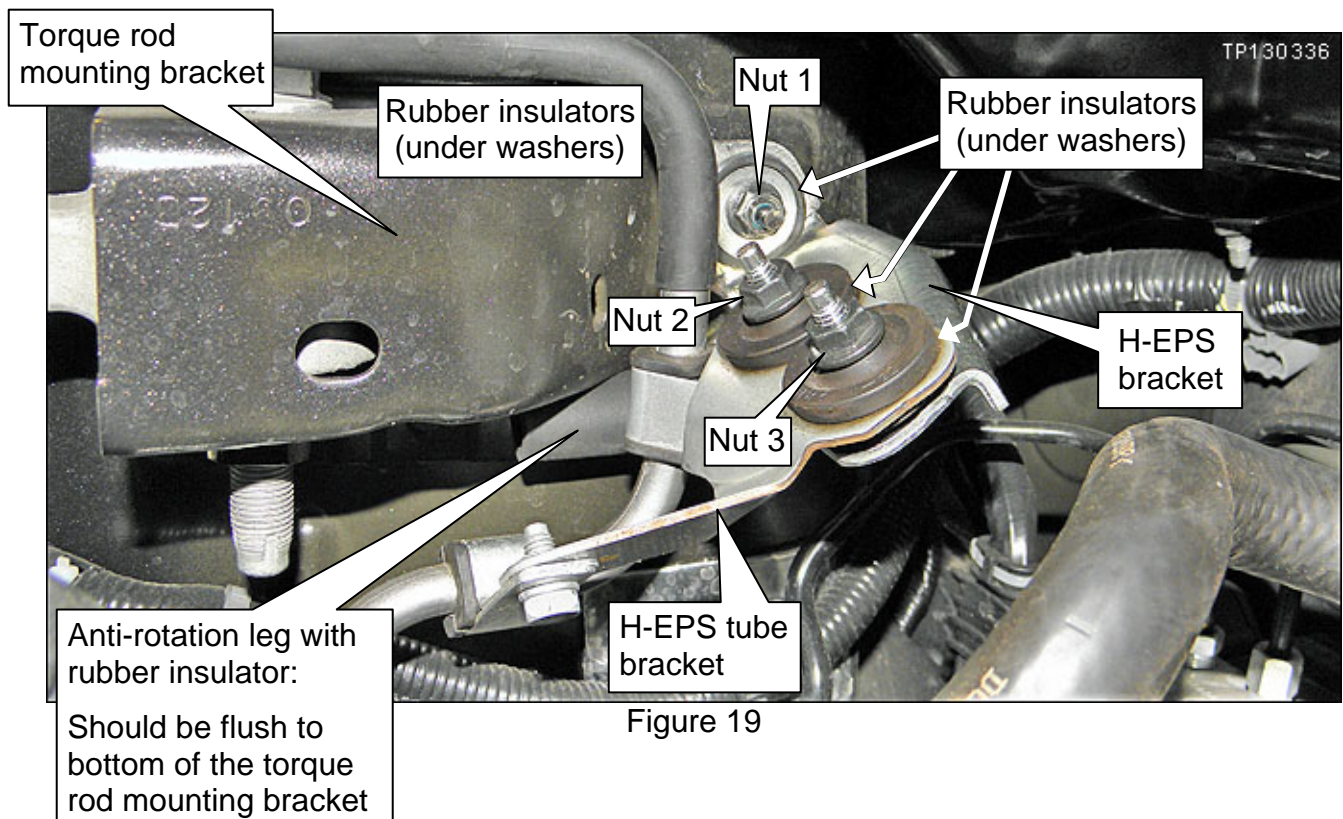
Make sure the H-EPS bracket and the H-EPS tube bracket are not touching (see Figure 19).

Make sure the anti-rotation leg of the H-EPS bracket is flush to the bottom of the torque rod mounting bracket (see Figure 19).

- a. Make sure there is a gap between the brackets all the way around.
- b. Make sure the rubber insulators are seated properly.
- c. If needed, reposition the brackets so they are not touching.

- a. Check the position the H-EPS bracket, make sure its anti-rotation leg is flush to the bottom of the torque rod mounting bracket.

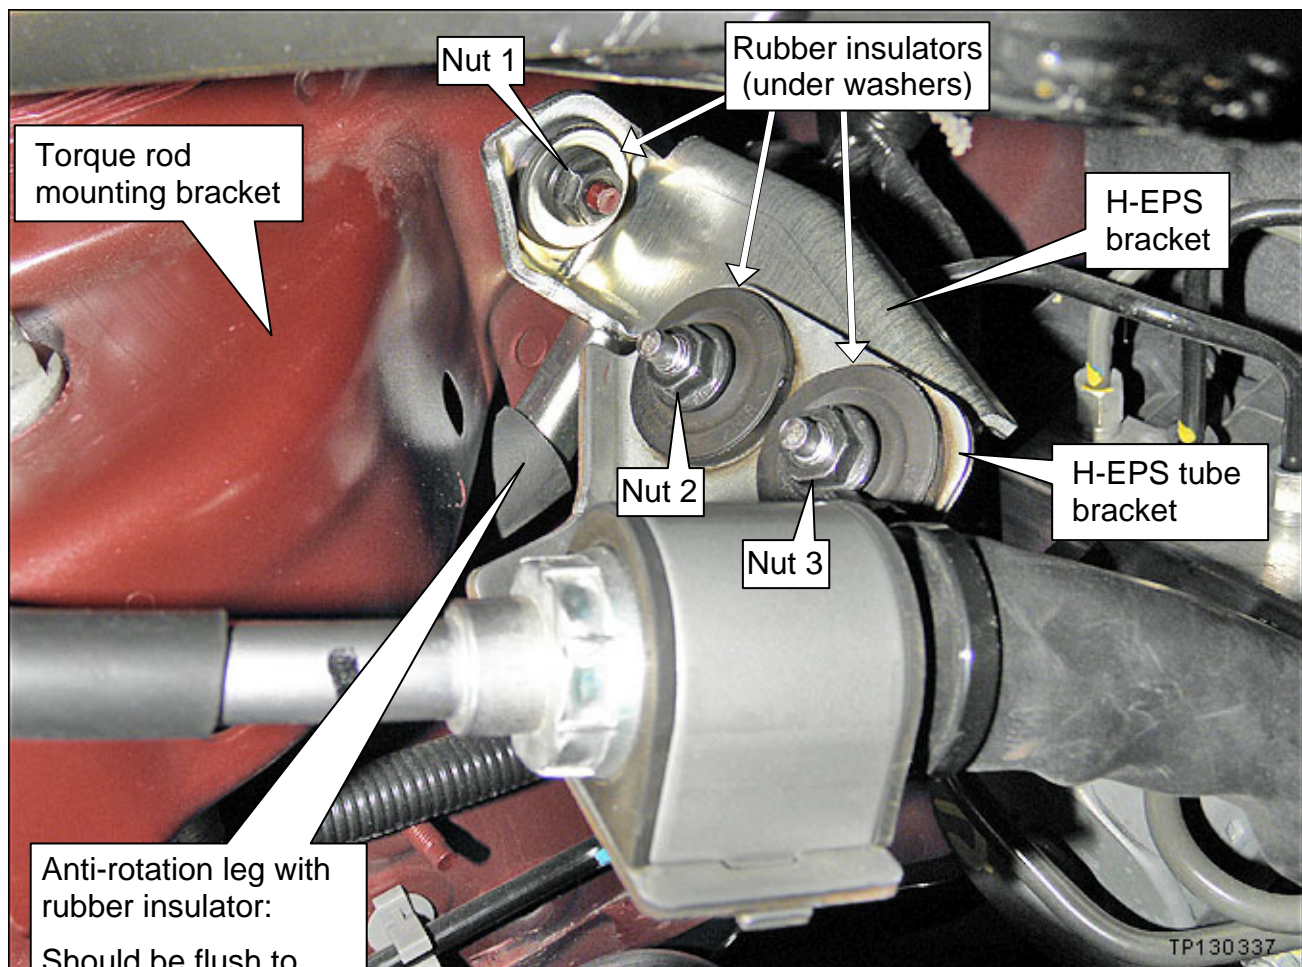
Figure 20

Make sure the H-EPS bracket and the H-EPS tube bracket are not touching (see Figure 20).

Make sure the H-EPS bracket's anti-rotation leg is flush to the bottom of the torque rod mounting bracket (see Figure 20).

- Make sure there is a gap between the brackets, all the way around.
- Make sure the rubber insulators are seated properly.
- If needed, reposition the brackets so they are not touching.

- Check the position the H-EPS bracket, make sure its anti-rotation leg is flush to bottom of the torque rod mounting bracket.
