EM14-007

ITB14-041

August 20, 2014

## 2014 QX80; OIL LEAKING FROM VVEL LADDER ASSEMBLY

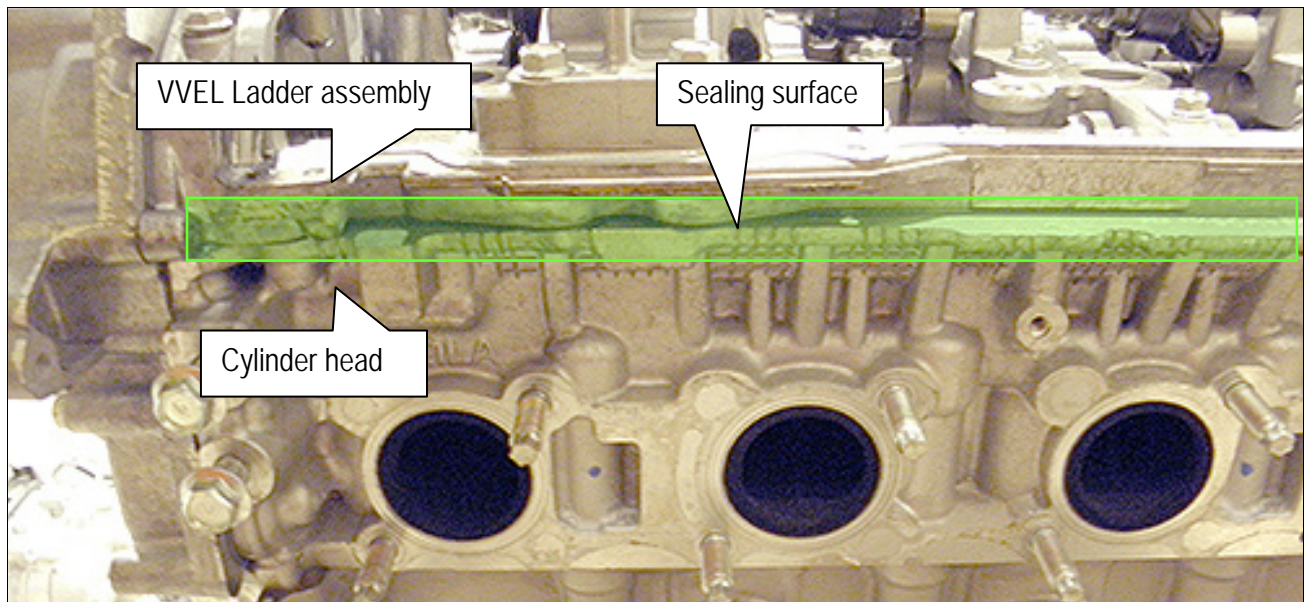
Oil is leaking from bank 1 and/or bank 2 at any point between the VVEL ladder assembly and the related cylinder head at sealing surface shown in Figure 1.

**NOTE:** Figure 1 does not show the entire sealing surface that can be affected and is only an example of where a leak may be found.

Remove the affected VVEL ladder assembly and reseal it.

**NOTE:** Refer to the Electronic Service Manual (ESM) section, **EM – Engine Mechanical / CAMSHAFT / Removal and Installation** for the procedure to remove the VVEL ladder assembly and reseal it.

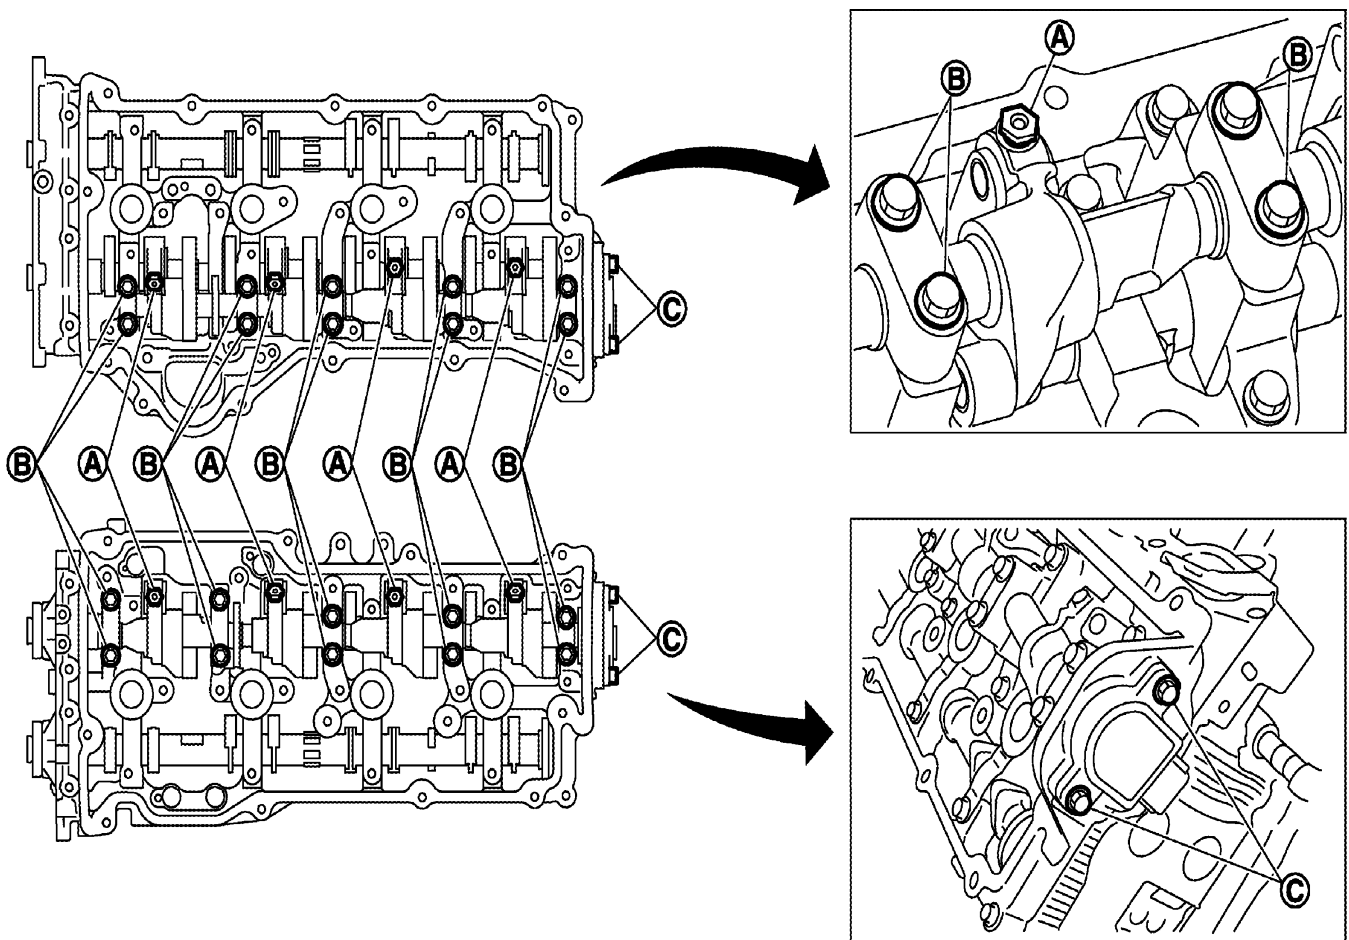
Figure 2

- Never loosen the adjusting bolts (A), mounting bolts (black color) (B) of VVEL ladder assembly, or the mounting bolts (C) of the VVEL control shaft position sensor. If loosened, the stroke of the cam lift will be out of adjustment. In such a case, the replacement of the VVEL ladder assembly and the cylinder head assembly is required.
- Never loosen the mounting bolts (C) of the VVEL control shaft position sensor. VVEL control shaft position sensor mounting bolts are required to be loosened for adjustment only when using a new VVEL ladder assembly.

- Never loosen the adjusting bolts (A), mounting bolts (black color) (B) of VVEL ladder assembly, or the mounting bolts (C) of the VVEL control shaft position sensor.
