SERVICE BULLETIN

Classification:	Reference:	Date:
BT14-006a	NTB14-016a	September 4, 2014

2013-2014 ALTIMA; SQUEAK FROM MOONROOF B-PILLAR AREA

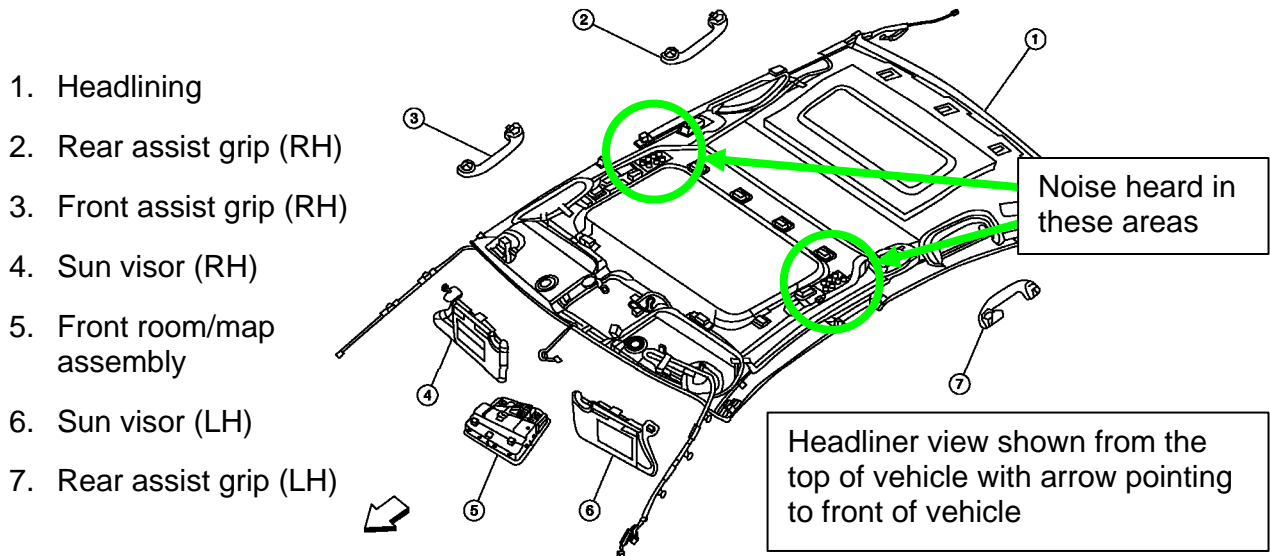
Figure A

A squeaking/ticking noise is coming from the Headliner between the Moonroof and B-pillar area shown in Figure A.

- Can occur on rough roads or during conditions that cause body flex such as when entering or exiting a sloped driveway.

Remove Moonroof brackets and apply "Ultra High Molecular Weight" (UHMW) tape, from Squeak and Rattle kit J-50397 (part # J-50397-15), to the bracket.
