SERVICE BULLETIN

Classification: EL14-045a	Reference: NTB14-090a	Date: October 28, 2014
------------------------------	--------------------------	---------------------------

2015 VERSA SEDAN AND NOTE; AUDIO SOFTWARE UPDATE

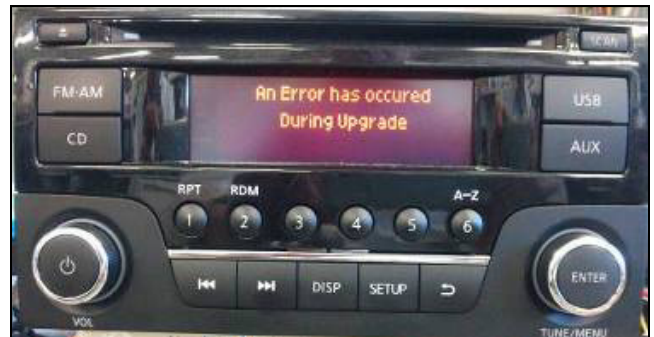
If the screens in Figure 20 or Figure 21 are displayed, the update did not complete:

- Turn the ignition OFF for 10 seconds or more.
- Turn ignition ON (Key On, engine OFF).
 - If the normal mode screen (Figure 4) is displayed, restart the procedure from step 7 on page 5.
 - If the initial update screen is displayed (Figure 5), restart the procedure for updating from step 8 on page 5.
 - If updating has been interrupted prematurely, restart the procedure from step 7 on page 5.
