NISSAN BULLETIN

2014-15 Nissan Pathfinder & Rogue Hub & Torque Member Bolt Dealer Inventory Inspection

Reference: PC330
Date: November 25, 2014

PC330 - Pathfinder (R52) / Rogue (T32) Hub Bolt SERVICE PROCEDURE

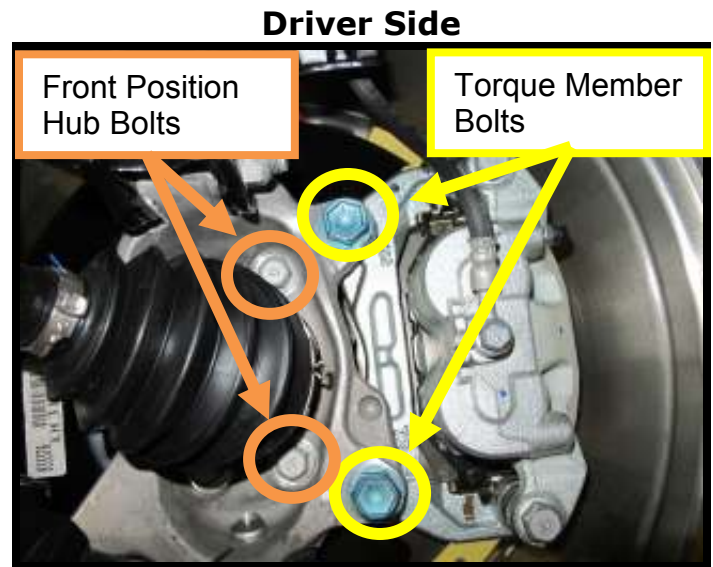
Figure 1

1. Turn the steering wheel to full left turn position.
2. Lift the vehicle using a hoist.
3. On the driver side knuckle, use a torque wrench to torque the following bolts (Figure 1):

- Torque member bolts:
Pathfinder 123N·m (91 ft-lb)
Rogue 165N·m (122 ft-lb)
- Front position hub bolts:
88.3N·m (65 ft-lb)

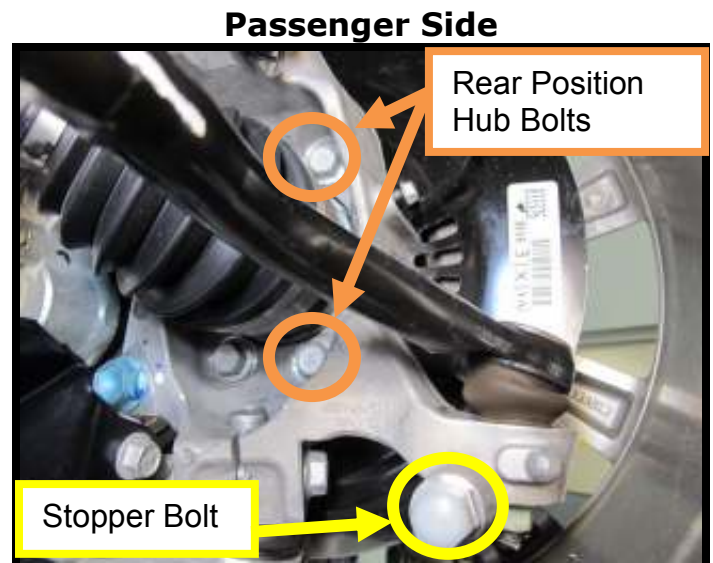
Figure 2

4. On the passenger side knuckle, use a torque wrench to torque the following bolts (Figure 2):

- Rear position hub bolts:
88.3N·m (65 ft-lb)
- Stopper bolt (**Pathfinder only**): 63N·m (46 ft-lb)

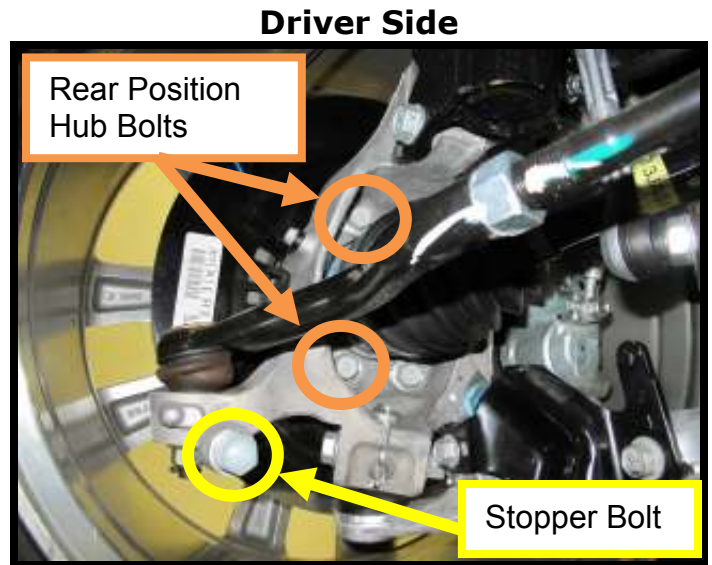
Figure 3

6. On the driver side knuckle, use a torque wrench to torque the following bolts (Figure 3):

- Rear position hub bolts: 88.3N·m (65 ft-lb)
- Stopper bolt (**Pathfinder only**): 63N·m (46 ft-lb)

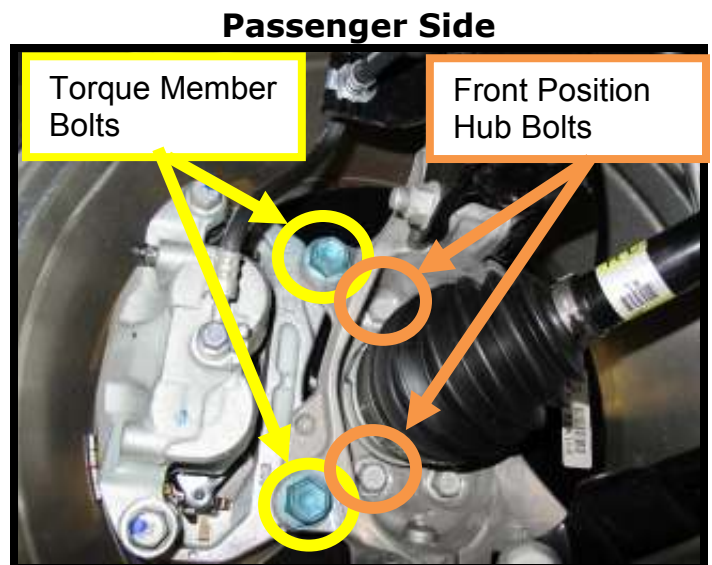
Figure 4

7. On the passenger side knuckle, use a torque wrench to torque the following bolts (Figure 4):

- Torque member bolts:
Pathfinder 123N·m (91 ft-lb)
Rogue 165N·m (122 ft-lb)
- Front position hub bolts: 88.3N·m (65 ft-lb)
