EC14-014

2013 JX35 AND 2014 QX60; IDLE QUALITY IN DRIVE AND A/C ON

APPLIED VEHICLES: 2013 JX35 (L50)
2014 QX60 (L50)

APPLIED ENGINE: VQ35 (6 cyl)

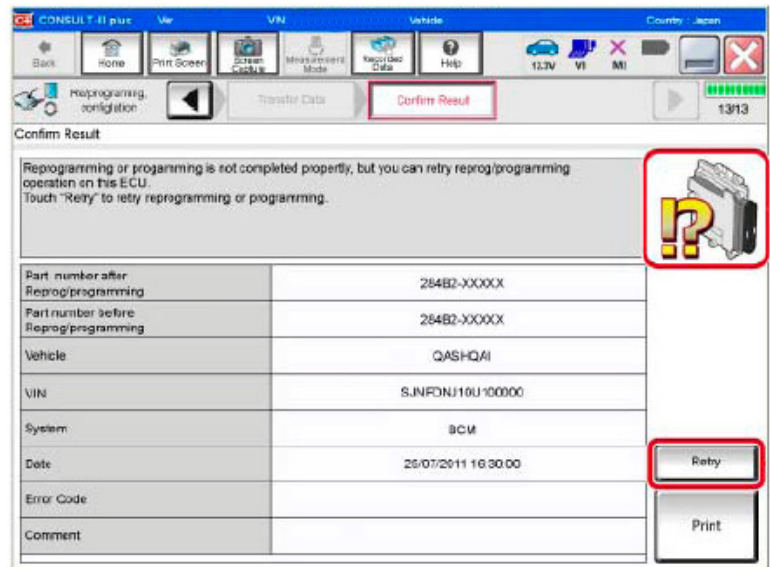
Figure 5

If reprogramming does not complete and the “!” icon displays as shown in Figure 5:

- Check battery voltage (12.0–15.5 V).
- Ignition is ON, engine OFF.
- External Bluetooth® devices are OFF.
- All electrical loads are OFF.
- **Select retry and follow the on screen instructions.**
- “Retry” may not go through on first attempt and can be selected more than once.

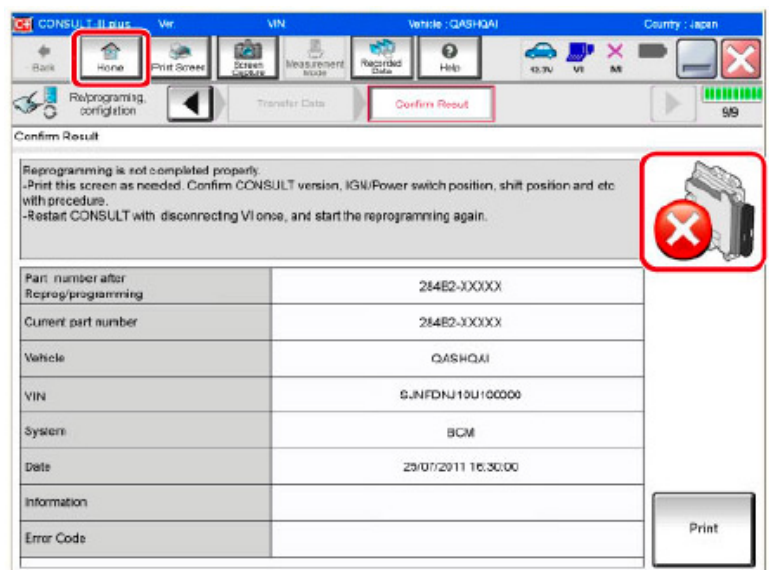
Figure 6

If reprogramming does not complete and the “X” icon displays as shown in Figure 6:

- Check battery voltage (12.0 – 15.5 V).
- CONSULT A/C adapter is plugged in.
- Ignition is ON, engine OFF.
- Transmission is in Park.
- All C-III plus / VI cables are securely connected.
- All C-III plus updates are installed.
- **Select Home, and restart the reprogram procedure from the beginning.**
