ITB15-006

January 28, 2015

## VOLUNTARY SERVICE CAMPAIGN 2015 QX60; RIGHT FRONT LOWER DASH SEAM SEAL

CAMPAIGN ID #: PC341  
APPLIED VEHICLE: 2015 QX60 (L50)  
2015 QX60 Hybrid (L50)

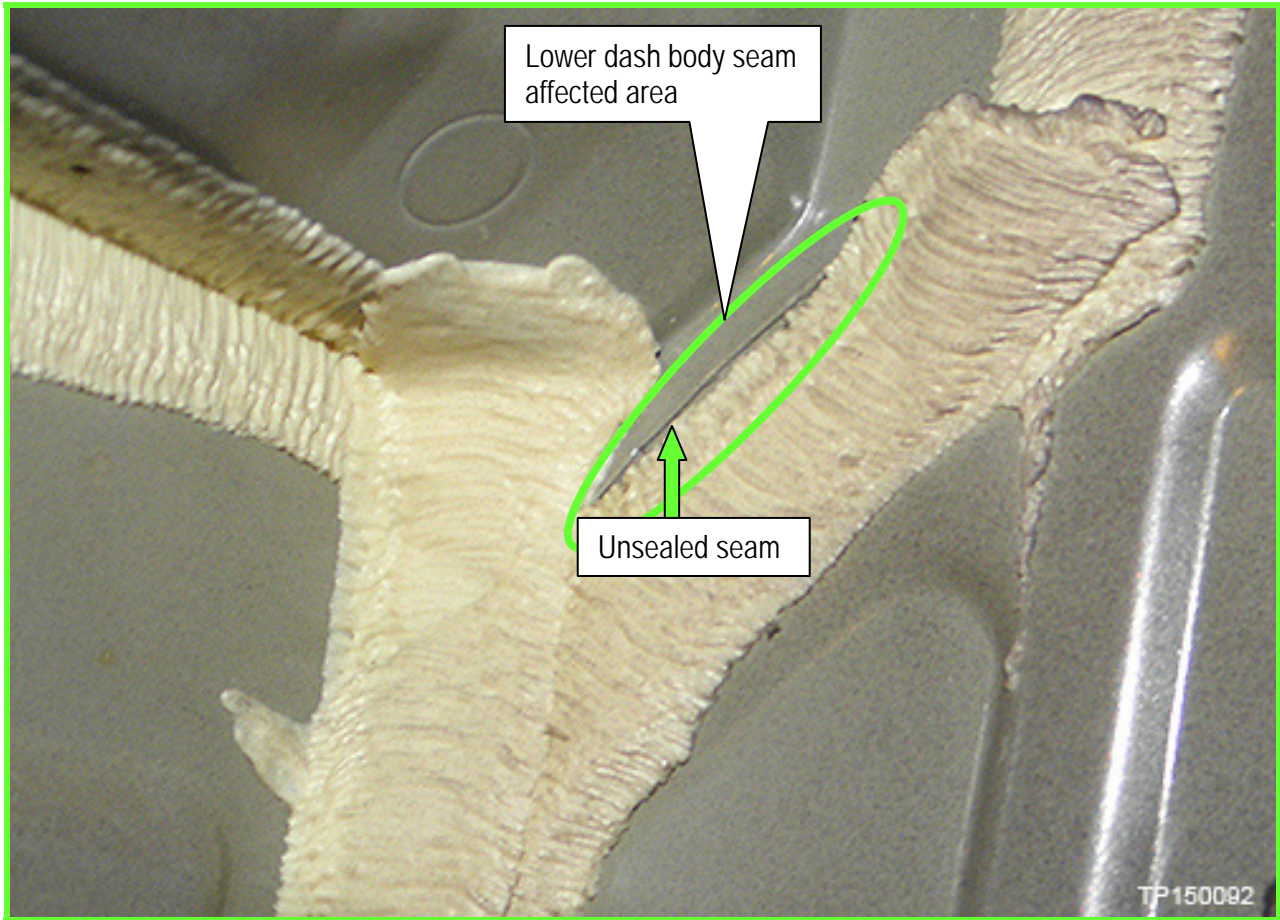
Infiniti is conducting a Voluntary Service Campaign on certain specific Model Year 2015 Infiniti QX60. A short section of the bulkhead seam under the passenger side A-Pillar was not completely sealed during vehicle production. This seam will be sealed at no charge for parts or labor.

12. Locate the lower dash body seam affected area, refer to Figure 8 and Figure 9.
