SERVICE BULLETIN

AT15-004

NTB15-017

2014 NV200 TAXI; MIL ON WITH DTC P0776 AND/OR VEHICLE LACKS POWER

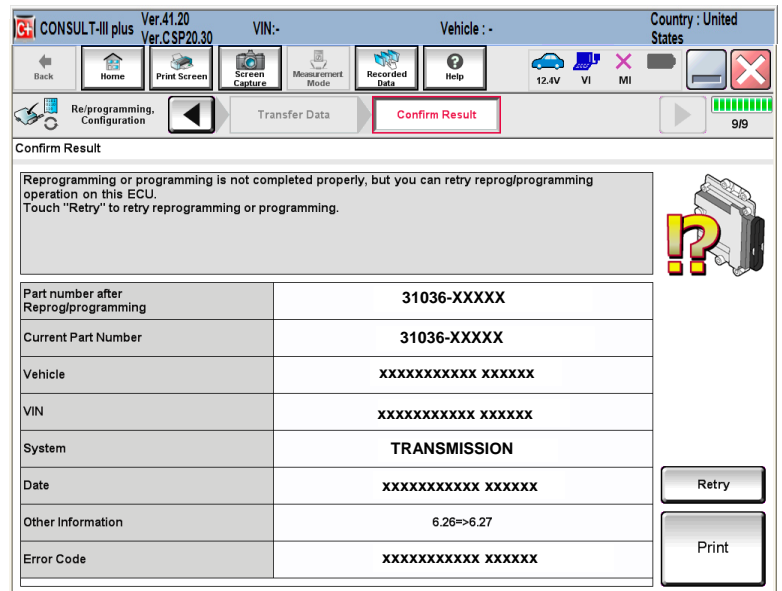
Figure 5

NOTE: If reprogramming does not complete and the **!?** displays as shown in Figure 5:

- Check battery voltage (12.0 - 15.5V).
- Ignition is ON, engine is OFF.
- External Bluetooth® devices are OFF.
- All electrical loads are OFF.
- **Select Retry and follow the on screen instructions.**
- **Retry may not go through on the first attempt and can be selected more than once.**

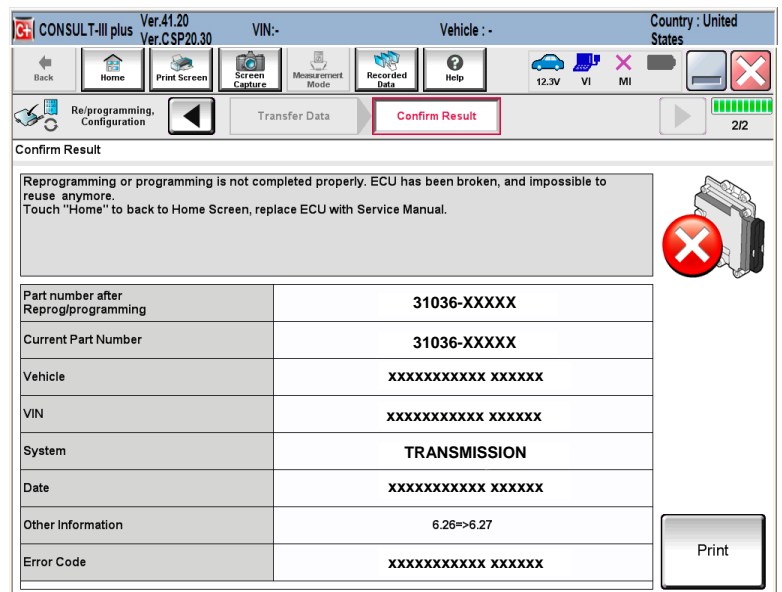
Figure 6

OR: If reprogramming does not complete and the **X** displays as shown in Figure 6:

Do not disconnect plus VI or shut down Consult III plus if reprogramming does not complete.

- Check battery voltage (12.0 - 15.5V).
- CONSULT A/C adapter is plugged in.
- Ignition is ON, engine is OFF.
- Transmission in Park.
- All C-III plus / plus VI cables are securely connected.
- All C-III plus updates are installed.
