SERVICE BULLETIN

Classification:	Reference:	Date:
EC15-007	NTB15-051	June 12, 2015

2015 ALTIMA, PATHFINDER, AND MURANO; MIL ON AND REAR O2 SENSOR RELATED DTC STORED

APPLIED VEHICLES: 2015 Altima (L33) with V6 engine ONLY
2015 Pathfinder (R52)
2015 Murano (Z52)

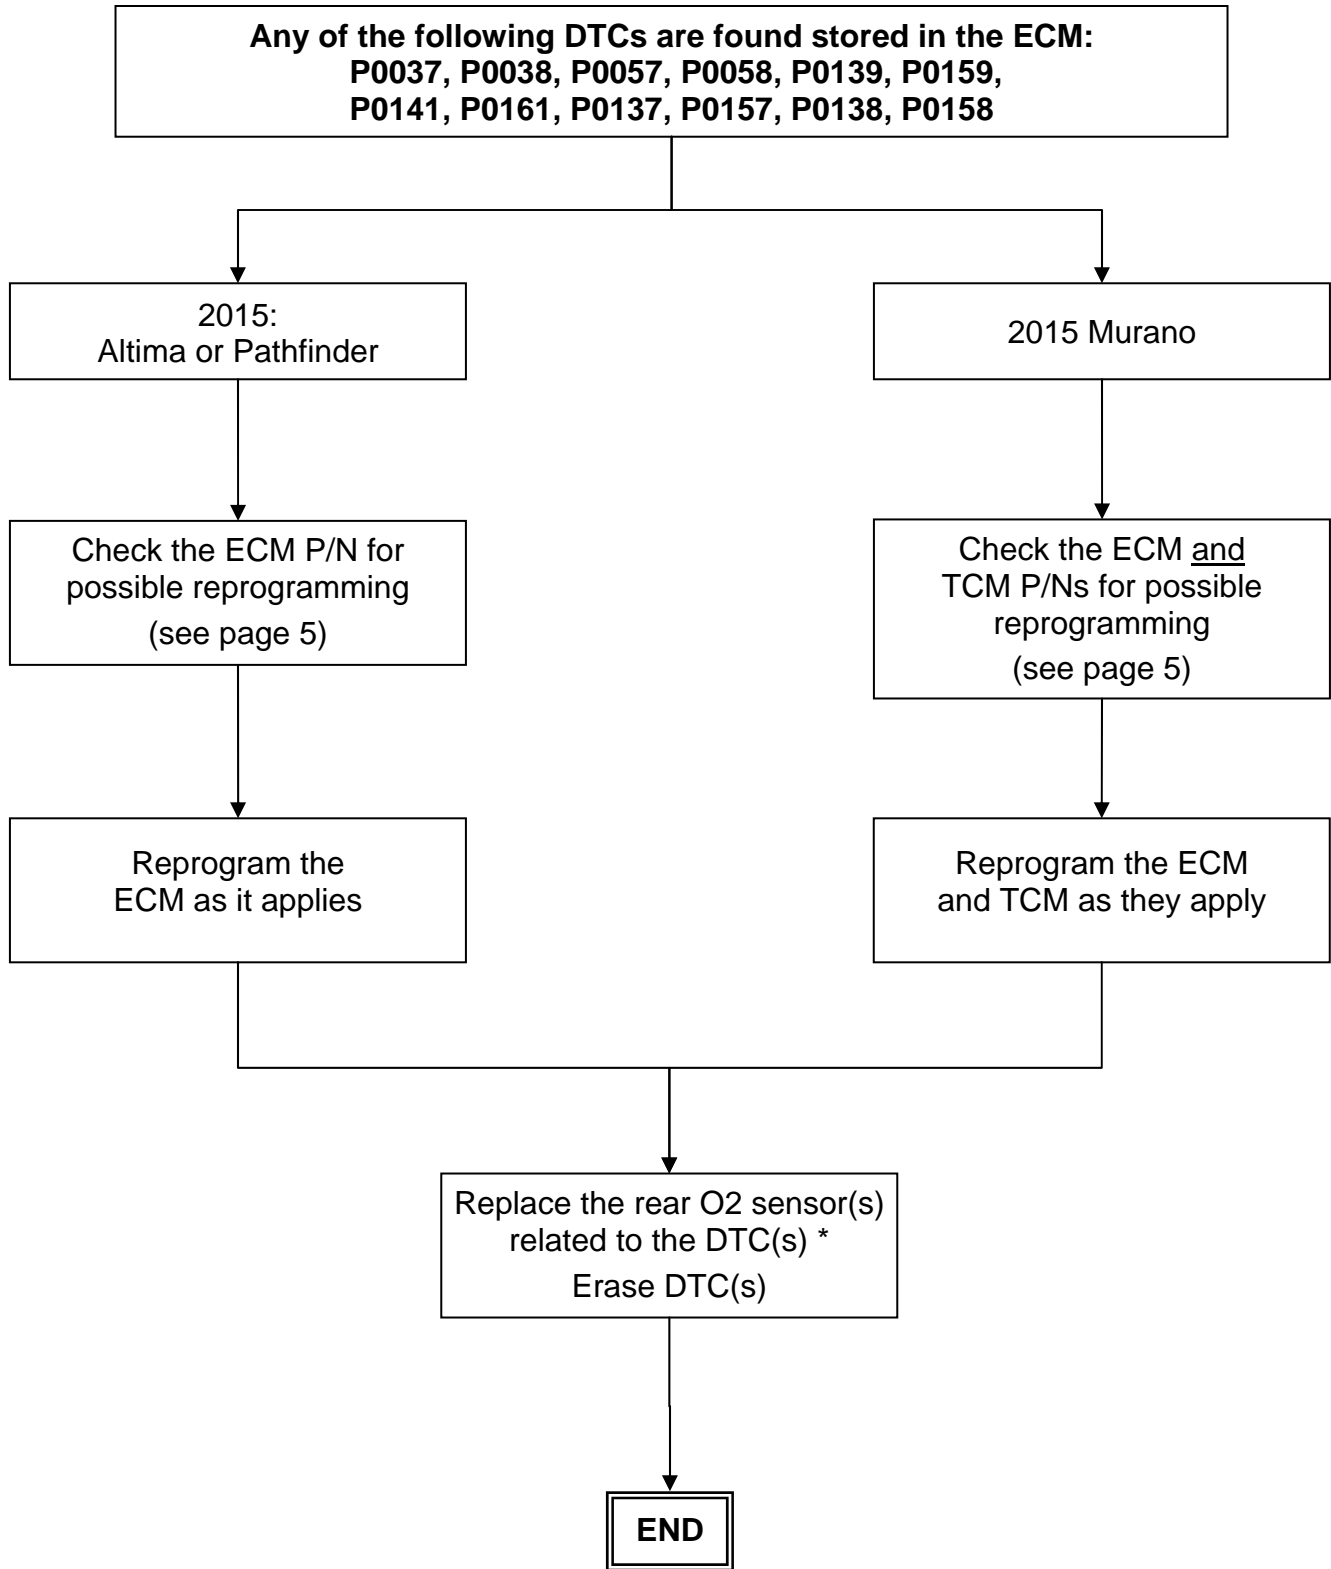
FLOW CHART

IF YOU CONFIRM:

Any of the following DTCs are stored in the ECM:

- P0037, P0038, P0057, P0058, P0139, P0159, P0141, P0161, P0137, P0157, P0138, P0158

* Replace only the rear O2 sensor that relates to the stored DTC(s) (B1 and/or B2). Do NOT replace both rear O2 sensors if the DTC(s) is for one rear O2 sensor.

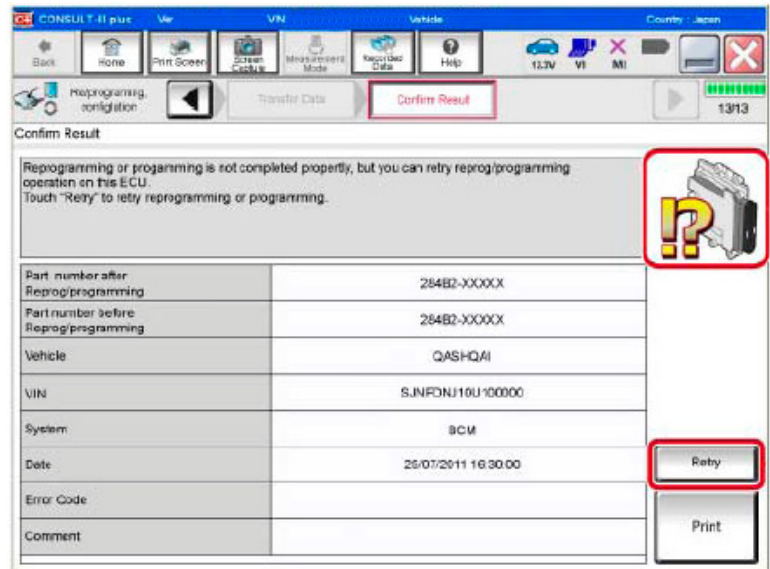
Figure 5

If reprogramming does not complete and the “!?” icon displays as shown in Figure 5:

- Check battery voltage (12.0–15.5 V).
- Ignition is ON, engine OFF.
- External Bluetooth® devices are OFF.
- All electrical loads are OFF.
- **Select retry and follow the on screen instructions.**
- “Retry” may not go through on first attempt and can be selected more than once.

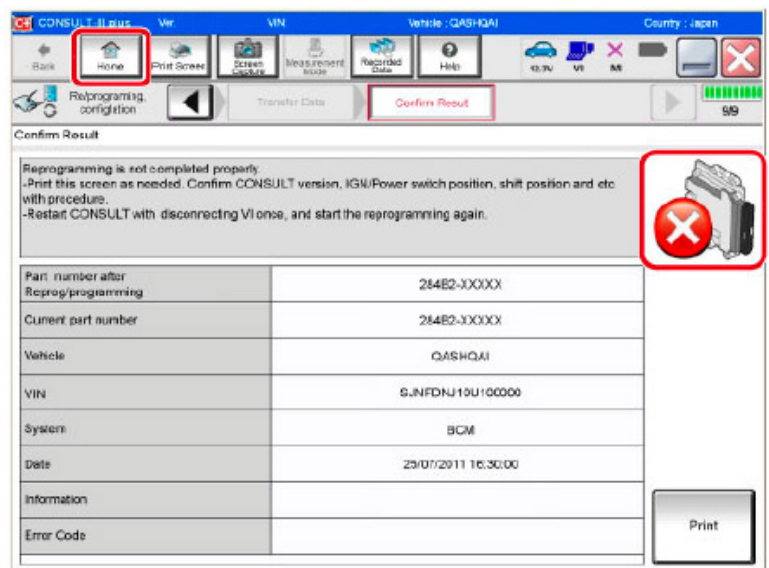
Figure 6

If reprogramming does not complete and the “X” icon displays as shown in Figure 6:

- Check battery voltage (12.0 – 15.5 V).
- CONSULT A/C adapter is plugged in.
- Ignition is ON, engine OFF.
- Transmission is in Park.
- All C-III plus / plus VI cables are securely connected.
- All C-III plus updates are installed.
- **Select Home, and restart the reprogram procedure from the beginning.**
