EC15-008

June 12, 2015

2015 QX60; MIL ON WITH REAR O2 SENSOR RELATED DTC STORED

APPLIED VEHICLE: 2015 QX60 (L50)

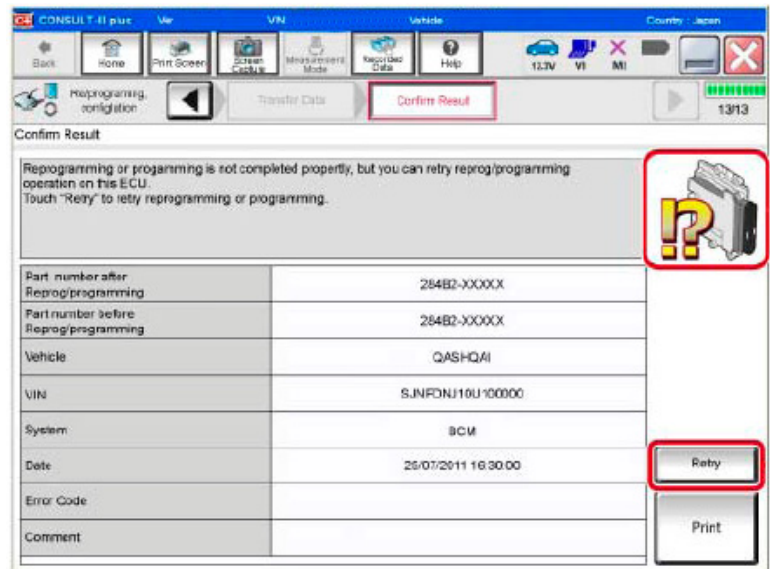
Figure 5

If reprogramming does not complete and the “!” icon displays as shown in Figure 5:

- Check battery voltage (12.0–15.5 V).
- Ignition is ON, engine OFF.
- External Bluetooth® devices are OFF.
- All electrical loads are OFF.
- **Select retry and follow the on screen instructions.**
- “Retry” may not go through on first attempt and can be selected more than once.

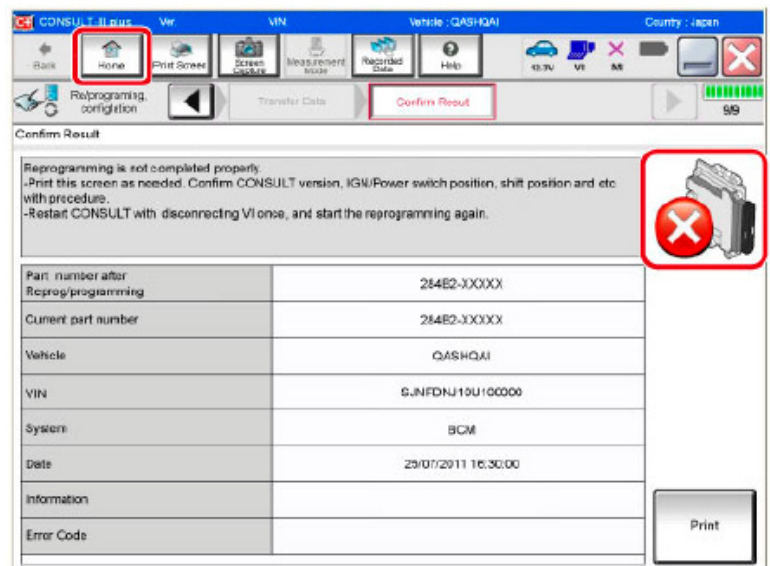
Figure 6

If reprogramming does not complete and the “X” icon displays as shown in Figure 6:

- Check battery voltage (12.0 – 15.5 V).
- CONSULT A/C adapter is plugged in.
- Ignition is ON, engine OFF.
- Transmission is in Park.
- All C-III plus / plus VI cables are securely connected.
- All C-III plus updates are installed.
- **Select Home, and restart the reprogram procedure from the beginning.**
