## 2015 QX60 Transverse Link

### Retailer Inventory Inspection

Reference: PC377  
Date: June 23, 2015

# PC377 – 2015 Infiniti - QX60 (L50) – Transverse (TV) Link Pivot Locking Nut and Torque Service Inspection SERVICE PROCEDURE

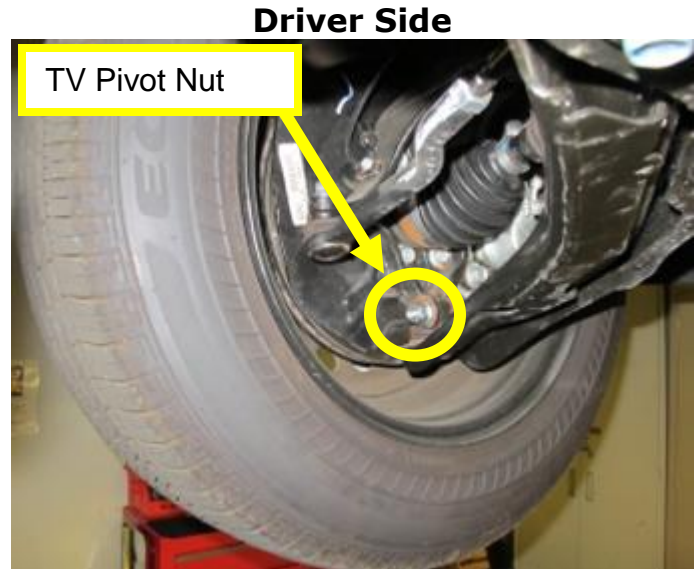
Figure 1

1. Lift the vehicle using a hoist.
2. On the driver side knuckle, inspect TV Link Pivot Nut/Bolt (Figure 1) to ensure it is a locking nut as pictured in (Figure 2).
3. If locking nut is present use a torque wrench and an 18MM wrench to hold the bolt secure while checking the torque to the following spec:
  - TV Link Pivot Nut/Bolt:  
97.5N·m (72 ft-lb)

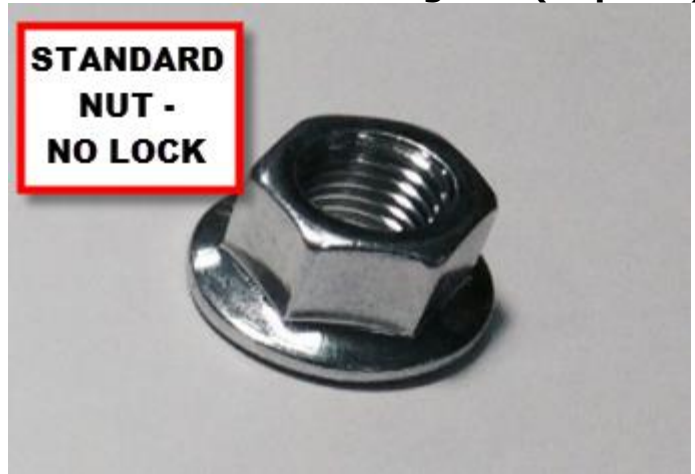
Figure 3

6. If a locking nut is **NOT** present (Figure 3) order the correct locking nut using normal Nissan Parts ordering system. Using a torque wrench and an 18 MM wrench to hold the bolt secure while torqueing to the following spec:

### Not Correct NON-Locking Nut (Replace)

- TV Link Pivot Nut/Bolt:  
97.5N·m (72 ft-lb)

- Replace TV Link Pivot nuts and torque to proper torque
  - 97.5N·m (72 ft-lb).
- Submit warranty claim using Op Code **PC3771** (see claims info).
- Release the vehicle.

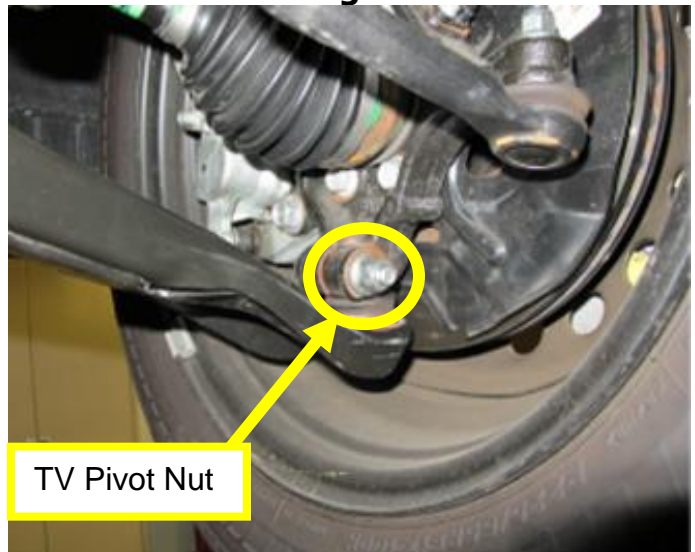
Figure 4

4. On the passenger side knuckle, inspect TV Link Pivot Nut/Bolt (Figure 4) to ensure it is a locking nut as pictured in (Figure 2).
5. If locking nut is present use a torque wrench and an 18MM wrench to hold the bolt secure while checking the torque to the following spec:
  - TV Link Pivot Nut/Bolt:  
97.5N·m (72 ft-lb)
