2015 Pathfinder & Rogue (T32) Transverse Link Dealer Inventory Inspection

Reference: PC378
Date: June 23, 2015

PC378 – 2015 Nissan – Pathfinder (R52) / Rogue (T32) – Transverse (TV) Link Pivot Locking Nut and Torque Service Inspection SERVICE PROCEDURE

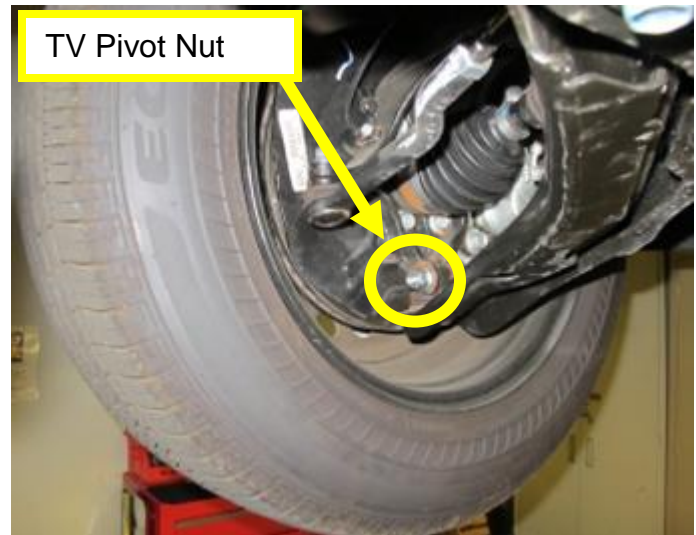
Figure 1

1. Lift the vehicle using a hoist.
2. On the driver side knuckle, inspect TV Link Pivot Nut/Bolt (Figure 1) to ensure it is a locking nut as pictured in (Figure 2).
3. If locking nut is present use a torque wrench and an 18MM wrench to hold the bolt secure while checking the torque to the following spec:

Driver Side

- **For Pathfinder:** TV Link Pivot Nut/Bolt:
97.5N·m (72 ft-lb)
- **For Rogue :** TV Link Pivot Nut/Bolt:
102.5N·m (76 ft-lb)

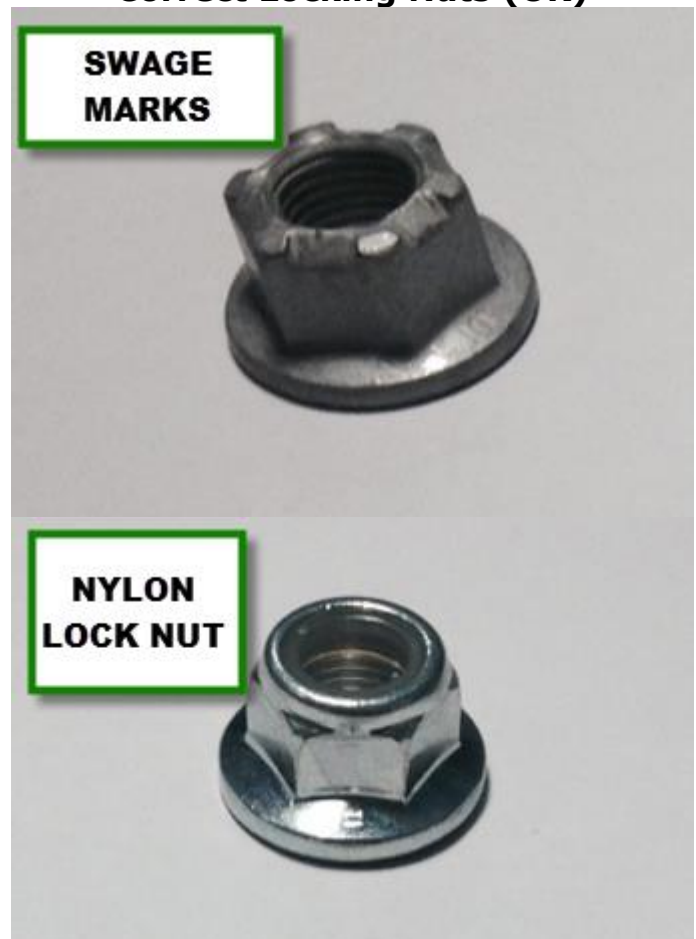
Figure 2

Correct Locking Nuts (OK)

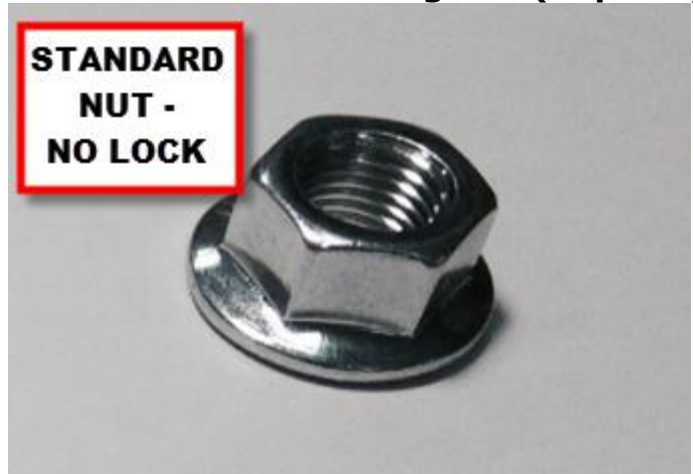
Figure 3

Not Correct NON-Locking Nut (Replace)

6. If a locking nut is **NOT** present (Figure 3) order the correct locking nut using normal Nissan Parts ordering system. Using a torque wrench and an 18 MM wrench to hold the bolt secure while torquing to the following spec:

- **For Pathfinder:** TV Link Pivot Nut/Bolt:
97.5N·m (72 ft-lb)
- **For Rogue :** TV Link Pivot Nut/Bolt:
102.5N·m (76 ft-lb)

- Replace TV Link Pivot nuts and torque to proper torque
 - **Pathfinder:** 97.5N·m (72 ft-lb).
 - **Rogue:** 102.5N·m (76 ft-lb).
- Submit warranty claim using Op Code **PC3781** (see claims info).
- Release the vehicle.

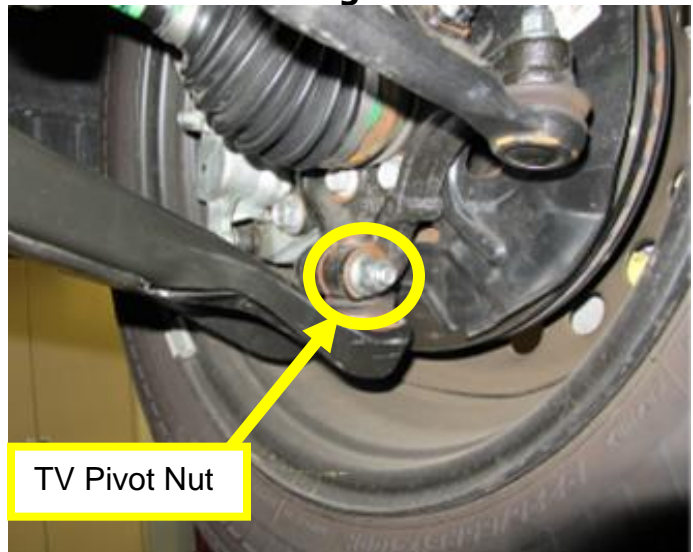
Figure 4

4. On the passenger side knuckle, inspect TV Link Pivot Nut/Bolt (Figure 4) to ensure it is a locking nut as pictured in (Figure 2).

Passenger Side

5. If locking nut is present use a torque wrench and an 18MM wrench to hold the bolt secure while checking the torque to the following spec:

- **For Pathfinder:** TV Link Pivot Nut/Bolt:
97.5N·m (72 ft-lb)
- **For Rogue :** TV Link Pivot Nut/Bolt:
102.5N·m (76 ft-lb)
