BR14-006a

ITB14-051a

July 29, 2015

## JX35, QX60, AND Q50; FCW MALFUNCTION AND DTC C1A27 STORED

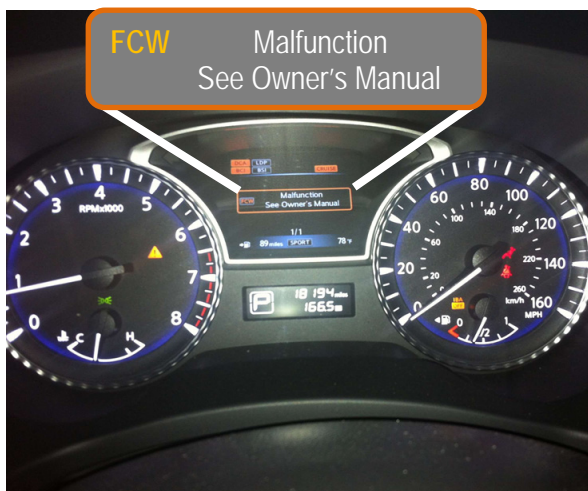
Figure A: JX35/QX60 combination meter

- The FCW (Forward Collision Warning) malfunction is ON or reported to have been ON, and
- DTC C1A27 (ECD POWER SUPPLY CIRCUIT) is stored (Past or Current), and
- The brake fluid level is normal.

**NOTE:** C1A27 is an ICC (Intelligent Cruise Control) DTC.

Reprogram the ABS control unit (ABS) per the Service Procedure in this bulletin.
