# SERVICE BULLETIN

Classification: AT15-011	Reference: NTB15-083	Date: October 7, 2015
-----------------------------	-------------------------	--------------------------

## 2013-2015 ALTIMA AND 2014-2016 ROGUE; ENHANCED DIAGNOSTIC LOGIC FOR CVT JUDDER

**APPLIED VEHICLES:** 2013-2015 Altima (L33)  
2014-2016 Rogue (T32)

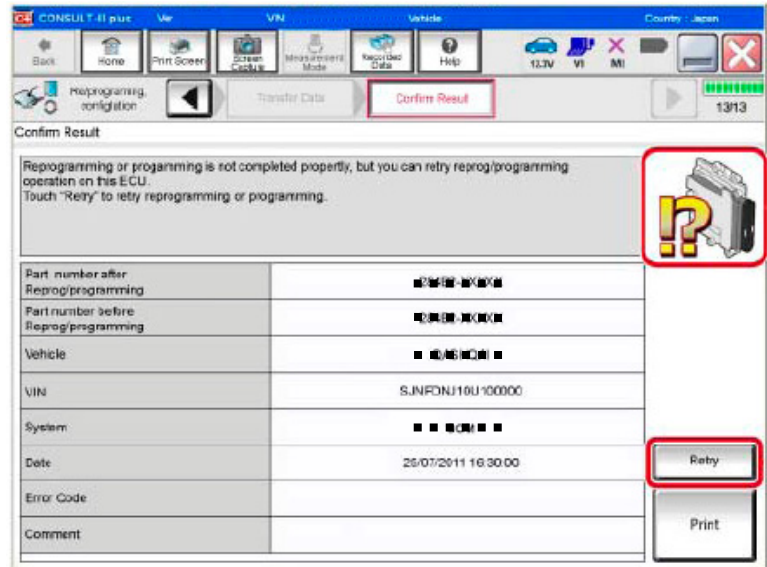
Figure 5

If reprogramming does not complete and the “!?” icon displays as shown in Figure 5:

- Check battery voltage (12.0–15.5 V).
- Ignition is ON, engine OFF.
- External Bluetooth® devices are OFF.
- All electrical loads are OFF.
- **Select retry and follow the on screen instructions.**
- “Retry” may not go through on first attempt and can be selected more than once.

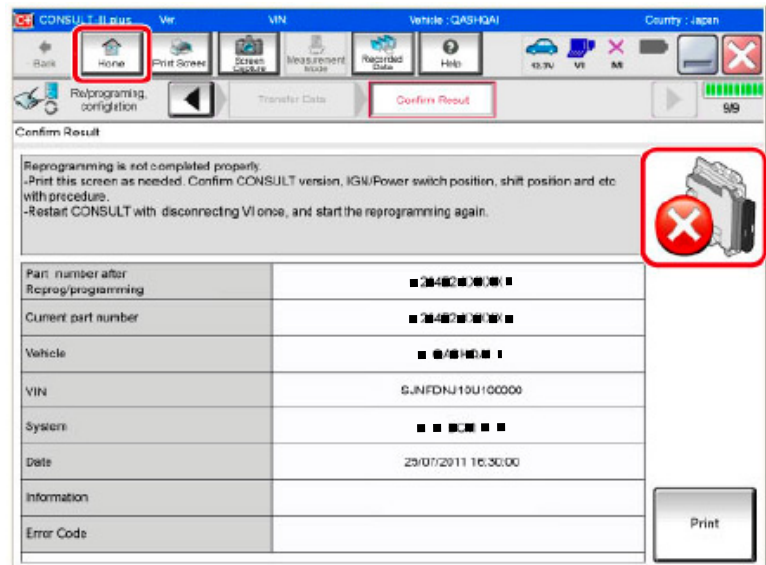
Figure 6

If reprogramming does not complete and the “X” icon displays as shown in Figure 6:

- Check battery voltage (12.0 – 15.5 V).
- CONSULT A/C adapter is plugged in.
- Ignition is ON, engine OFF.
- Transmission is in Park.
- All C-III plus / VI cables are securely connected.
- All C-III plus updates are installed.
- **Select Home, and restart the reprogram procedure from the beginning.**

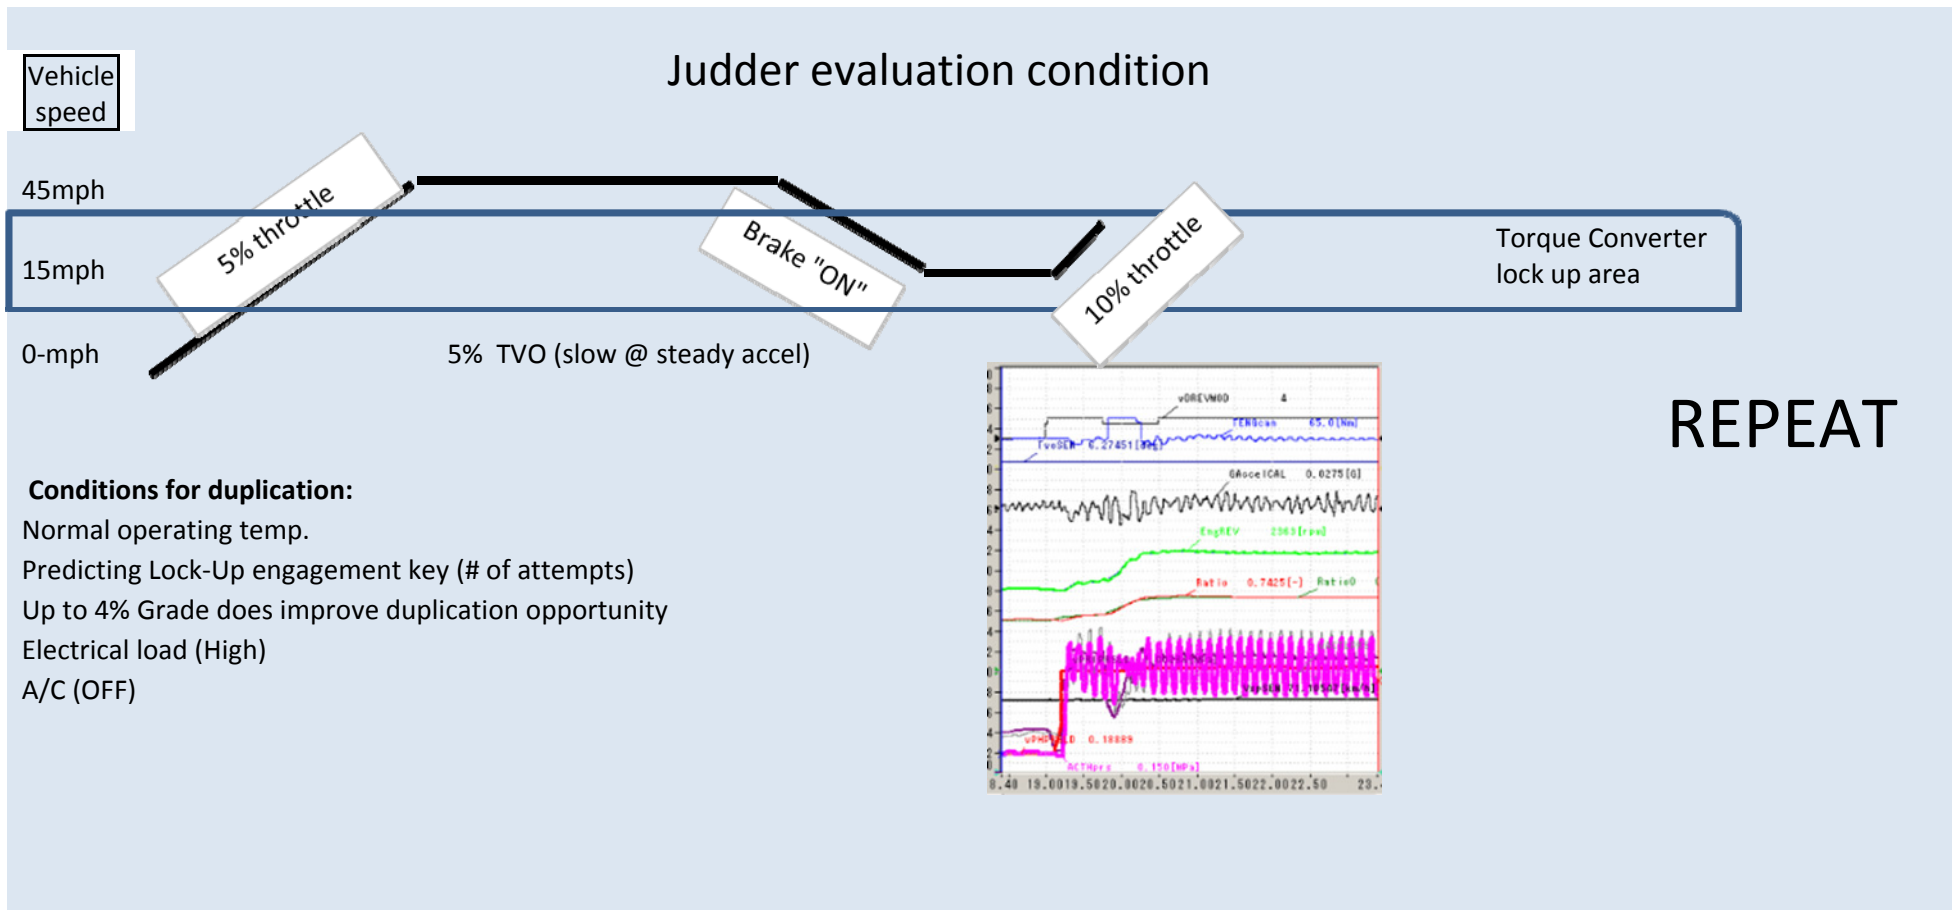
- This new diagnostic logic will monitor conditions in the CVT while the customer is operating their vehicle in their usual daily drive patterns.
- Figure 8, on the next page, illustrate conditions under which judder can be reproduced.
- Specific drive conditions that can be used to test for judder (shake, shudder, single or multiple bumps or vibration) are:
  1. Slowly accelerate from a stop (zero mph), applying only slight accelerator pedal (**0% - 10% throttle opening**) until 40 mph is reached.
    - During acceleration, torque converter engagement (full lock up) can occur between 20-35 mph.
  2. Prior to torque converter lock up, slowly modulate accelerator pedal:
    - a. Decrease accelerator pedal pressure slowly, approaching a closed throttle position.
    - b. Smoothly and slowly reapply accelerator pedal pressure back to approximately 10% throttle opening.

- Slight grade (climbing hill) may aid in performing the above drive conditions.
- DTC detection logic will require three events before storing a DTC.
- If DTC P17F1 or P17F0 is stored, refer to NTB15-084 for repair information.

- Figure 8 below illustrates conditions under which judder can be reproduced.
