Concentric Slave Cylinder (CSC) Tube  
Dealer Service Action

Reference: P5319

Date: November 13, 2015

## P5319 370Z Clutch Tube Replacement

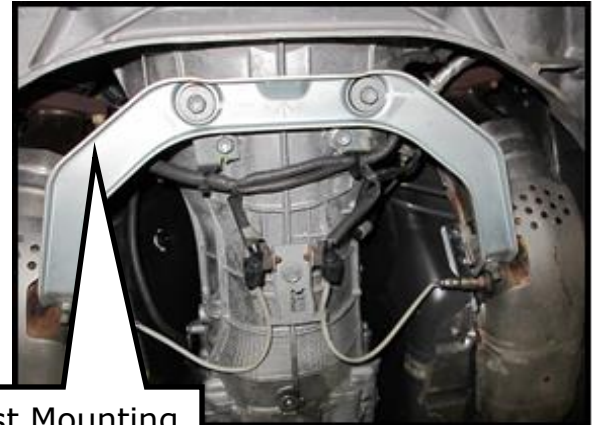
**Figure 1**

1. Set the car on lift and raise it up.
2. Remove the exhaust mounting bracket (Figure 1).
  - Discard one time use retaining bolts and nuts.

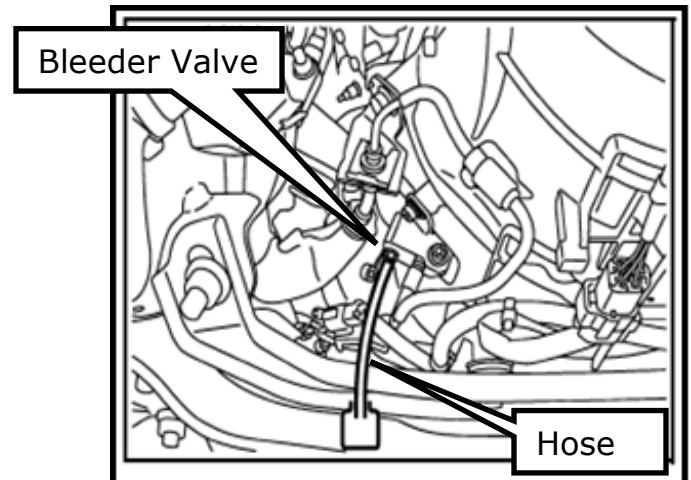
**Figure 2**

3. Connect a hose to the air bleeder valve. Depress the clutch pedal and loosen air bleeder valve to completely drain clutch fluid (Figure 2).

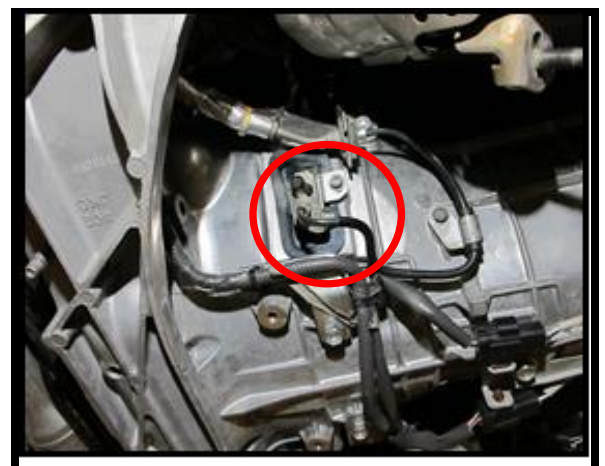
**Figure 3**

4. Remove the clutch tube from the clutch pipe using a 10MM wrench (Figure 3).

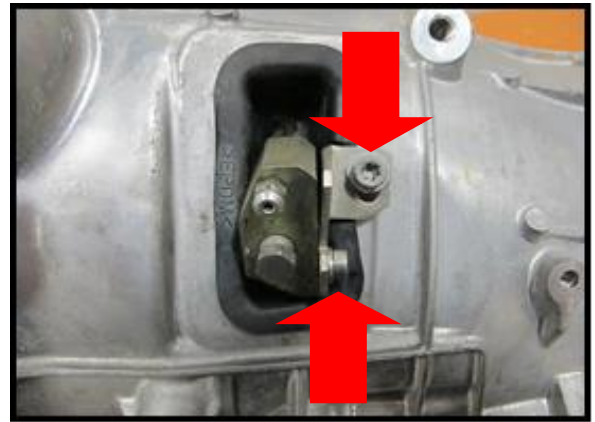
**Figure 4**

- Remove the two T30 bolts that hold the Concentric Slave Cylinder (CSC) tube and bracket to the transmission (Figure 4).

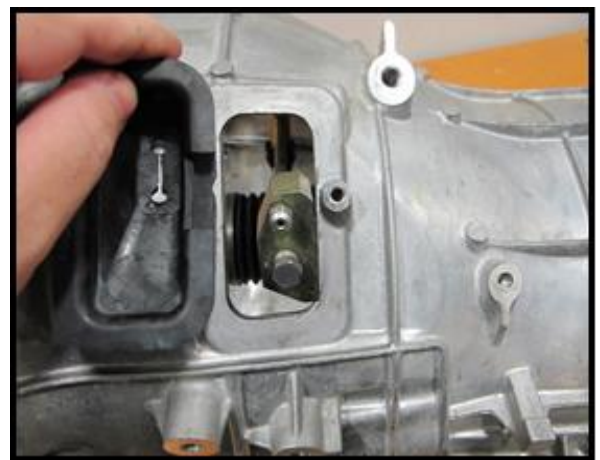
**Figure 5**

- Remove the rubber grommet from around the CSC tube assembly, it is OK to use lubricant to make it easier for removal (Figure 5).

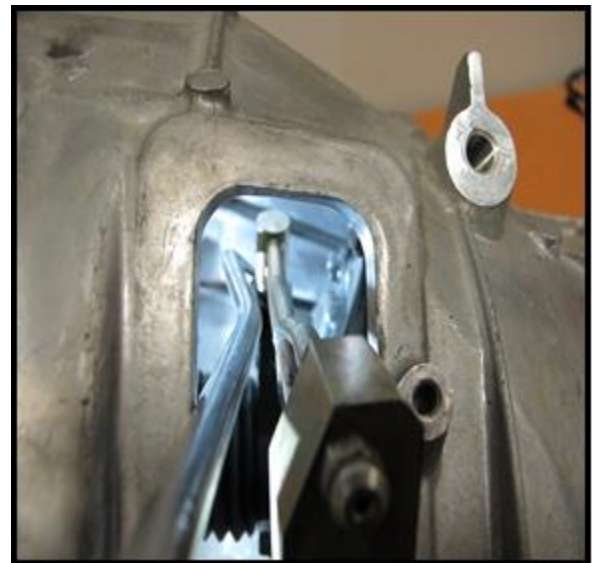
**Figure 6**

- Insert a long hook tool through the opening of transmission to the top of the CSC tube to release the spring clip that is attached to the CSC (Figure 6).

**IMPORTANT: Gently push the clip forward until you feel a click, DO NOT PUSH THE CLIP OFF THE CSC or it will drop to the bottom of the transmission bellhousing and will need to be retrieved. (Refer to the "IMPORTANT" in Step 9)**

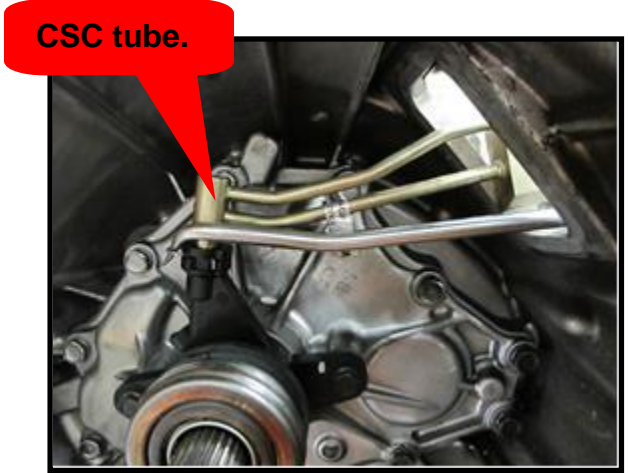
**Figure 7**

8. Figure 7 shows the use of the hook tool to release the spring clip on the CSC.

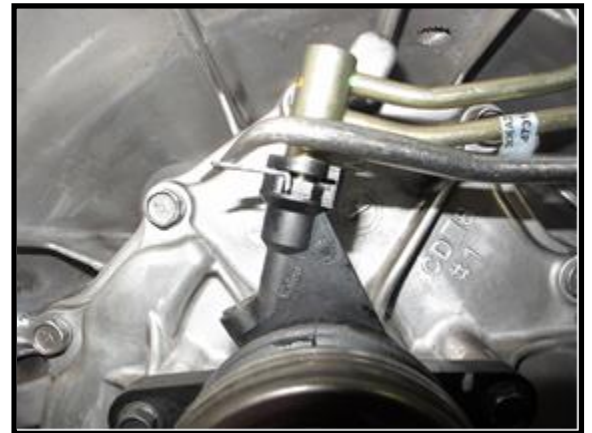
**Figure 8**

9. In Figure 8, the clip on the CSC is released.

**IMPORTANT: If the clip is pushed off the CSC it will be necessary to insert a magnetic pick-up tool through the CSC tube opening in the transmission and retrieve it. The clip can be reinstalled on the CSC using long needle nose pliers.**

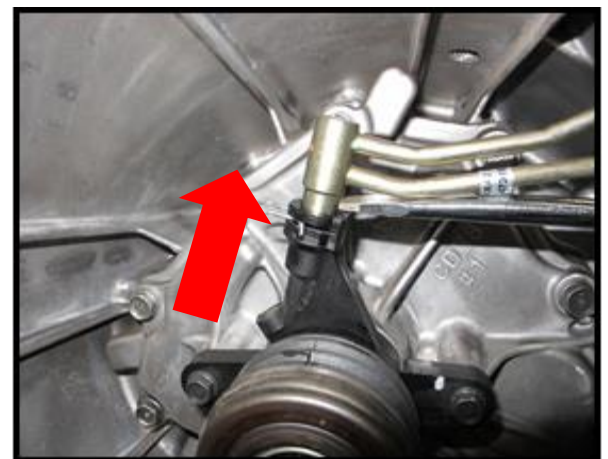
**Figure 9**

10. Gently push up on the CSC tube using a large flat blade screw driver as shown in Figure 9.

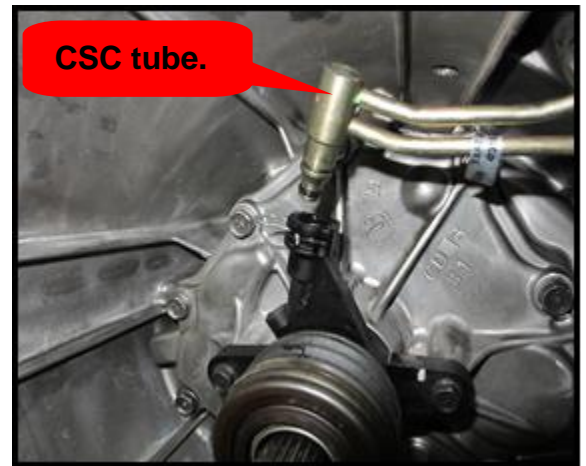
**Figure 10**

11. Remove the CSC tube as displayed in Figure 10.

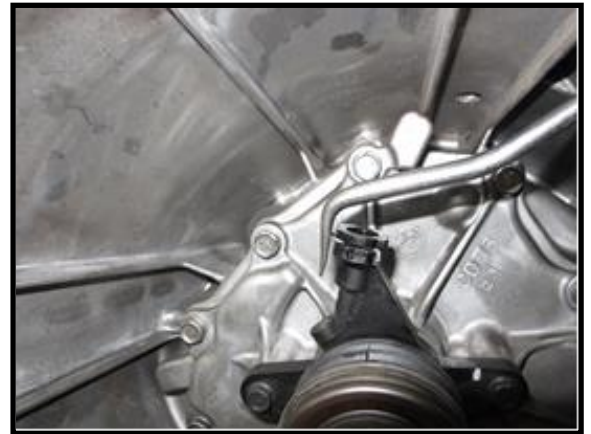
**Figure 11**

12. Reinsert a hook tool and close the spring clip on top of the Concentric Slave Cylinder (Figure 11).

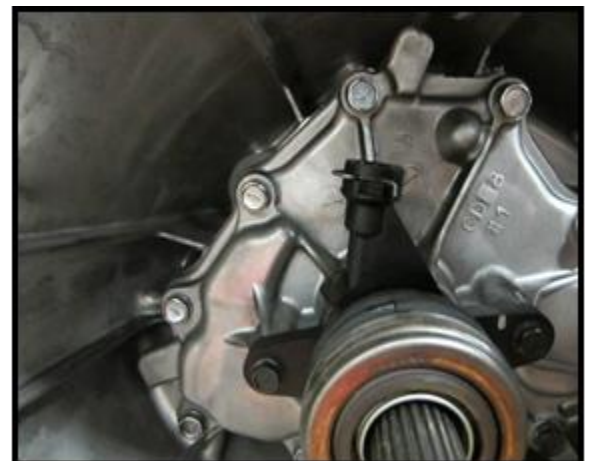
**Figure 12**

13. Figure 12 shows the spring clip on top of the CSC in the fully closed position.

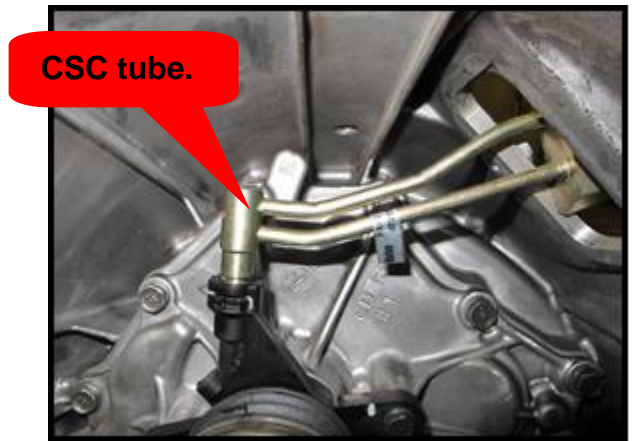
**Figure 13**

14. Position NEW CSC tube making sure the end of tube is in the slave cylinder inlet.

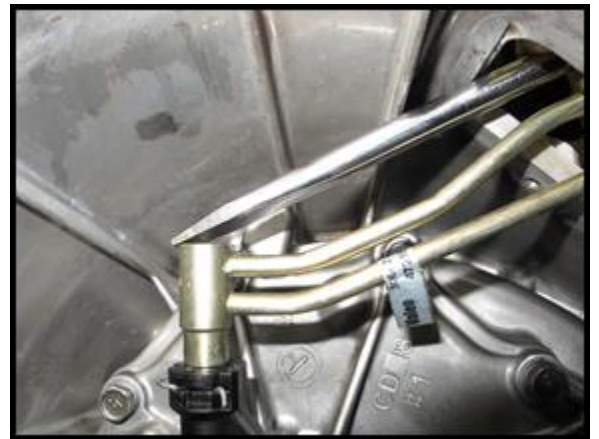
**Figure 14**

15. Using a large flat blade screwdriver, gently push the top of the tube downward until a loud click is heard.

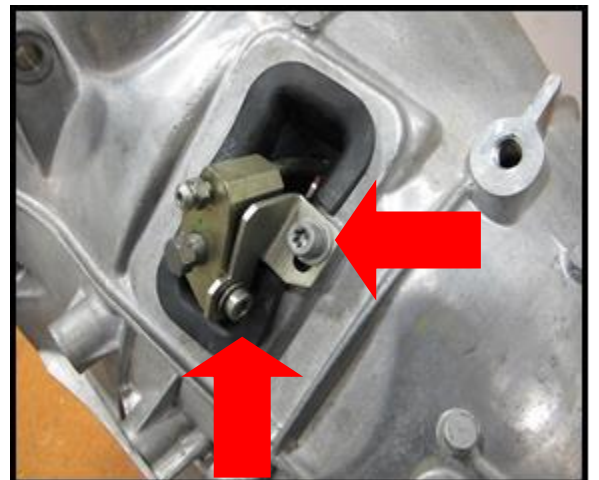
**Figure 15**

16. Reinstall the rubber grommet and the mounting bracket, tighten the two T30 bolts to 9 N·m (80 in-lb) as in Figure 15.

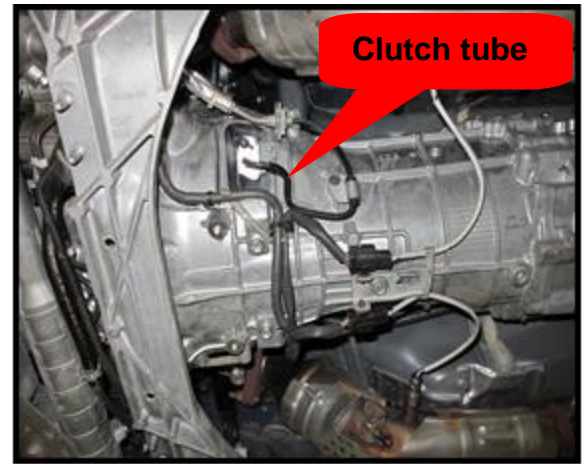
**Figure 16**

17. Reinstall the clutch tube using a 10MM wrench.

**Note: Do not over tighten the nut on the tube.**

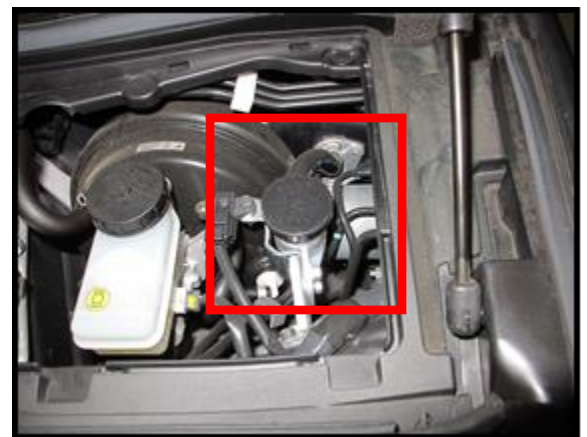
**Figure 17**

- The clutch fluid reservoir is to the right of the brake fluid reservoir (Under plastic cover) Refer to Figure 17.
- For filling of the clutch fluid reservoir make sure all painted services are covered.
- Use only DOT 3 brake fluid for the clutch reservoir.

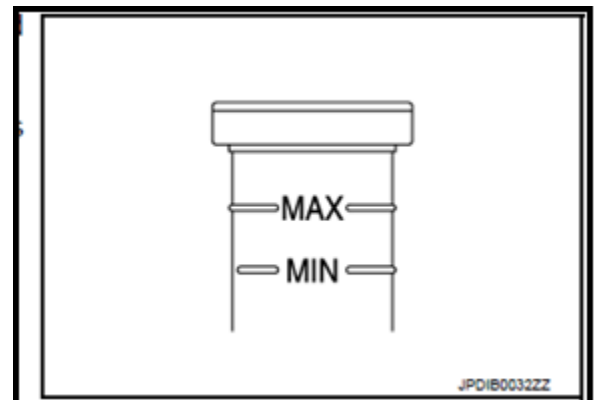
**Figure 18**

19. Fill the clutch master cylinder reservoir tank with NEW clutch fluid to the MAX line (Figure 18).

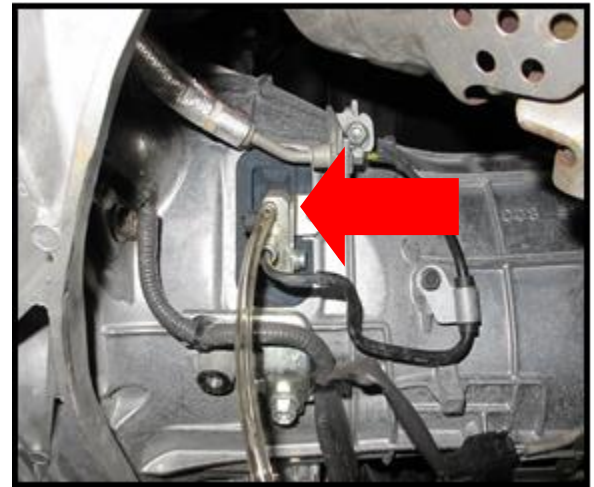
**Figure 19**

- Install a clear hose on the CSC bleeder screw (Figure 19).
- With the air bleeder valve loosened, cycle the clutch pedal until clutch fluid drains. After fluid is present snug up the bleeder screw.

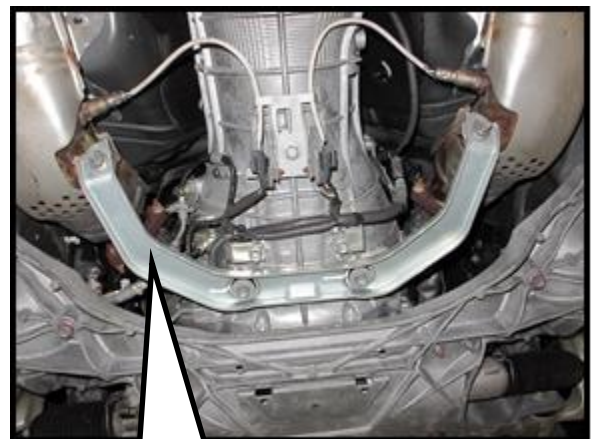
**Figure 21**

22. Reinstall the exhaust mounting bracket using NEW 14MM nuts and bolts setting torque at 28.5 N·m (21 ft-lb). Refer to Figure 21.

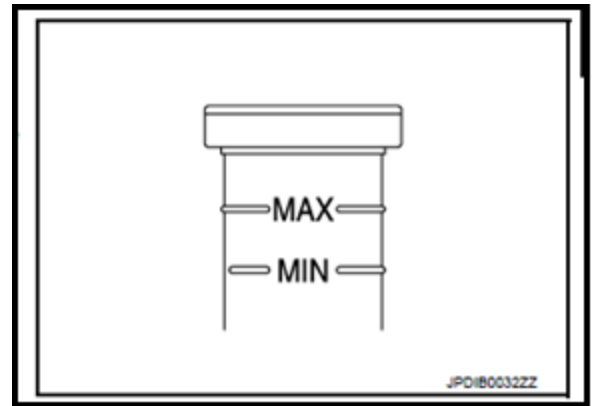
**Figure 22**

- Fill the clutch master cylinder reservoir tank with NEW clutch fluid to the MAX line (Figure 22).
- For filling of the clutch fluid reservoir make sure all painted services are covered.
- Use only DOT 3 brake fluid for the clutch reservoir.
