NISSAN BULLETIN Hood Primary Latch Dealer Service Action

Reference: PC419

Date: December 16, 2015

PC419 – Rogue, Pathfinder, Murano, Maxima Hood Latch SERVICE PROCEDURE

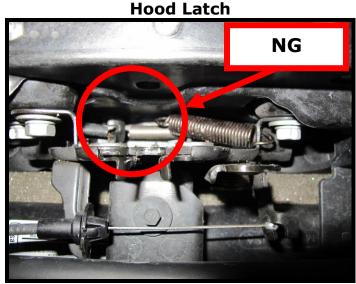
Figure 1

- 1. Open the hood for inspection.
- 2. Inspect the black hood latch spring position (Figure 1):
 - If the hood latch spring is in the proper position, shown in Figure 2, continue to step 3.
 - If the hood latch spring is out of position, as shown in Figure 1, replace hood latch per the Electronic Service Manual (ESM).

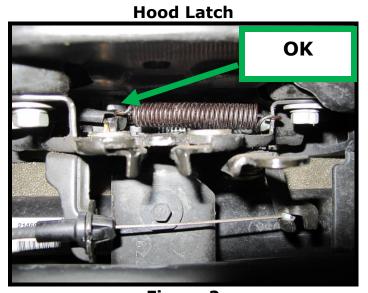
Figure 2

- 3. Open and close the hood 30 times.
 - Pull release lever
 - Open hood
 - Close hood fully
 - Repeat 30 times
- 4. After cycling the hood inspect the black hood spring position:
 - If the spring is still in place (Figure 2) the inspection is complete.
 - If the spring has dislodged (Figure 1), replace the hood latch assembly per the ESM.
