EL16-004

February 10, 2016

INFINITI; FRONT SONAR PARKING SENSOR SERVICE INFORMATION

APPLIED VEHICLES: All Infiniti vehicles equipped with front sonar parking sensor

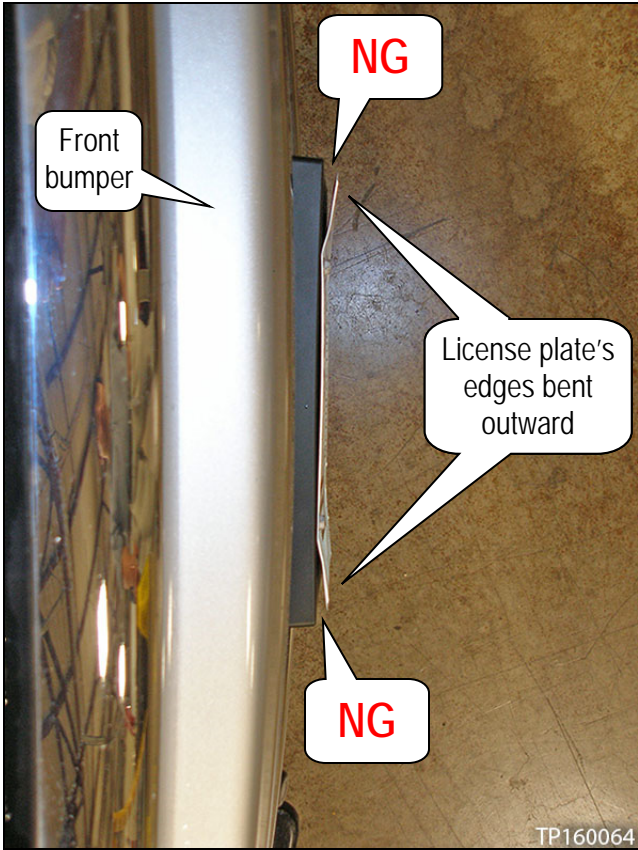
Figure 1

- The front license plate is bent outward from its bracket (there is a gap between the license plate and the bracket).
- or
- The front license plate frame is bent or loose and is hanging outward, away from the license plate and/or bracket (there is a gap between the license plate frame and the license plate and/or bracket).
- or
- The bracket is loose and is hanging outward, away from the bumper (there is a gap between the bracket and the bumper).

If any of these conditions are found, correct it by removing the gap (straighten the license plate, straighten and/or secure the license plate frame, or secure the bracket, as it applies).
