SERVICE BULLETIN

Classification:	Reference:	Date:
EC16-006	NTB16-016	February 17, 2016

2015-2016 QUEST; MIL IS ON WITH DTC P0101

APPLIED VEHICLES: 2015-2016 Quest (E52)

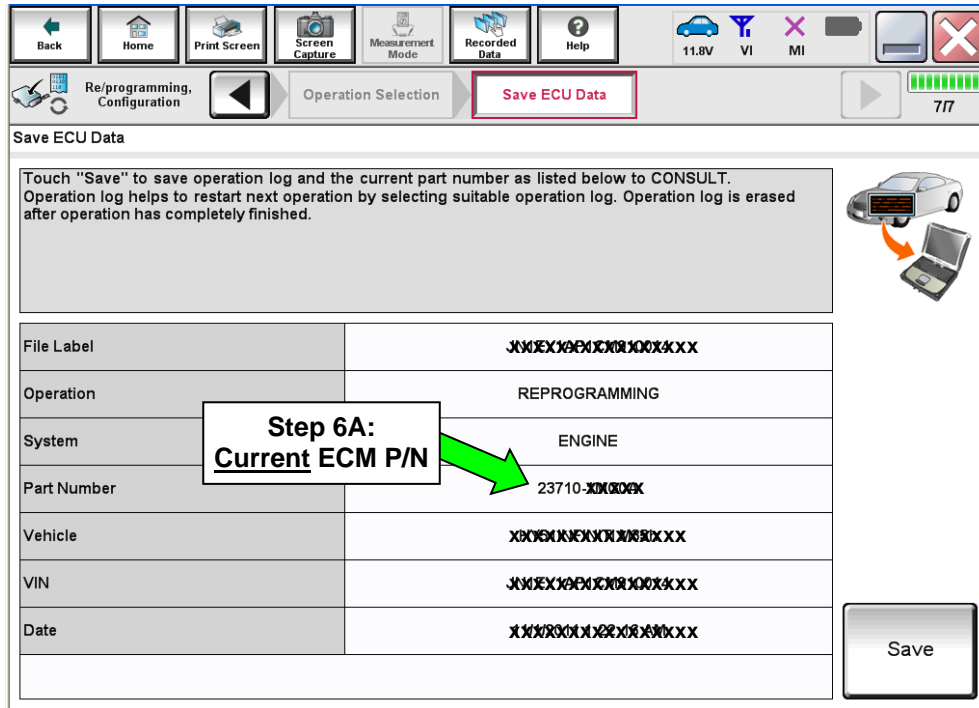
Figure 2

6. When you get to the screen shown in Figure 2, confirm this bulletin applies as follows.

A. Find the ECM **Part Number** and write it on the repair order.

B. Compare the P/N you wrote down to the numbers in the **Current ECM Part Number** column in **Table A** below.

- If there is a match, this bulletin applies. Continue with the reprogramming procedure.
- If there is not a match, this bulletin does not apply. Close C-III plus and refer to ASIST for further diagnostic information.

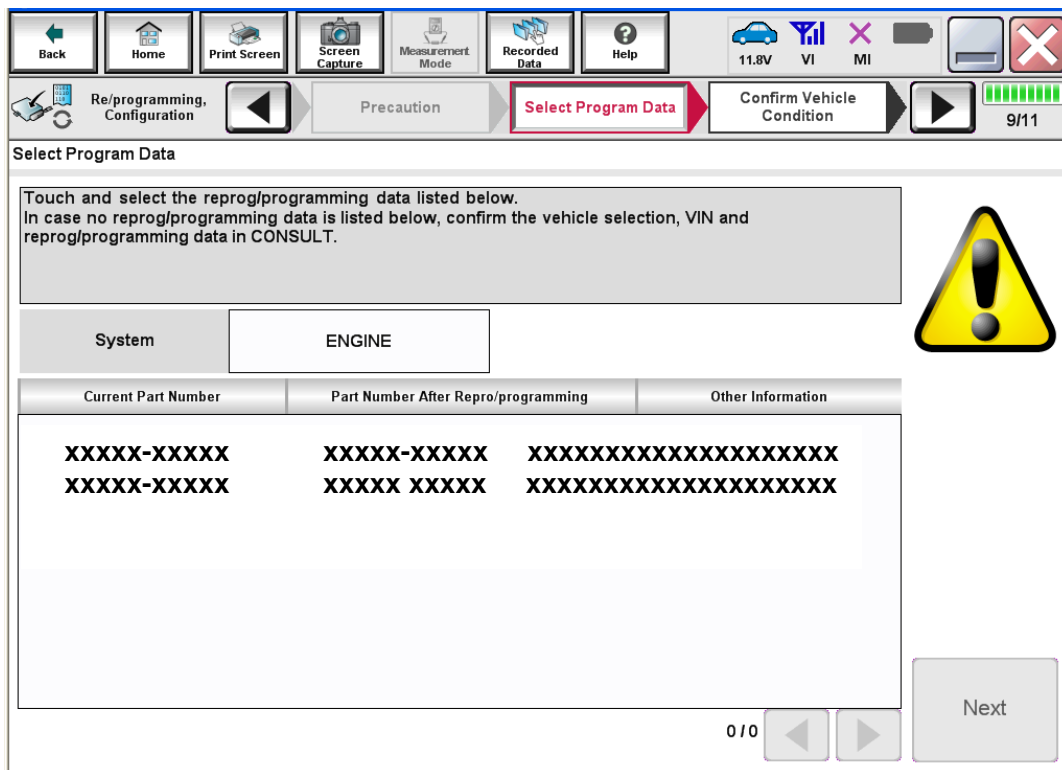
- In some cases, more than one new P/N for reprogramming is available.
 - If more than one new P/N is available, the screen in Figure 3 displays.
 - Select and use the reprogramming option that **does not** have the message “Caution! Use ONLY with NTBXX-XXX”.
- If you get this screen and it is blank (no reprogramming listed), it means there is no reprogramming available for this vehicle. Close C-III plus and refer back to ASIST for further diagnosis.

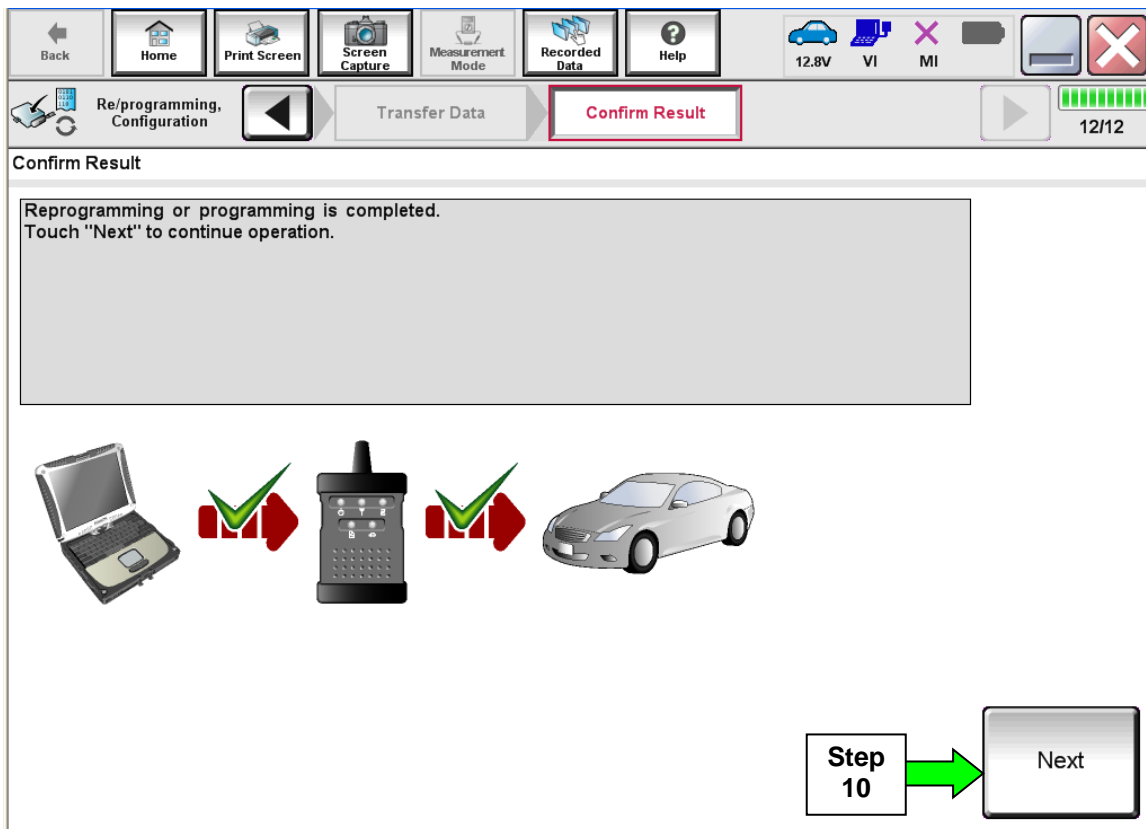
8. When the screen in Figure 4 displays, reprogramming is complete.

NOTE: If the screen in Figure 4 does not display (reprogramming does not complete), refer to ECM recovery on the next page.

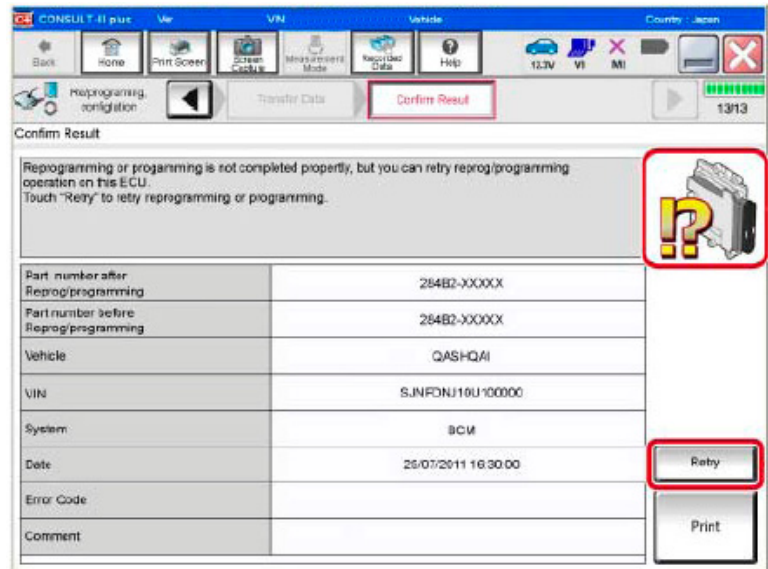
Figure 5

If reprogramming does not complete and the “!” icon displays as shown in Figure 5:

- Check battery voltage (12.0 - 15.5 V).
- Ignition is ON, engine OFF.
- External Bluetooth® devices are OFF.
- All electrical loads are OFF.
- **Select retry and follow the on screen instructions.**
- “Retry” may not go through on first attempt and can be selected more than once.

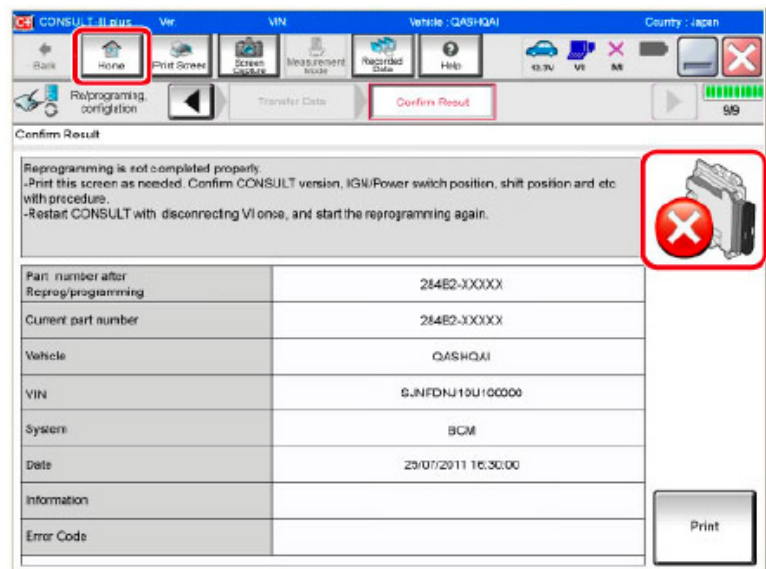
Figure 6

If reprogramming does not complete and the “X” icon displays as shown in Figure 6:

- Check battery voltage (12.0 - 15.5 V).
- CONSULT A/C adapter is plugged in.
- Ignition is ON, engine OFF.
- Transmission is in Park.
- All C-III plus / VI cables are securely connected.
- All C-III plus updates are installed.
- **Select Home, and restart the reprogram procedure from the beginning.**

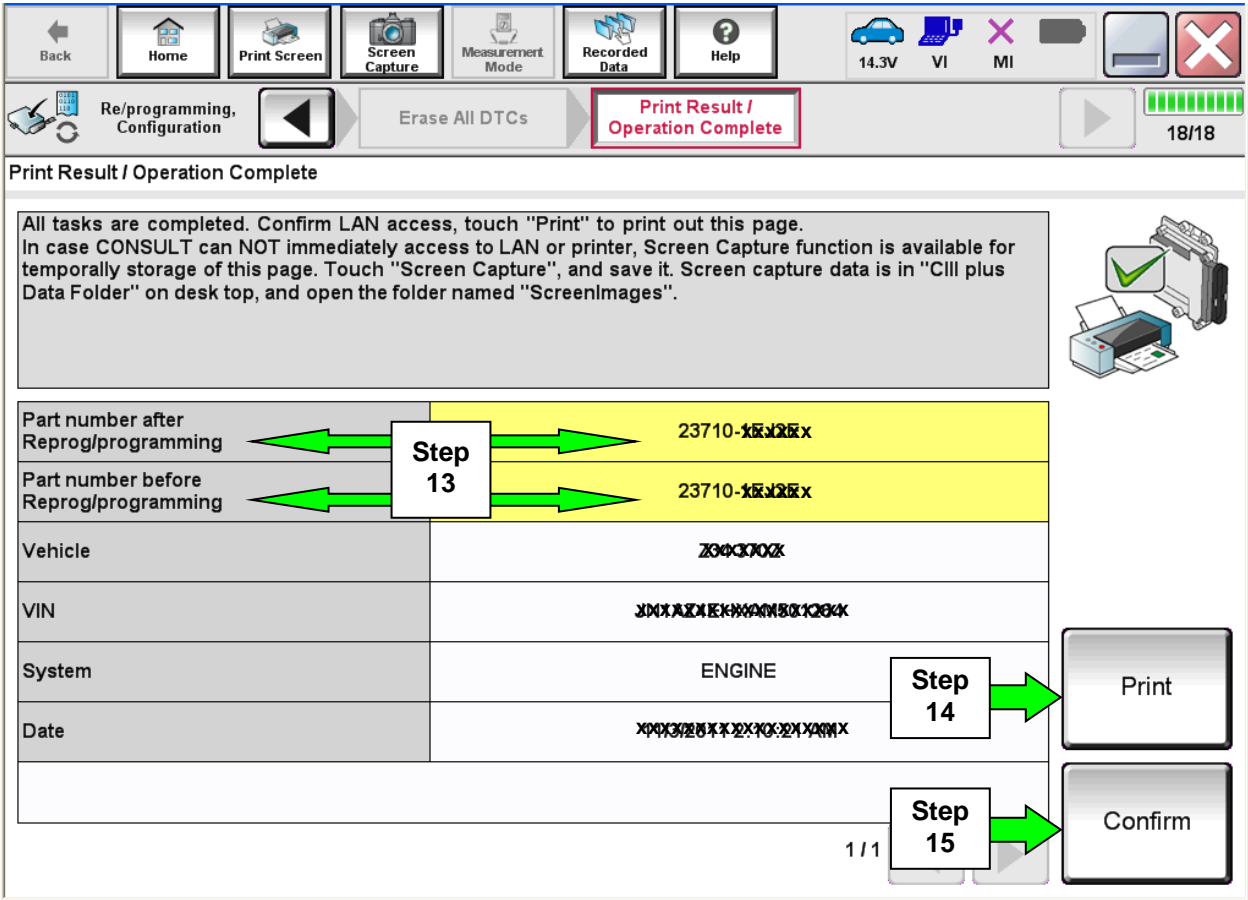
- 12. When the entire reprogramming process is complete, the screen in Figure 7 will display.
- 13. Verify the before and after part numbers are different.
- 14. Print a copy of this screen (Figure 7) and attach it to the repair order for warranty documentation.
- 15. Select **Confirm**.
