ITB15-034b February 25, 2016

# VOLUNTARY SERVICE CAMPAIGN 2014-2015 Q50 HYBRID 12 VOLT BATTERY REPLACEMENT

CAMPAIGN ID #: P5326

APPLIED VEHICLES: 2014-2015 Q50 Hybrid (V37)

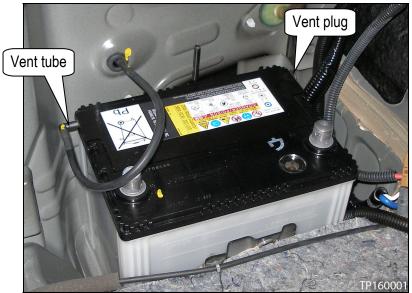
Figure 1

NOTE: The replacement battery does not come with a new vent tube or vent plug. The preexisting vent tube and vent plug are to be reused (see Figure 1).
