EL03-031j

HEADLAMP FOGGING

APPLIED VEHICLES: 2011-2016 Infiniti – All models

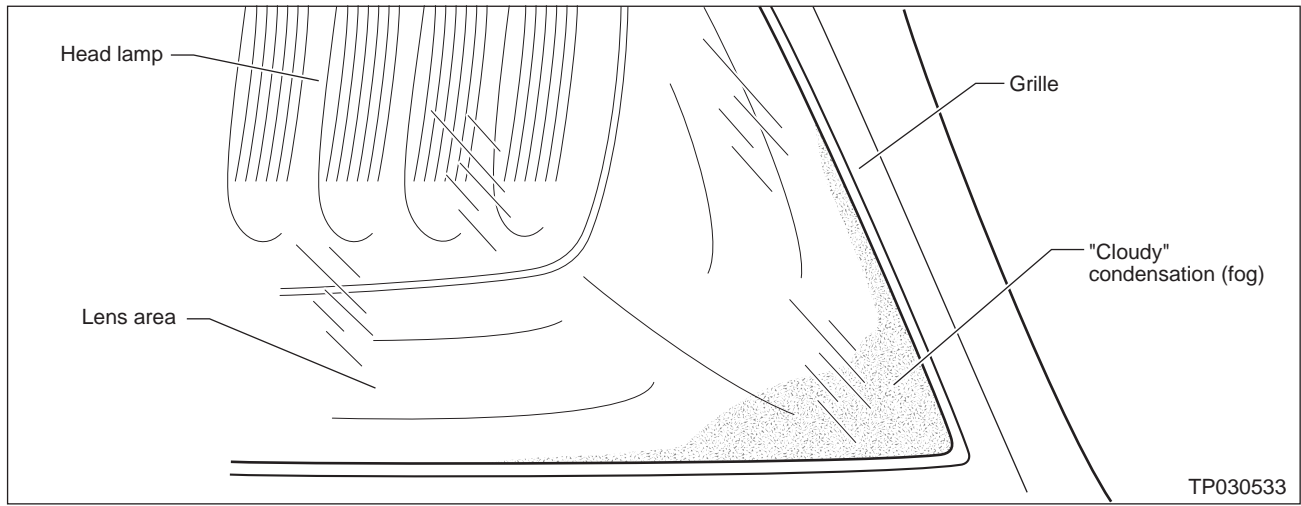
Fog may temporarily form inside the lens of the headlamp assemblies based on environmental conditions or sudden temperature changes (such as in a car wash, or parked on a cold, sunny day). This is normal. See Figure 1.

Figure 1: Example of normal condensation, ok

NOTE: This condensation can appear anywhere on the outer lens, typically at its coldest location.

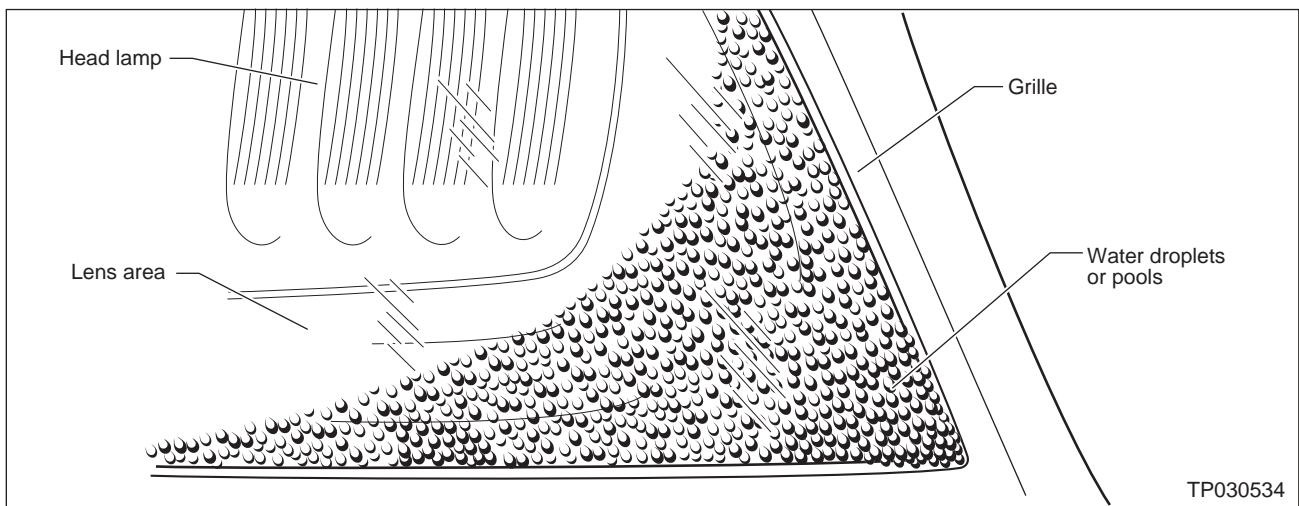
Figure 2: Condition may not be normal

If the moisture trickles, drips, or pools, it may not be considered normal and the headlamp assembly may have a water leak path. See Figure 2 for an example.

If large drops of water collect inside the lens, refer to the flow chart on page 3 to find the next step to take.
