## **SERVICE BULLETIN**

EC16-009
 NTB16-031
 March 23, 2016

## 2013-2016 ALTIMA WITH QR25DE ENGINE; MIL ON WITH DTC P0116

**APPLIED VEHICLE:** 2013-2016 Altima (L33)

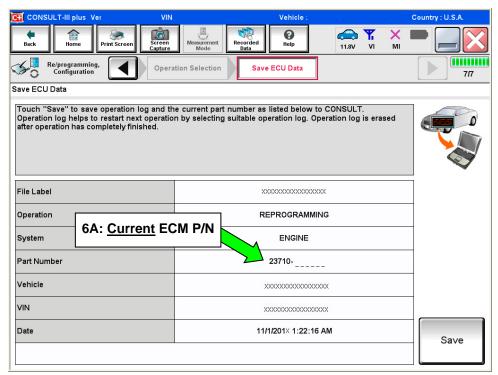
Figure 2

- 6. When you get to the screen shown in Figure 2, confirm this bulletin applies as follows.
  - A. Find the ECM **Part Number** and write it on the repair order.

**NOTE:** This is the <u>current</u> ECM Part Number (P/N).

- B. Compare the P/N you wrote down to the numbers in the **Current ECM Part Number** column in **Table A** on the next page.
  - If there is a <u>match</u>, this bulletin <u>applies</u>. Continue with the reprogramming procedure.
  - If there is <u>not a match</u>, this bulletin <u>does not apply</u>. Close C-III plus and refer to ASIST for further diagnostic information.

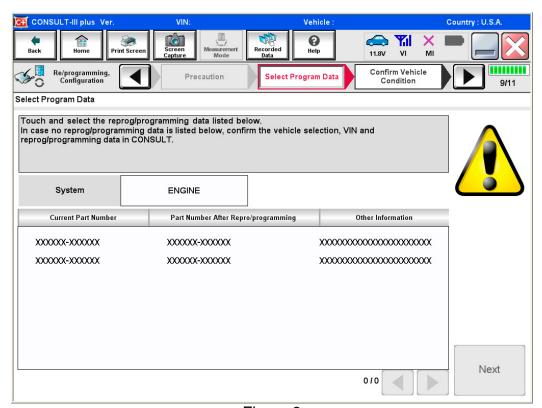
- In some cases, more than one new P/N for reprogramming is available.
  - ➤ If more than one new P/N is available, the screen in Figure 3 displays.
  - Select and use the reprogramming option that <u>does not</u> have the message "Caution! Use ONLY with NTBXX-XXX".
- If you get this screen and it is <u>blank</u> (no reprogramming listed), it means there is no reprogramming available for this vehicle. Close C-III plus and refer back to ASIST for further diagnosis.

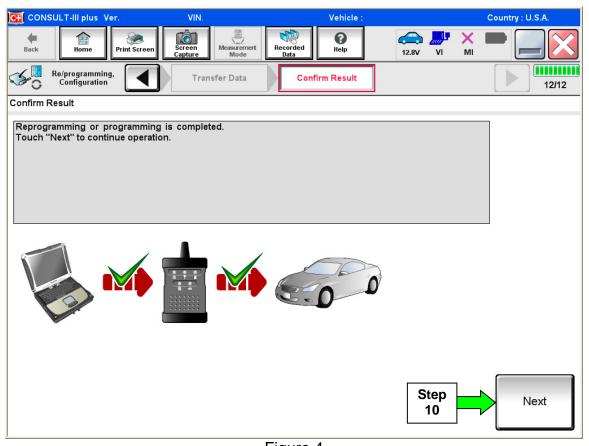
8. When the screen in Figure 4 displays, reprogramming is complete.

**NOTE:** If the screen in Figure 4 does <u>not</u> display (indicating that reprogramming did <u>not</u> complete), refer to the information on page 8.

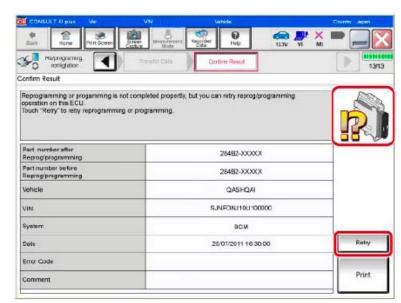
Figure 5

If reprogramming does <u>not</u> complete and the "!?" icon displays as shown in Figure 5:

- Check battery voltage (12.0–15.5 V).
- Ignition is ON, engine OFF.
- External Bluetooth® devices are OFF.
- All electrical loads are OFF.
- Select <u>retry</u> and follow the on screen instructions.
- "Retry" may not go through on first attempt and can be selected more than once.

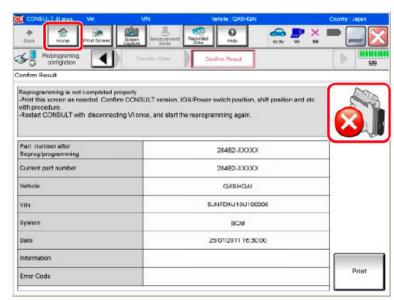
Figure 6

# If reprogramming does <u>not</u> complete and the "X" icon displays as shown in Figure 6:

- Check battery voltage (12.0 – 15.5 V).
- CONSULT A/C adapter is plugged in.
- Ignition is ON, engine OFF.
- Transmission is in Park.
- All C-III plus / VI cables are securely connected.
- All C-III plus updates are installed.
- Select <u>Home</u>, and restart the reprogram procedure from the beginning.

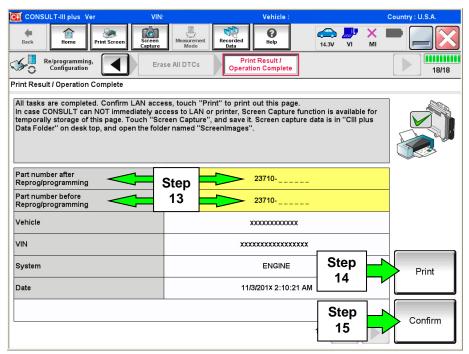
- 12. When the entire reprogramming process is complete, the screen in Figure 7 will display.
- 13. Verify the before and after part numbers are different.
- 14. Print a copy of this screen (Figure 7) and attach it to the repair order for warranty documentation.
- 15. Select Confirm.
