**Service Bulletin 523
Issue 1 - April 2015**

Subject: Clutch Cable Routing				
Bulletin Number	Models Affected	VIN Range		Markets Affected
523	Thrupton	From	672150	Brazil only
	Bonneville T100	To	679983

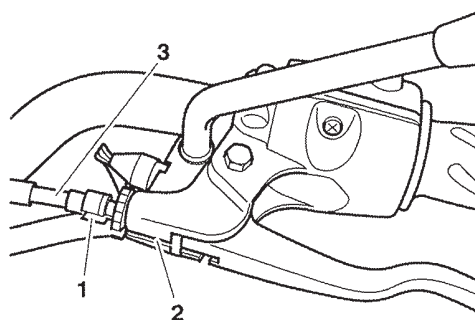
1. Slot in upper adjuster
2. Slot in clutch lever bracket
3. Clutch cable

1. Loosen the cable lock nut and release the adjuster at the clutch cover end to give maximum play in the cable.
2. Align the clutch cable adjuster and lever bracket slots.
3. Pull in the clutch lever and turn the inner cable anti-clockwise through the slots in the adjuster, until the cable can be detached from the lever by pushing downwards.

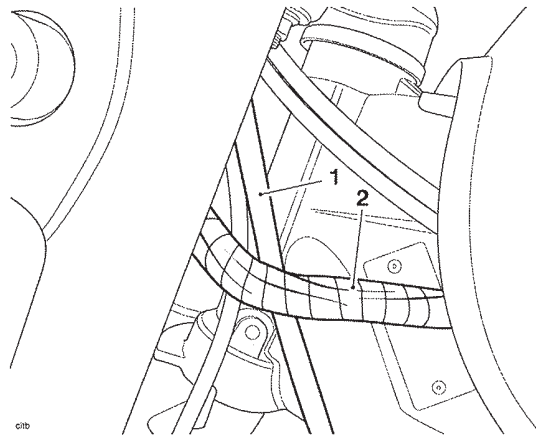
We have identified a need to re-route the clutch cable as it has been incorrectly routed over the main wiring harness in the headstock area.

1. Clutch cable
2. Main wiring harness

-
4. Re-route the cable such that it is between the main wiring harness and the headstock, as shown below.
