**Technical News 165**  
**October 2015**  
**Strictly Confidential**

<b>Contents</b>		
<b>Item</b>	<b>Subject</b>	<b>Model Affected</b>
Item 1.	Mudguard Extension Australia, India and New Zealand Markets Only	Models With A Mudguard Extension

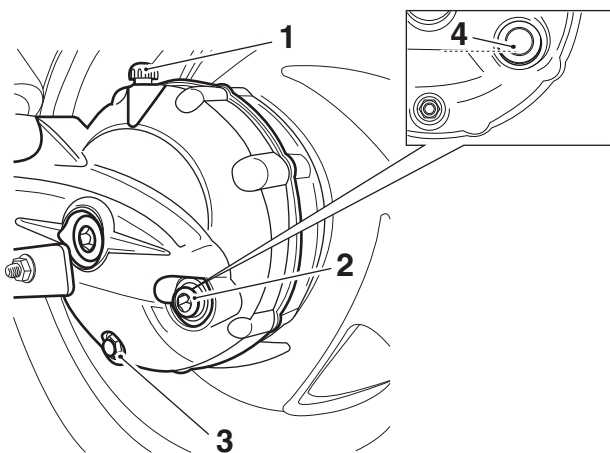
When checking the oil level in the final drive unit during the pre-delivery inspection or service, always ensure the motorcycle is stationary and in an upright position to allow the fluid level to stabilise.

1. Breather outlet
2. Filler/level plug
3. Final drive unit (silencer removed for illustrative purposes)
4. Oil level mark

If oil is noticed around the area of the breather outlet, always confirm the oil level is correct before commencing any further repair.

- Clean the area around the breather outlet.
- Remove the filler/level plug (not the lower drain plug) to determine the fill level.
- With the aid of an assistant hold the motorcycle in an upright position.
- Allow any excess oil to drain, the oil level is correct when the oil is level with the bottom of the filler.
- Refit the oil filler/level plug and tighten to **60 Nm**.

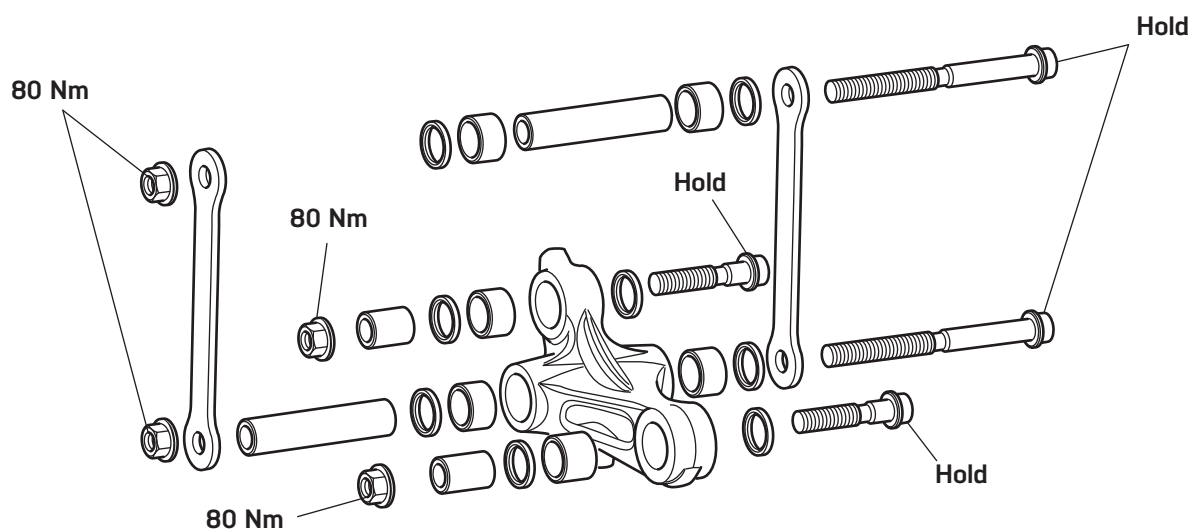
Tightening the rear suspension linkage fixings by any method other than the one described above may lead to an incorrect torque value being set.

Incorrectly tightened rear suspension linkage fixings may cause an unsafe riding condition, leading to loss of motorcycle control and an accident.

- When tightening the drag link and drop link fixings, hold the bolts to prevent rotation, while tightening the nuts to **80 Nm**.

Always ensure during rear suspension linkage assembly that the linkage bolts are held while the nuts are tightened to **80 Nm**.

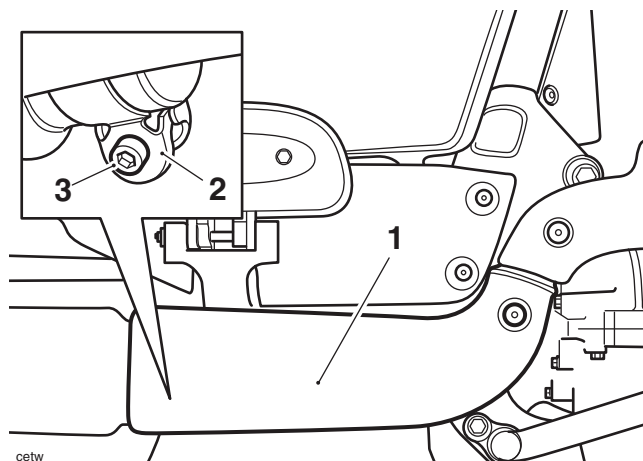
1. Silencer heat shield (right hand shown)
2. Clamp
3. Fixing

The torque figure for the silencer heat shield clamp fixings has changed to **5 Nm** on the above models.

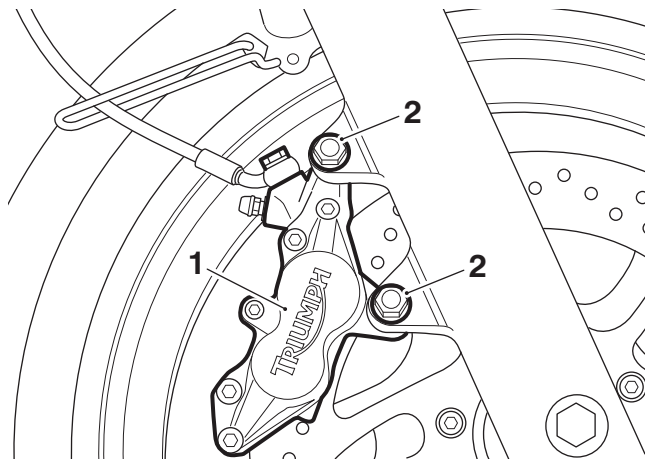
We have introduced the application of a high temperature copper-based grease to the threads of the front brake caliper bolts on the above models from VIN 723736.

1. Caliper (Thunderbird shown)
2. Bolts

- Prior to fitment, lubricate the threads of the caliper bolts using a minimum amount of proprietary high temperature copper-based grease.

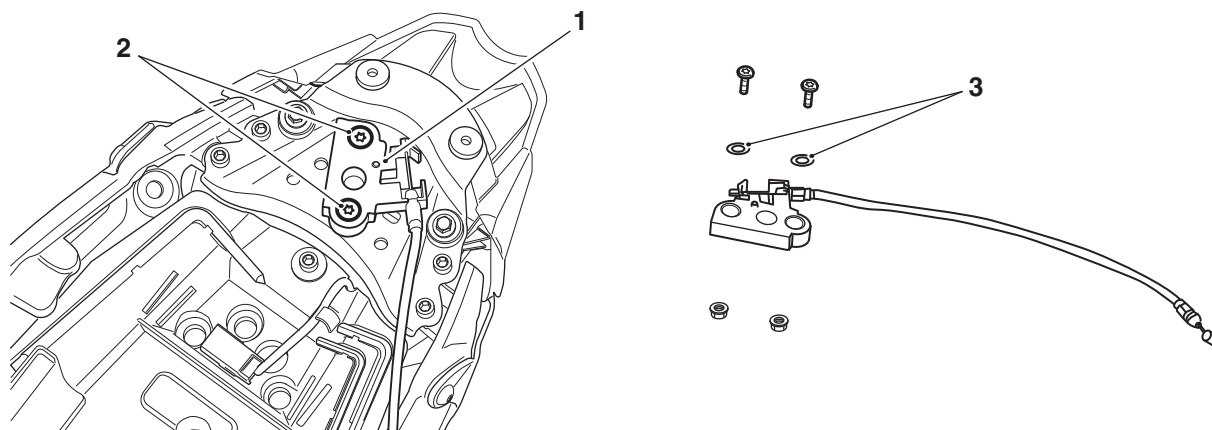
1. Seat latch
2. Fixings
3. Washers

The torque figure for the seat latch fixings has changed to **5 Nm** on the above models.  
Washers have also been introduced to the seat latch fixings on the above models from VIN 718549.

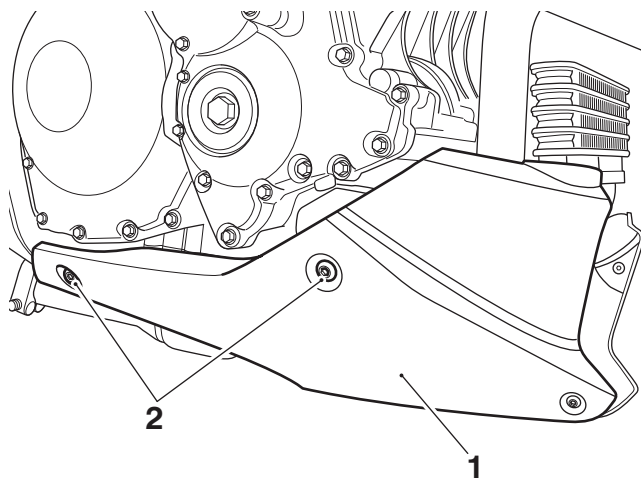
1. Belly pan (right hand side shown, left hand side similar)
2. Fixings

The torque figure for the belly pan fixings has changed to **10 Nm** on the above models.

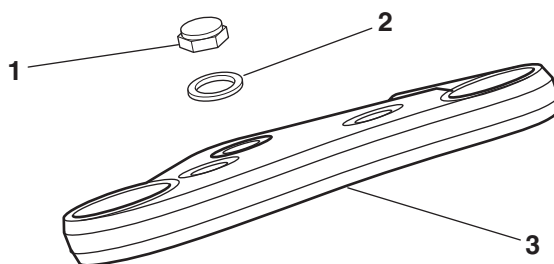
- 1. Top nut
- 2. Washer, 3.2 mm
- 3. Top yoke

A 3.2 mm thick washer has been introduced to the above models from VIN 724298 and is retrofittable. The washer is located between the yoke and the top cap. The torque figure for the top nut remains at **65 Nm**.
