39-20-01 - Bevel Box Case Half Leak

Release date: 5/3/2021

# Technical Service Bulletin

Transaction No: 2060391/4

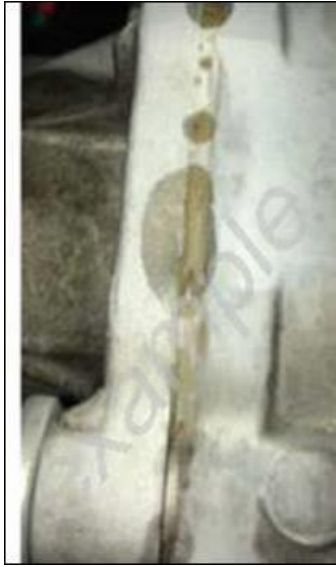
Figure 1.

Gear oil leak from the case halves of the bevel box due to currently used sealant type (Figure 1).

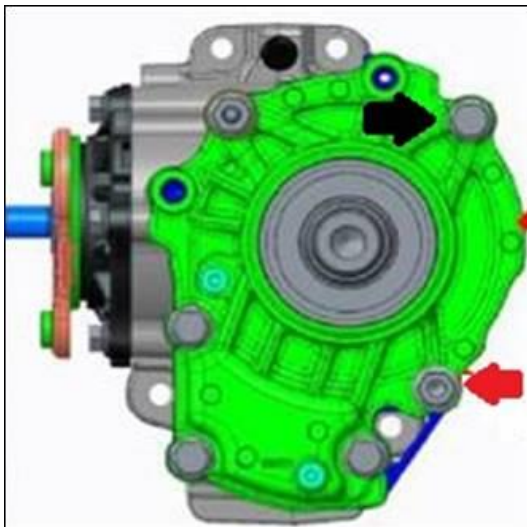
Figure 2.

Source of leak is between the case halves at the right side of the bevel box between the two bolts seen in Figure 2 (red and black arrows).
