# Technical Service Bulletin

## 60 Panoramic sunroof opening outer perimeter seal is loose

60 21 53 2063187/1 May 7, 2021.

Model(s)	Year	VIN Range	Vehicle-Specific Equipment
Q7	2017 - 2023	All	Not Applicable
Q5	2018 - 2023	All	Not Applicable
A4 allroad, Q3, Q8, and Audi e-tron quattro	2019 - 2023	All	Not Applicable
Audi e-tron Sportback	2020 - 2023	All	Not Applicable

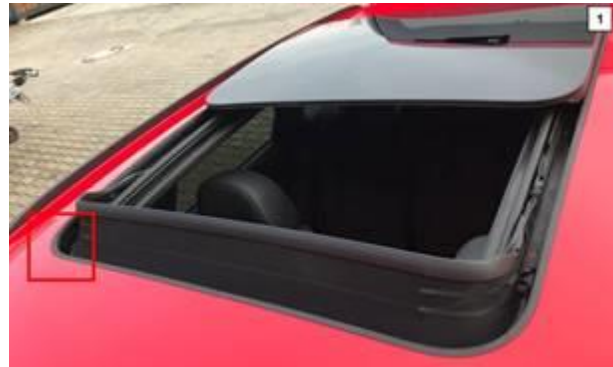
1. Begin the inspection of the sunroof opening perimeter seal adhesion by fully opening the front sunroof glass panel (Figure 1).

**Figure 1.** Front sunroof panel open.

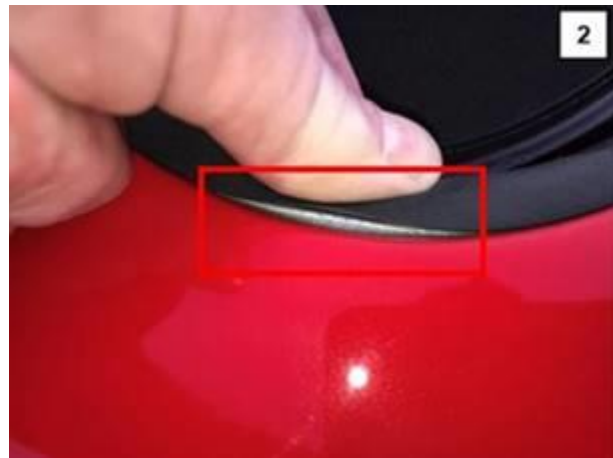
2. Press the seal downwards and inwards with your fingers until the adhesive tape for the seal is visible (Figure 2). The foam adhesive tape may be stretched but it must not be loose or detached from the roof panel to any degree.

**Figure 2.** Checking the adhesion quality.

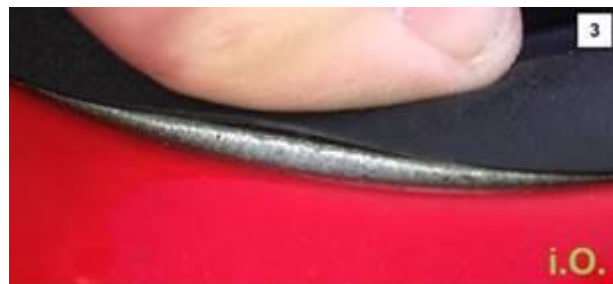
3. Figure 3 shows a properly adhered adhesive band.

**Figure 3.** A properly adhered perimeter seal.

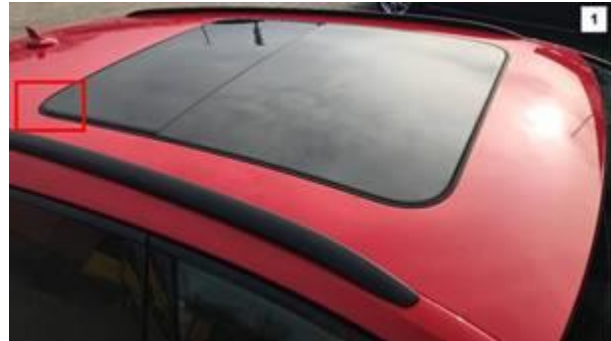
5. Using the same inspection principle used in the inspection of the front portion of the sunroof opening perimeter seal check the seal adhesion in the rear portion of the sunroof opening (Figure 4).

**Figure 4.** Begin inspection of the rear portion of the perimeter seal.

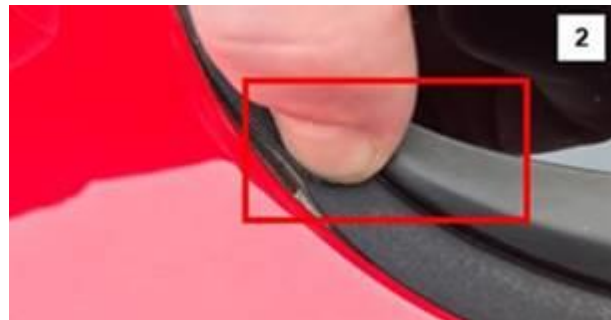
6. Figures 5 – 8 clearly show that the adhesive tape has come loose from the vehicle body. The obvious color and shape difference at the point of contact revealing the gaps is evidence of detachment.

**Figure 5.** Clear evidence of adhesive detachment.

8. The locations where the adhesion is compromised or has failed is a possible entry point for water into the cabin. The area directly below these openings is outside the area of the sunroof drainage. If any adhesion is found to be compromised or failed to any extent replace the sunroof opening perimeter seal. Follow the procedure in ElsaPro explicitly to ensure proper seal adhesion paying particularly close attention to the adhesion surface preparation.

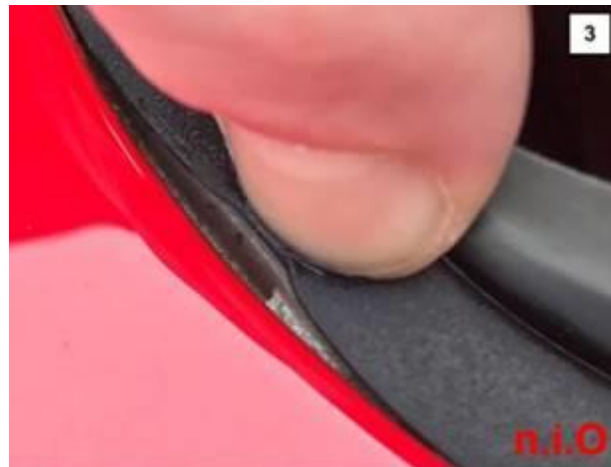
7. A gap in the attachment is revealed in the examples in Figures 5 - 8.

**Figure 6.** Seal adhesive band detachment revealed.

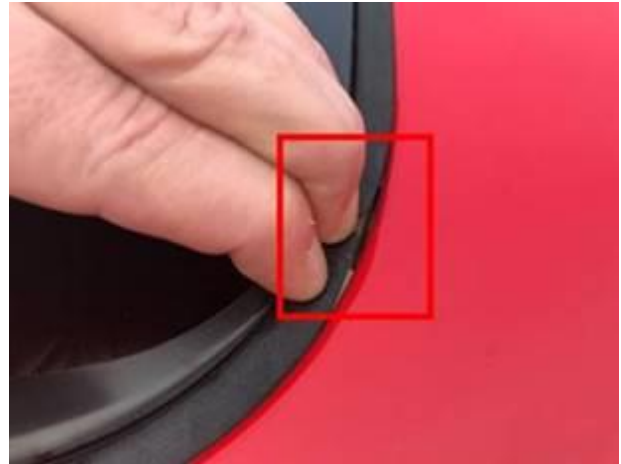
**Figure 7.** Adhesive band detachment.

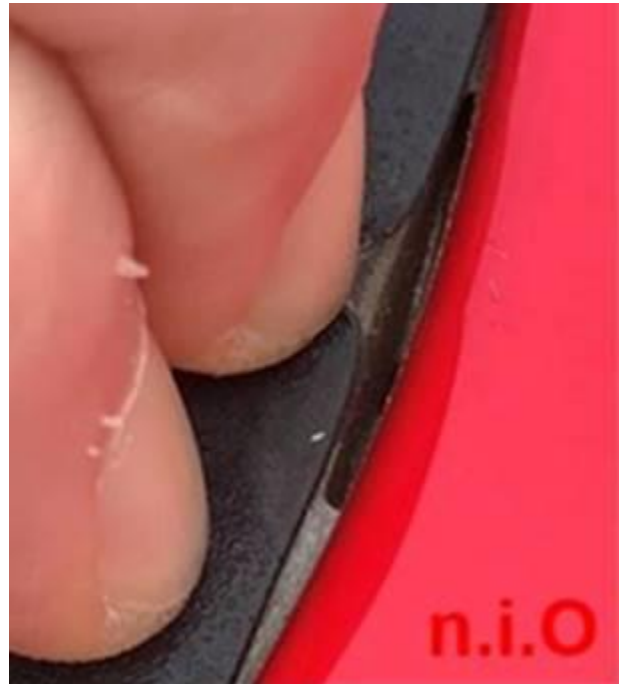
**Figure 8.** Close-up view of the detachment area from Figure 7.
