Technical Service Bulletin: TSB190165

Released Date: 20-Apr-2021

Soot or Ice Deposits in the Intake Air Connection and Fault Codes: 1866, 3361, 3382, 3383, 3389, 7232, 7233 and/or 4729

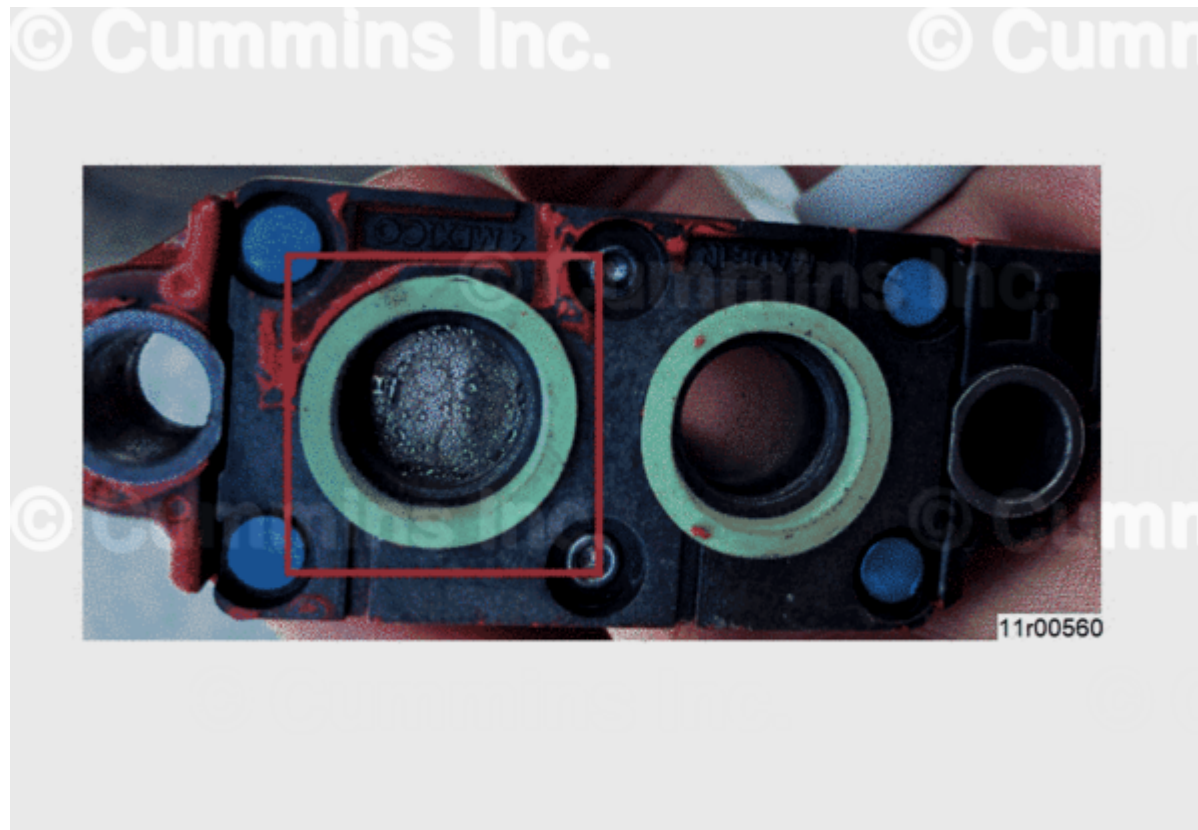
- Soot deposits in the intake air connection exhaust gas recirculation (EGR) differential pressure horizontal and vertical ports are present and have affected EGR flow measurements.
- Icing/condensation in the intake air connection exhaust gas recirculation (EGR) differential pressure sensor or horizontal and vertical ports are present and have affected EGR flow measurements.
 - Icing may **not** be present at the time of the repair, but presence of condensation/water droplets in the EGR Differential Pressure sensor indicates that icing of the sensor is the root cause of this issue.

Figure 1, Condensation on the EGR Differential Pressure Sensor.

- If soot is found, gently wipe away with a clean towel. Be sure not to apply too much pressure on the sensor elements, as they can become damaged.
 - If ice or condensation is found (See Figure 1 below), gently wipe away with a clean towel. Be sure **not** to apply too much pressure on the sensor elements, as they can become damaged.
