Preliminary Information

PIT5825B Vibration Type Noise Heard at Highway Speeds or with Engine Speed at 1,300-1,500 RPM

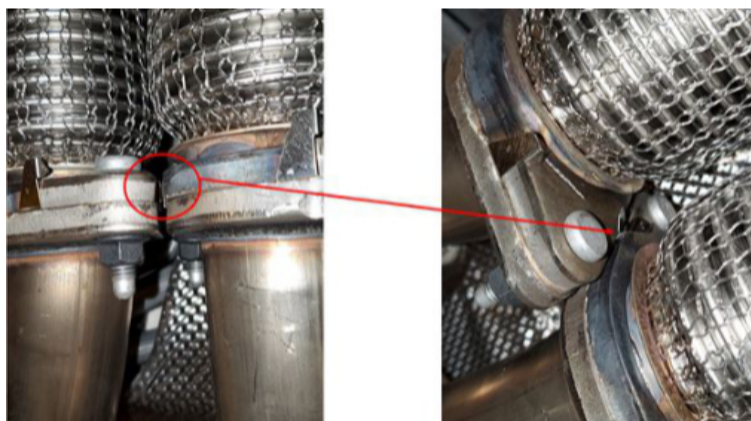
Involved Region or Country	North America
Condition	Vibration type noise at highway speeds or with Engine Speed at 1,300-1,500 RPM heard under the vehicle.
Cause	Some of the metal gasket tabs between the front exhaust and muffler are not fully crimped, exhibiting some spring-back, allowing for them to touch at certain speeds / RPMs.

With a small punch or chisel and hammer bend/crimp the tabs on the exhaust gasket in further to prevent any spring-back and provide increased clearance between the two tabs to correct the noise or cutting the tabs off the gaskets is also acceptable.
