Bulletin No.: PIP5803

PIP5803 Inspection Loose Upper Bolt For Timing Chain Guide Oil Leak Front Timing Cover Removal 2.0 LTG

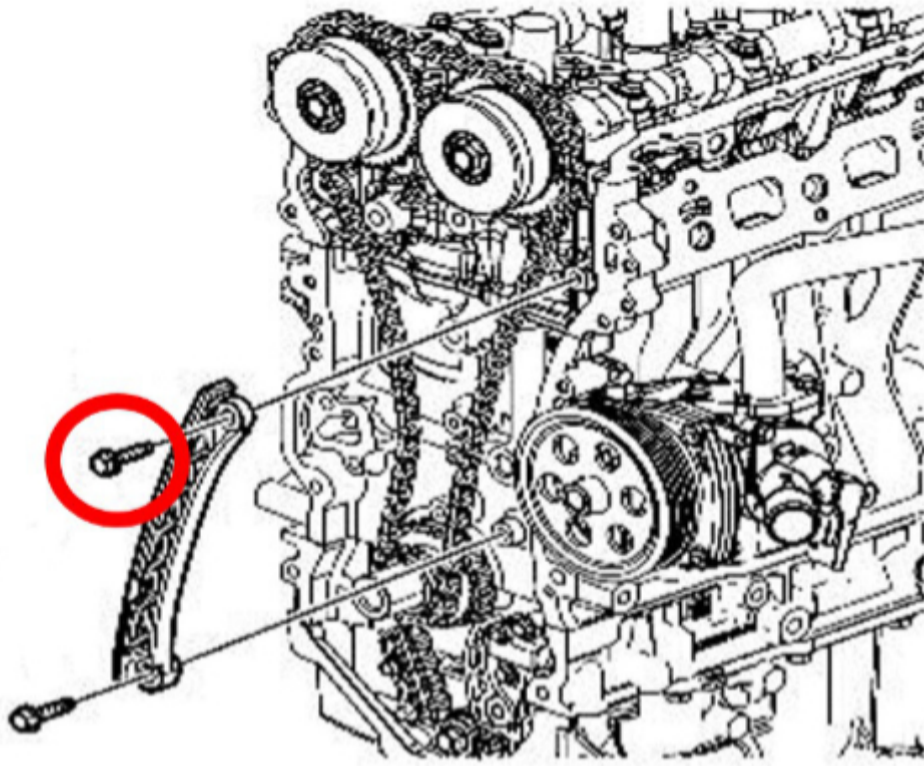
Involved Region or Country	North America
Condition	If a technician is making a repair that requires the front timing cover to be removed and finds the timing chain guide upper bolt (circled) loose enough to turn by hand, replace the timing chain guide and bolts.
Cause	The cause of this loose bolt has not been determined yet and is being investigated by engineering.

Replace the timing chain guide and bolts.
