Bulletin No.: PIT5717A
Published date: 04/26/2021

PIT5717A Sunroof, Rear Sliding Window, And/Or Wireless Charging Inoperative - Fuse F2DL And/Or F8DL Open

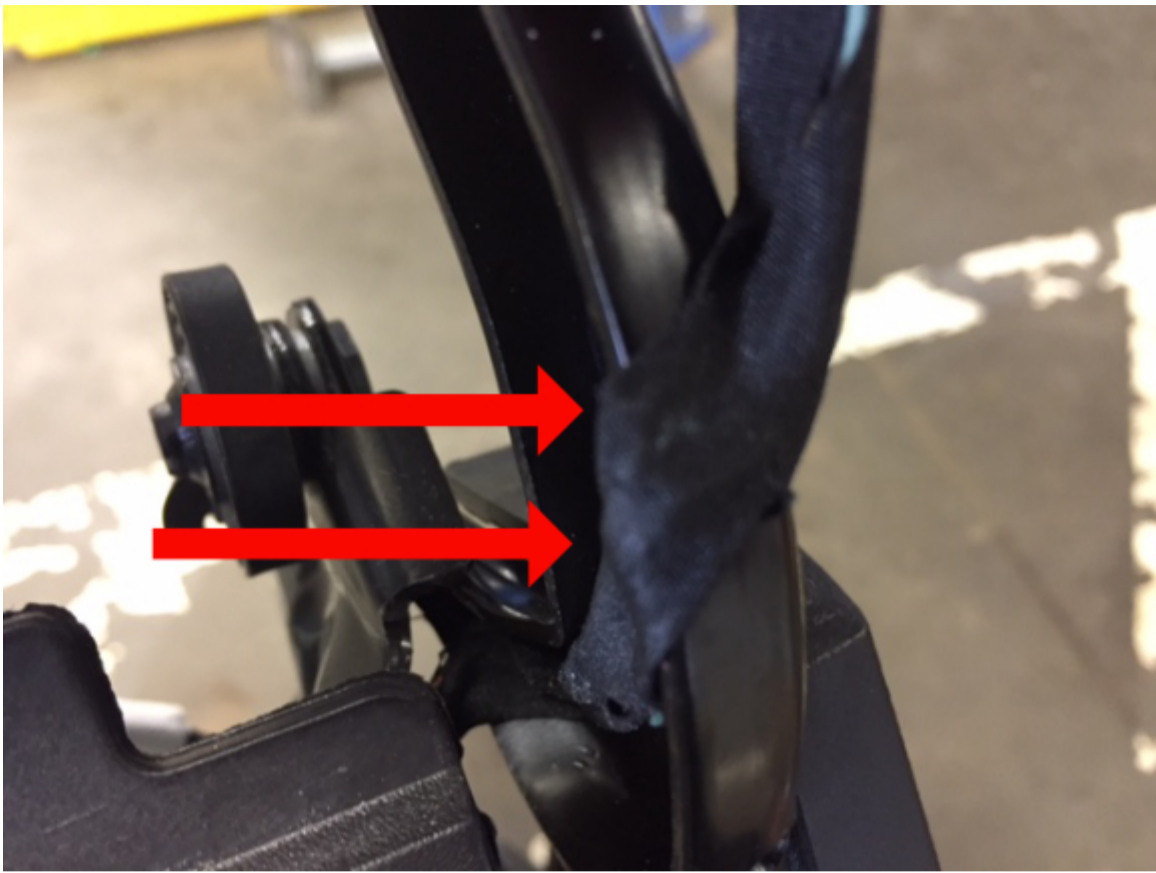
Involved Region or Country	North America
Condition	Some customers may comment the sunroof, rear sliding window, and/or the wireless charging mat may be inoperative. Technicians may find the F2DL or F8DL open.
Cause	Harness chaffing at the hinge area of the center console.

Inspect the center console harness at any part of the hinge area for chaffing. See example below.

If any harness damage is found, repair as necessary.
