Service Information Letter

May 14, 2021

Units Affected: Certain units built from July 2020 to October 2020 using utility body wheel well fender rubber part number 991054016. (Verify that your unit serial number is affected by reviewing the attached list in this SIL or by accessing your fleet on connect.altec.com/login)

Fender Rubber Inspection

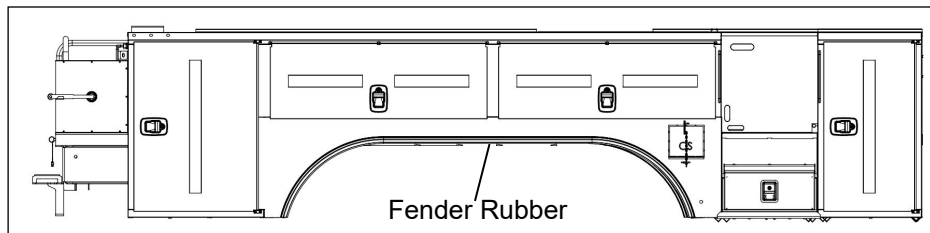
Figure 1 — Utility Body

1. Position the unit on a level surface, apply the parking brake, and turn off the engine. Remove the key from the ignition and secure it. Chock the wheels. Follow your employer's vehicle lockout/tagout procedure.
2. Pull lightly outward on the fender rubber with not more than 7 to 10 pounds of force to check that it is completely adhered to the fender panel (refer to Figure 1). Only apply pulling force outward from the fender panel. Do not twist or pull down on the fender rubber when testing for adhesion. Repeat this check every 4" along the length of the fender rubber on both sides of the body.

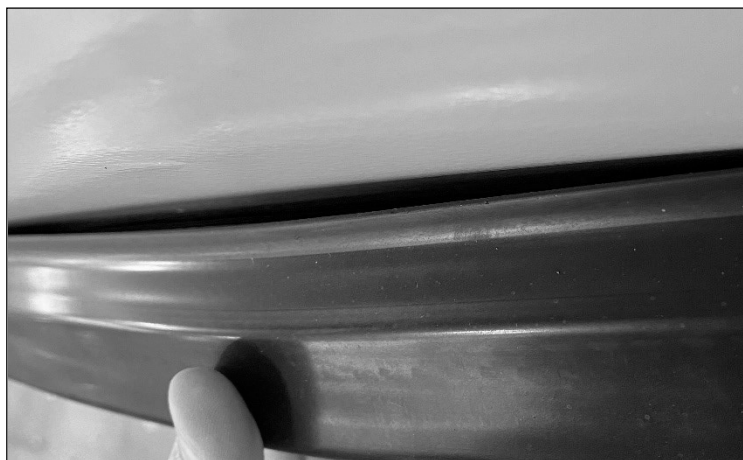
Figure 2 — Fender Rubber Separation

Altec has learned that the affected units have fender rubber which can become detached from the wheel well fender cutout of the utility body.

3. If there are any areas of separation between the adhesive strip and the fender panel, the fender rubber is not properly adhered (refer to Figure 2).

4. Review the results of the inspection.
 - If separation is found, order the Fender Rubber Replacement Kit, part number 991311362, and install it at the unit's next scheduled maintenance. One kit will have enough material for both sides of a body. Do not complete the Inspection Sheet at the end of this document.
 - If the fender rubber is properly adhered, complete the Inspection Sheet at the end of this document to record SIL 801 completion.
