## STAR ONLINE PUBLICATION

**Case Number:** S2123000022

### Symptom/Vehicle Issue: Steering Damper Mounting Information

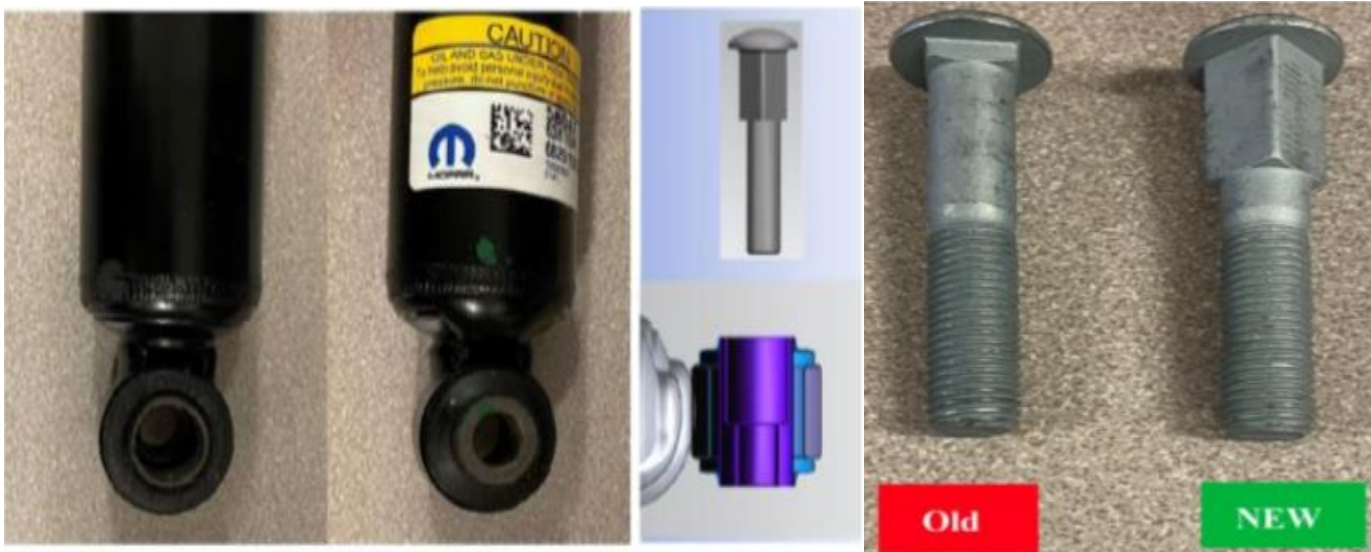
**Customer Complaint/Technician Observation:** Steering Damper 68251580AF has updated mounting to ensure the damper goes on the correct direction (fig 1). The AF level damper requires a new outboard attachment bolt be installed that features a longer square shoulder 06513445AA (new in fig 1). As with past practice the bolt must be replaced every time the damper is serviced.

Fig 1  
New mounting bushing and bolt design

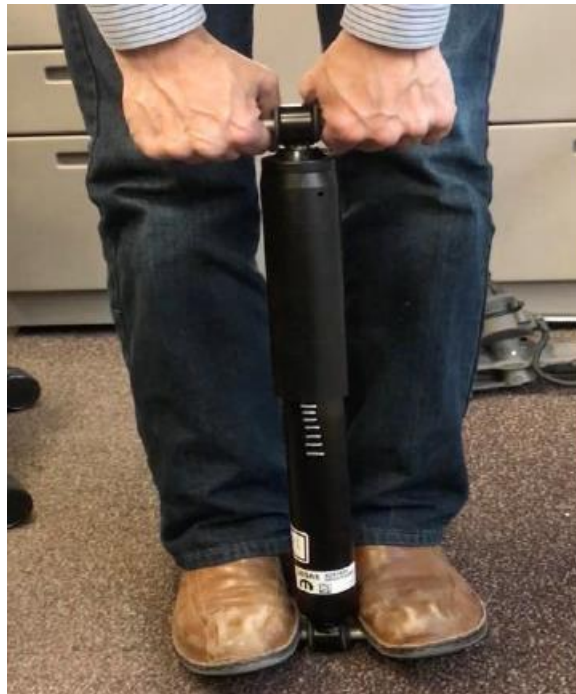
Fig 2 Damper Priming

Prior to installation the damper needs to be purged with the ROD END UP and Body down. Using long screw drivers or bolts as handles prime the damper full strokes 5 times as shown in fig 2.

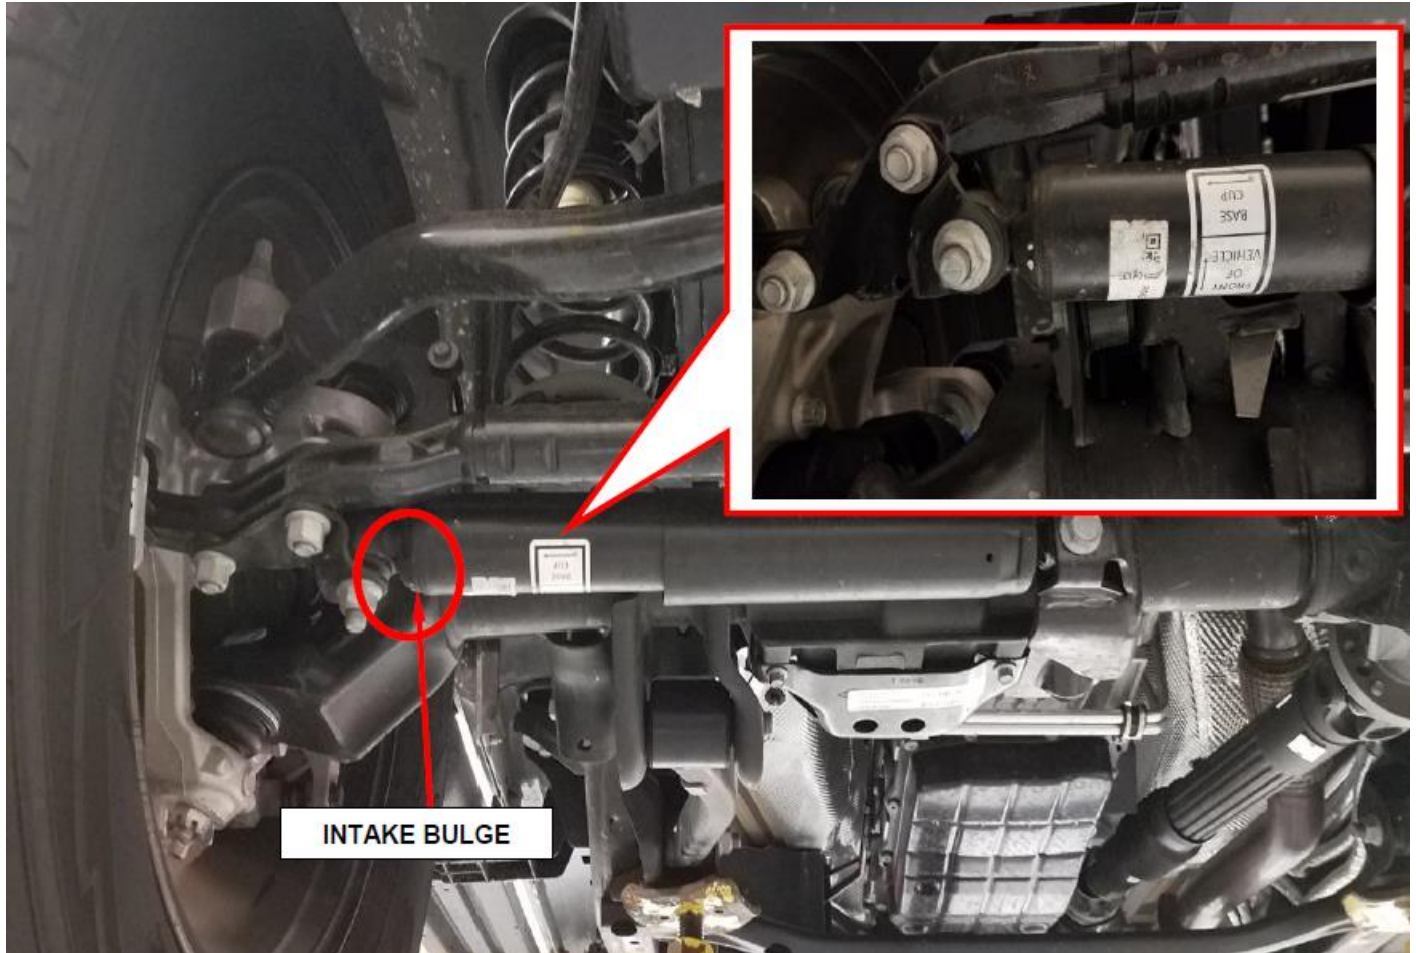
Fig 3 orientation of the intake bulge (down)

Proper installation has the intake bulge position down indicated in fig 3. NOTE>>> this is critical for proper damper operation.

Follow service information for fastener torque and installation.
