STAR ONLINE PUBLICATION

Case Number: S2108000105

Symptom/Vehicle Issue: Service Park Sense Message Displayed On Cluster

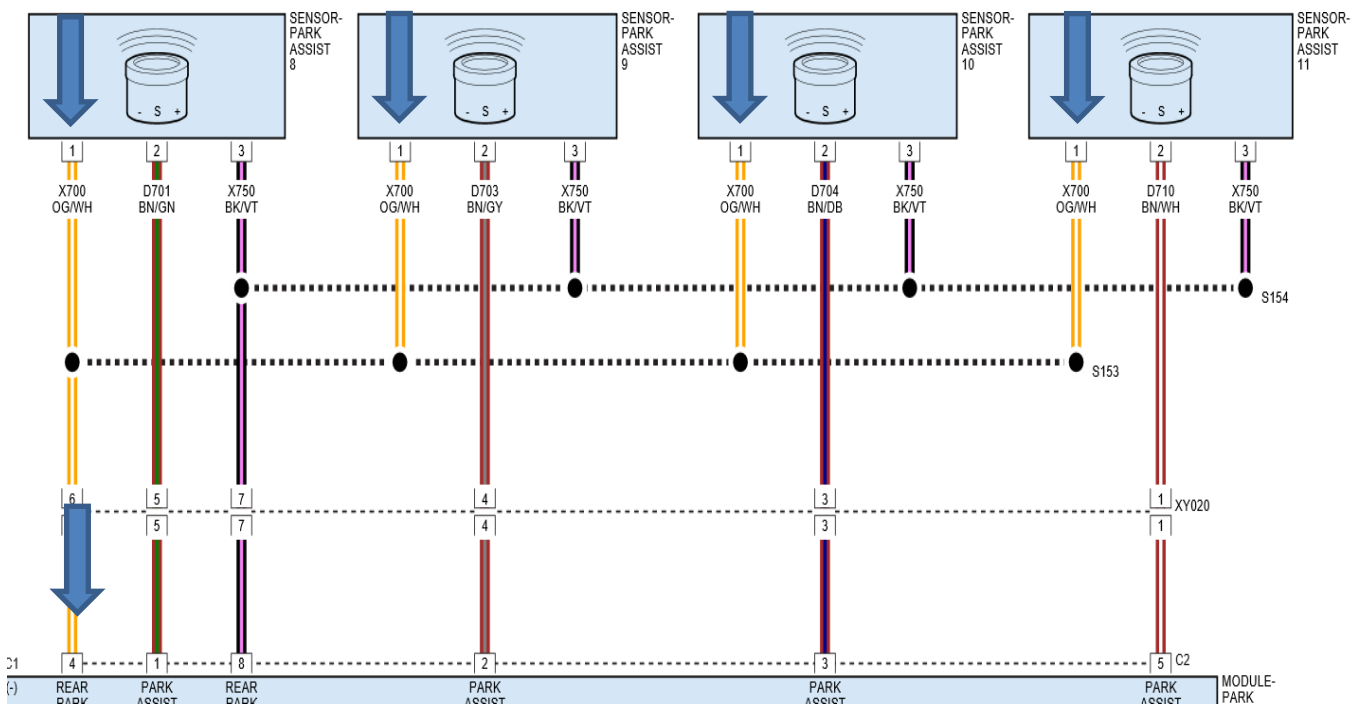
Fig 1

Customer Complaint/Technician Observation: Owner complains of a service park sense message displayed on the cluster. Technician observed the cluster message and a DTC setting in the PAM module, C10171C Sensor Supply Circuit Voltage Out Of Range.

Repair Procedure: Inspect the rear park assist sensor connectors for any signs of water intrusion at the sensor connectors, clean and secure as needed no parts required. If no issues at the sensor connectors, trace the X700 circuit sensor supply, back to the park assist module Fig 1, 2.
