# Service Bulletin

Bulletin No.: 20-NA-047

**Subject: Front or Rear Crankshaft Oil Leak, Malfunction Indicator Lamp (MIL) Illuminated - DTC P1101 Set**

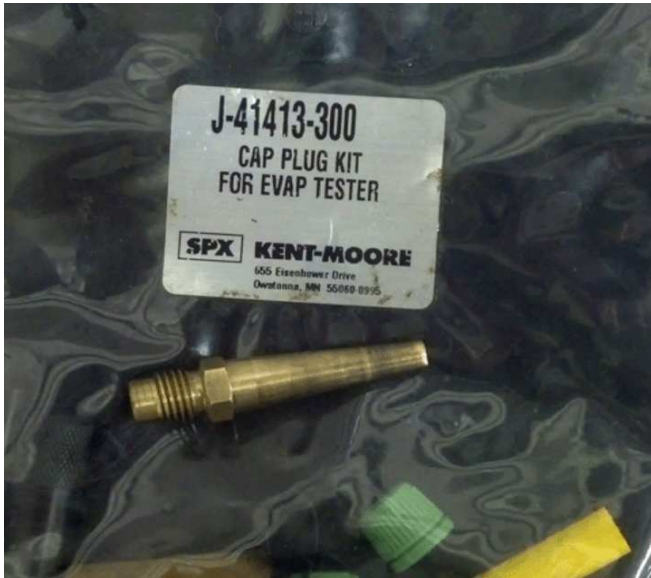
3416804

EEST hose adaptor

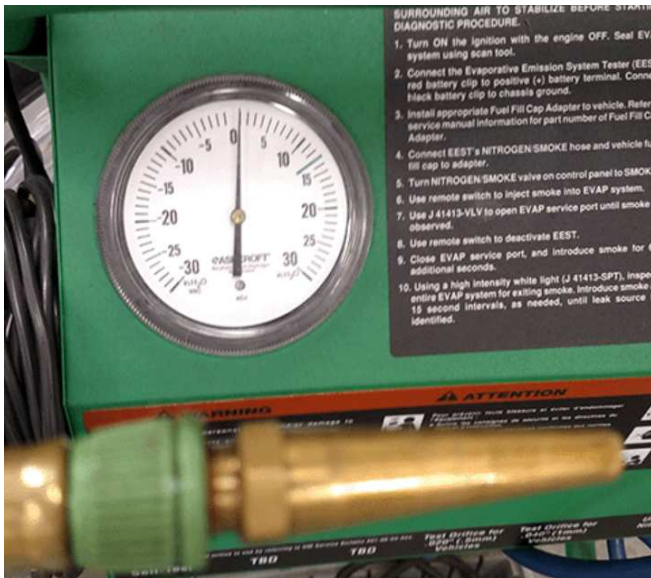
4573240

EEST Gauge at 0 reading

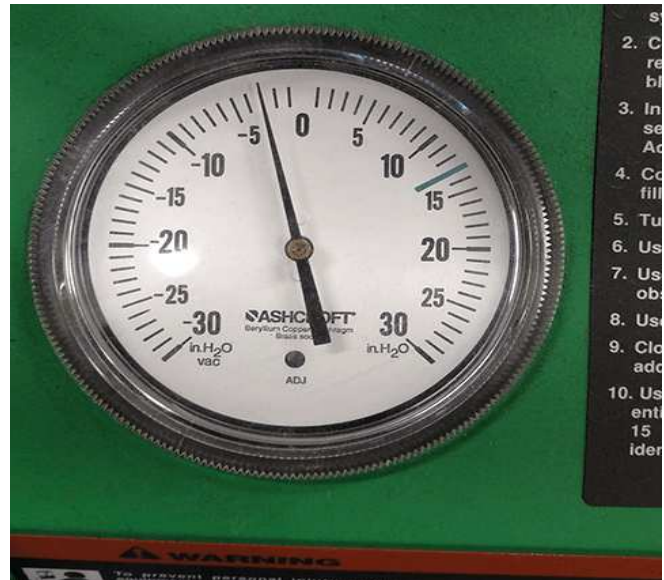
4573243

Normal crankcase pressure readings for the L3A, LE2, LFV and LYX are between -1 & -5 inches of water in park at hot idle.

- If the crankcase pressure is in the proper range, follow Strategy Based Diagnostics for engine oil leaks and/or P1101 per SI.
- If the crankcase pressure is excessively positive, above 0 inches of water (0 inches of HG / vacuum), then a positive crankcase pressure concern exists requiring further diagnostics.

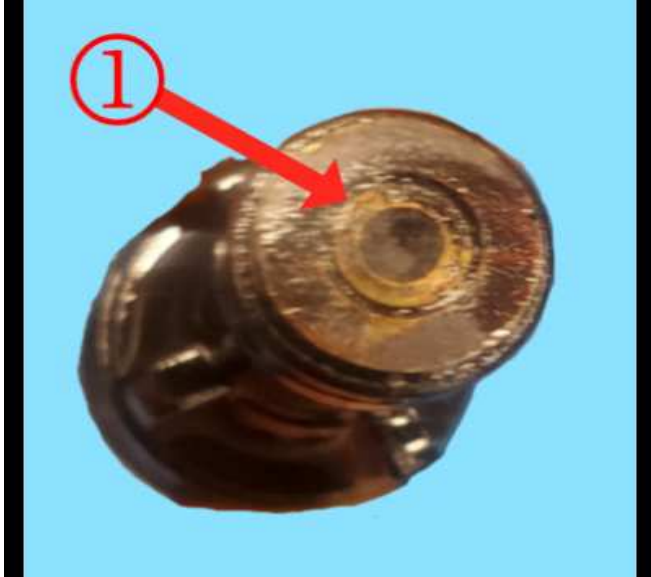
5513764

If diagnosing for oil leaks and/or DTC P1101 with no engine oil leaks and excessive positive crankcase pressure exists, an obstructed PCV orifice (1) would be suspect requiring a PCV orifice replacement.

Remove the camshaft cover and remove the PCV orifice and inspect for blockage. Replace the orifice as necessary along with the camshaft cover gaskets. Make sure the camshaft cover does not have any blockages in the PCV passages.
