TECH TALK

Volume 219 - March, 2016

Vehicle Technical Information

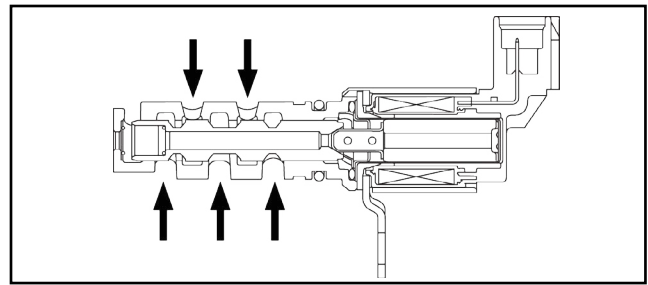
MIL ON, DTCs FOR VARIABLE VALVE TIMING CODES P0010, P0011, P0013, P0014, P0016, OR P0017 -- 2013-2015 Outlander Sport/RVR. Remove the intake and exhaust oil control valves and inspect for contamination in the mechanical portion of the valve. If debris is found, use a dental pick or similar tool to remove it from all 5 oil passages. See drawing at upper right.

Confirm the solenoids' electrical operation by performing Actuator Test (Item No. 17) as detailed in Group 13A before reinstalling the intake and exhaust oil control valves.

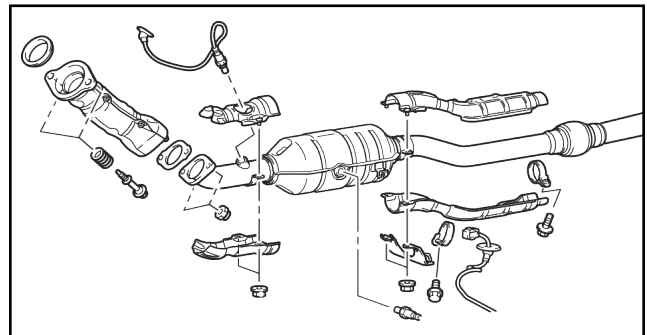
EXHAUST HEAT SHIELD SERVICE PARTS AVAILABILITY -- 2013 and newer Outlander Sport/RVR. Several of the exhaust pipe heat shield components are now available as service parts. When repairing a vehicle for a noise due to a loose heat shield, do not replace the center exhaust pipe with catalytic converter if the heat shield can be serviced separately. Consult CAPS for further details.

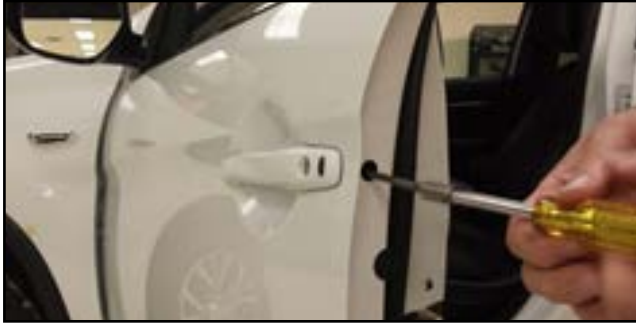
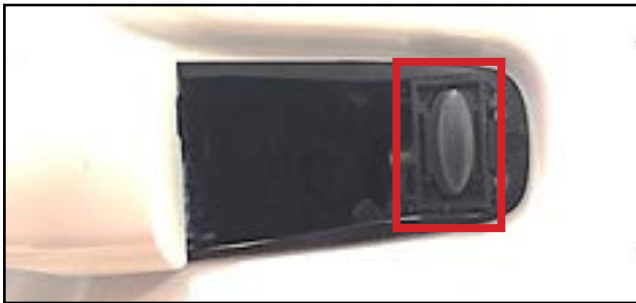
KOS OUTSIDE DOOR LOCK PUSH BUTTON SWITCH NOT FUNCTIONING – 2013-2015 Outlander Sport/RVR. The LH and RH outside door lock push button switch can become stuck against the side of the door handle cap. This causes the lock button to not extend above the door handle surface making the locking function inoperable. This may be an intermittent condition.

Repair: Remove the outside door handle cap from the door assembly per the following instructions. Open the door and remove the round black sticker adjacent to the outside door handle from the rear face of the door (save for reuse). Loosen the Torx 30 bolt through the uncovered access hole. The bolt will not come completely out as it is retained in the handle assembly by a clip. When the bolt is loosened, it must be pulled rearward (magnet) to clear the handle cap attaching hole. Open the outside door handle half way and pull the cap straight out. Examine the surface of the rubber boot to confirm there are no holes that would allow water into the switch. Replace the push button switch on any vehicles with damaged switch boots. Apply Krytox Weatherstrip Lubricant - MMNA P/N 04773427 to the side surfaces of the rubber boot cover. Allow a minimum of 15 minutes of drying time before reassembling. Only Krytox should be used due to its long term durability and lack of silicone. Silicone

based lubricants can adversely affect the electrical function of the door latch immediately below this KOS switch.

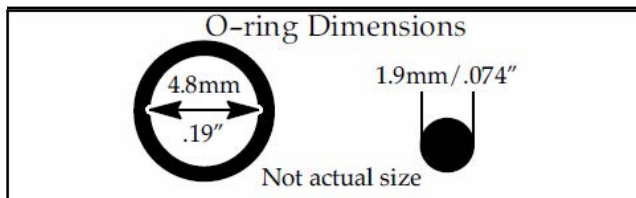
✓ **WASHER PUMP LEAKING AT FITTINGS**
2013-2015 Outlander Sport/RVR. If you find leakage at the washer pump forward of the right front tire, or the washer is inop, check if the washer pump fluid inlet/outlet assembly has become dislodged from the pump (refer to Group 51 - Exterior → Windshield Wiper and Washer for information). Confirm the o-rings on the pump outlets are in place. If o-rings are missing, it is NOT necessary to replace the entire washer pump. Though not available from your facing PDC, suitable replacements can be sourced locally using o-rings made of EPDM (Ethylene Propylene Diene Monomer) rubber, with an I.D. of 4.8mm and a material cross section of 1.9mm (NAPA p/n - 727-2602).

Install the new o-rings to the outlet fluid connections and reinstall the outlet to the pump. If the o-rings are simply dislodged, but not lost, and they are not cut or damaged, they can be reused. If it is necessary to replace the gasket between the fluid tank and pump, it is available separately (PNC 84233, p/n 8260A161).

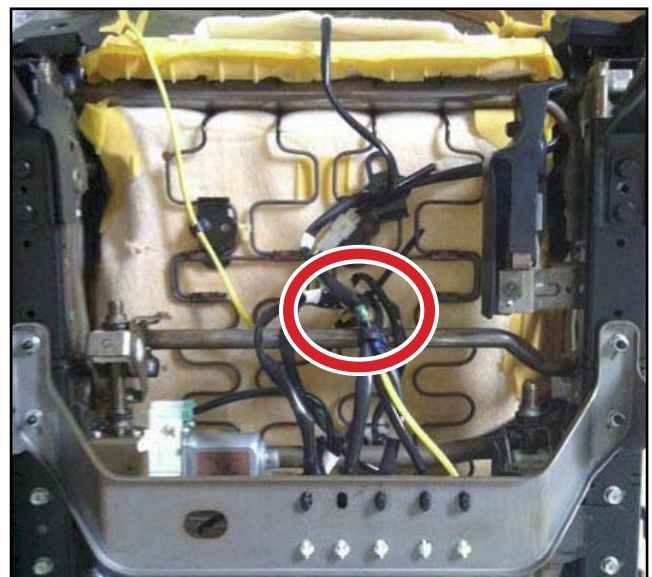
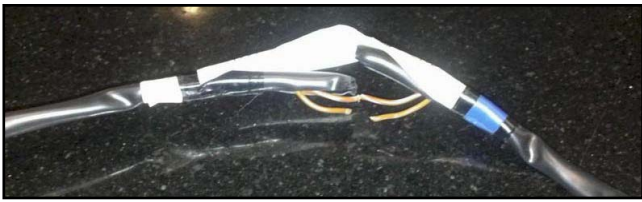
DRIVER'S SEAT SLIDE SENSOR WIRING HARNESS DAMAGE UNDER DRIVER'S SEAT with DTC B1556 -- *2013-2015 Outlander Sport/RVR.* As published in TIN-15-52B-001, MMNA has identified warranty claims for SRS DTCs B1558 [Occupant Classification-ECU DTC Present] and B1556 [Driver's Seat Slide Sensor Malfunction (Occupant Classification-ECU)] with OCM DTC B1B8D [Driver's Seat Slide Sensor Open Circuit]. Additional OCM DTCs that may also be present are: B1B8C [Driver's Seat Slide Sensor Circuit Performance] and B1B8E [Driver's Seat Slide Sensor Short Circuit].

During diagnosis, technicians should check for damage to the driver's seat slide position sensor harness in the location shown below.

If a damaged harness is found, DO NOT replace the front seat adjuster or SRS ECU for this condition. The harness is now shown in CAPS and is available as P/N 6979A429.

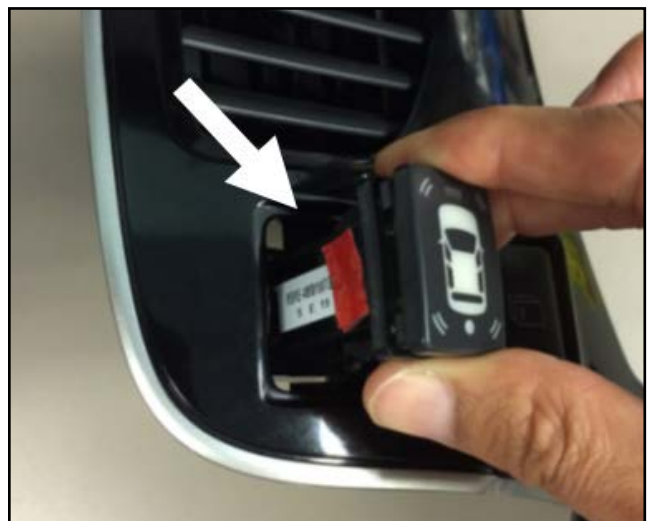
FRONT AND REAR ACCESSORY PARK ASSIST SWITCH INTERMITTENTLY STICKS -- 2016 Outlander. The Park Assist switch (located on the far left side of the vent panel) may intermittently stick when depressed. The left side switch slot wall support is thin/slanted allowing the switch to sit at an angle when fully inserted. **NOTE:** Replacing the vehicle vent panel with a new part will not resolve the concern.

Repair Procedure: Remove the Park Assist switch from the panel. Add a 3M tape or equivalent onto the left side of switch (as shown above). Dimensions: L 20mm x W 10mm and thickness of 1.5mm

Reinstall switch and verify proper operation. Verify switch is secured by the 2 locking tabs.

NOTE: The Park Assist switch fits slightly proud compared to the other switches in the vent panel. This is normal.
