# Technical Service Bulletin

## 91 Parking assistance provides false warnings

91 21 04 2024323/8 May 18, 2021. Supersedes Technical Service Bulletin Group 91 number 21-64 dated January 25, 2021 for reasons listed below.

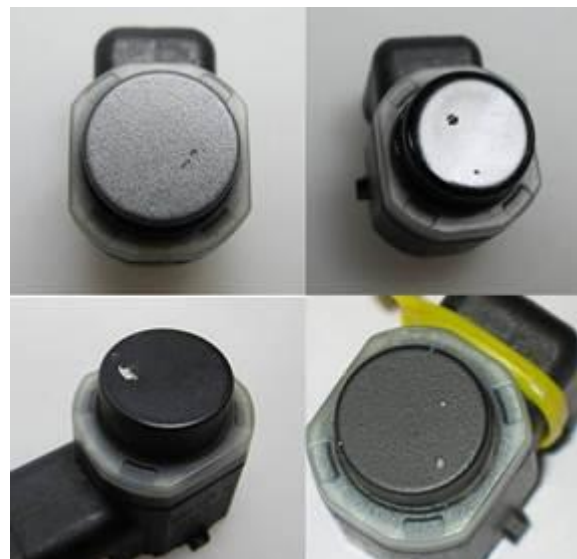
3. Check parking sensors (Figure 3) for obvious issues:
  - Mechanical damage (stone chips, scratches).
  - Dirt, ice, foreign bodies, and/or foil adhered to the sensor.
  - Damage to the bumpers that may indicate an accident (or paint indicating a previous incident).

**Figure 3.** Stone chips causing sensor failure.

**Tip:** Exterior damage to the vehicle, including stone chips and scratches, is not covered by Audi Warranty. When painting sensors, the special painting instructions for parking sensors in the paint repair manual must be observed.

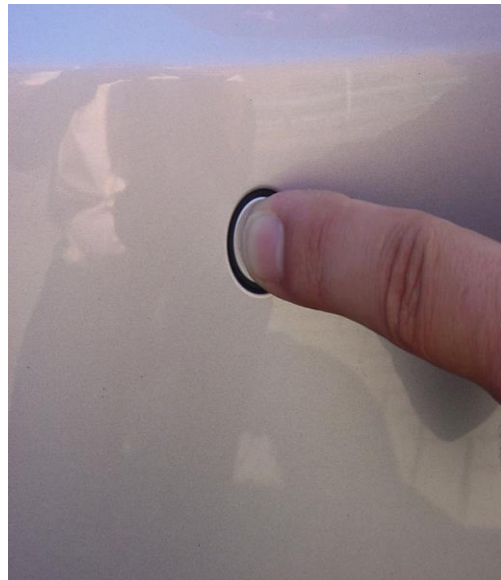
**Figure 4.** A pressure check on a parking aid sensor.

4. Check for non-Audi Genuine Accessories which can interfere with parking aid operation, including:
  - Aftermarket towing bar.
  - Aftermarket lowering kit.
  - Aftermarket spoiler or air deflector.
  - Aftermarket bumper.
5. For 8 and 12 channel systems, check the installation of the front license plate holder for:
  - Protrusion. The license plate and holder must fit on flat.
  - Bent corners. Any bent-open corners may cause false readings.
  - Correct fit. Oversized license plate holders or frames can obstruct parking aid sensors.
6. Pressure check for a tight fit and correct attachment of the parking sensors (Figure 4). If the sensor is not snug or feels loose, remove the bumper and reinstall the sensor.

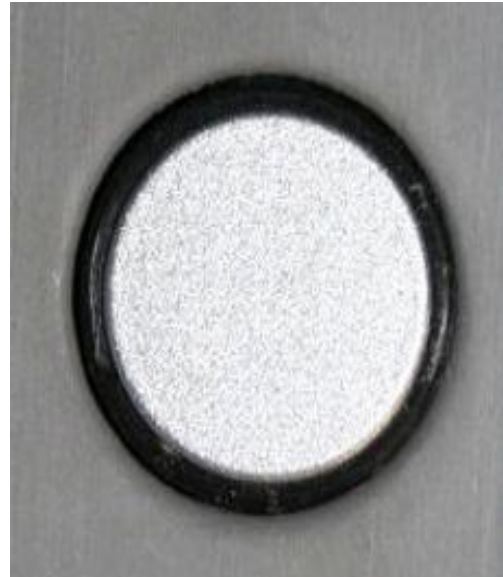
**Figure 5.** A correctly seated decoupling ring.

7. Check that the decoupling ring is correctly seated (Figures 5 - 7). If the ring is folded or bulging, remove the bumper and reinstall the sensor.

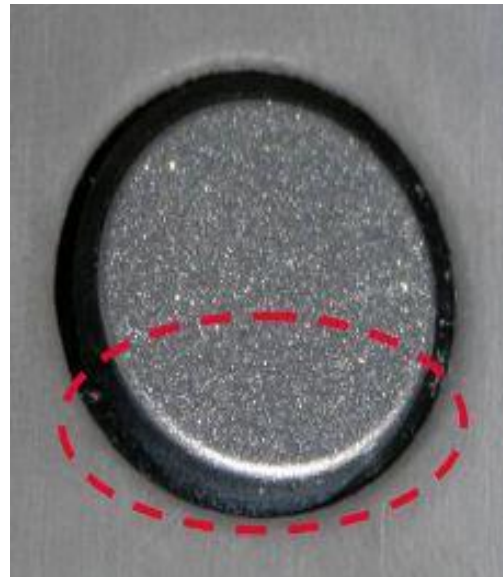
**Figure 6.** An incorrectly seated decoupling ring (bulging).

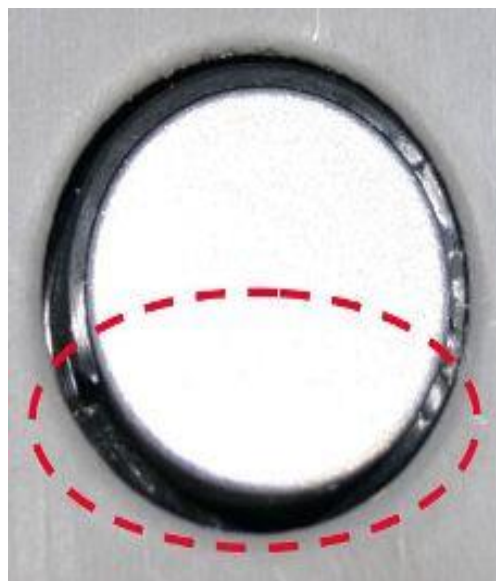
**Figure 7.** An incorrectly seated decoupling ring (folded).

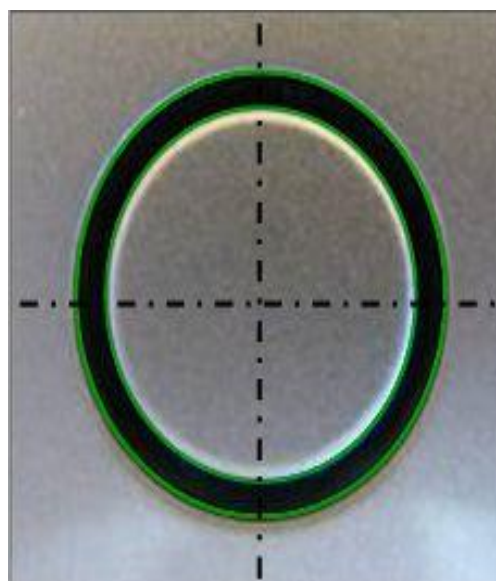
**Figure 8.** A correctly centered parking aid sensor.

8. Verify that the sensor is centered inside of the mounting hole (Figures 8 - 9). If the sensor is mounted off-center, remove the bumper and reinstall the sensor.

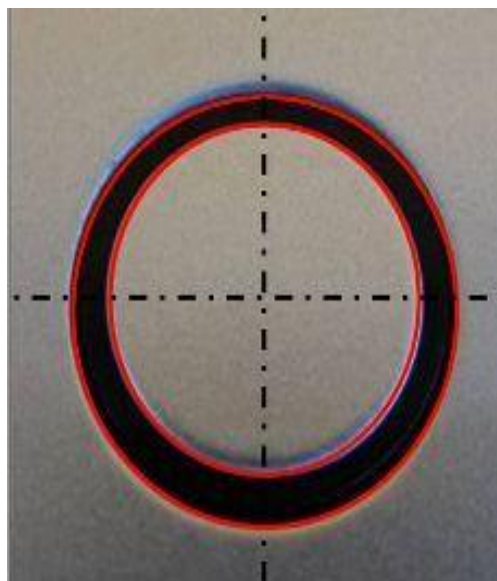
**Figure 9.** An off-center parking aid sensor.

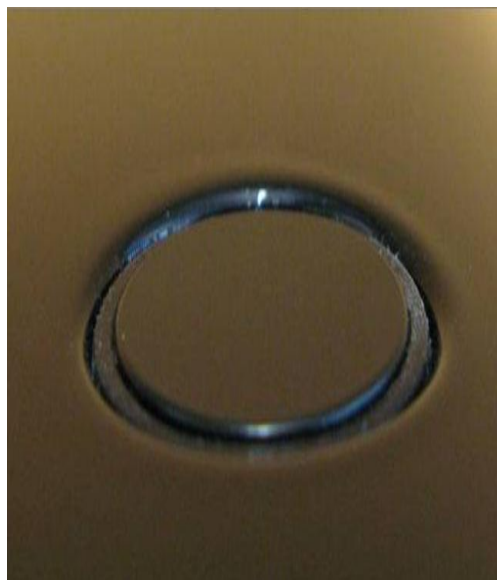
**Figure 10.** A correctly installed parking aid sensor.

9. Ensure the sensor sits flush with the bumper (Figures 10 - 11). If the sensor is recessed or bulging, remove the bumper and reinstall the sensor.

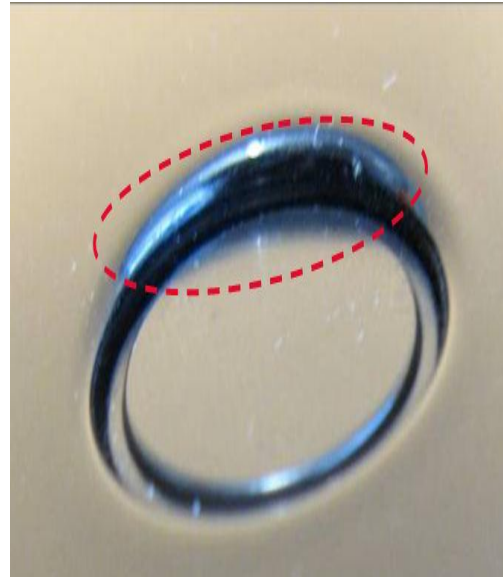
**Figure 11.** A recessed parking aid sensor.

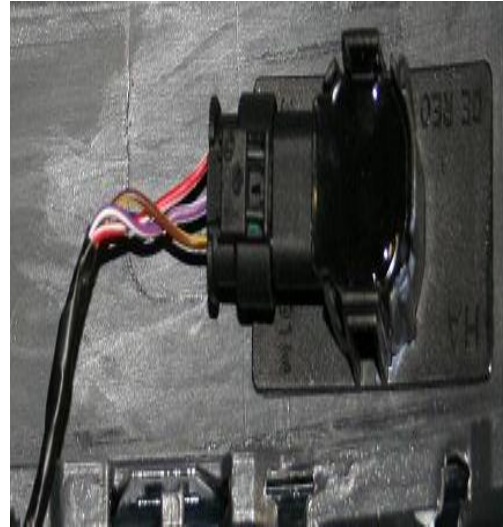
**Figure 12.** A correctly installed cable with sufficient length.

12. Check the cables in the bumper for damage and sufficient length (Figures 12 - 13). Cables that are too short can cause damage to the harness.
- If the cable is damaged, repair the cable using VAS Repair Kit 1978.
  - If the cable is too tight, correct the routing by moving the support clip so the cable is no longer under tension.

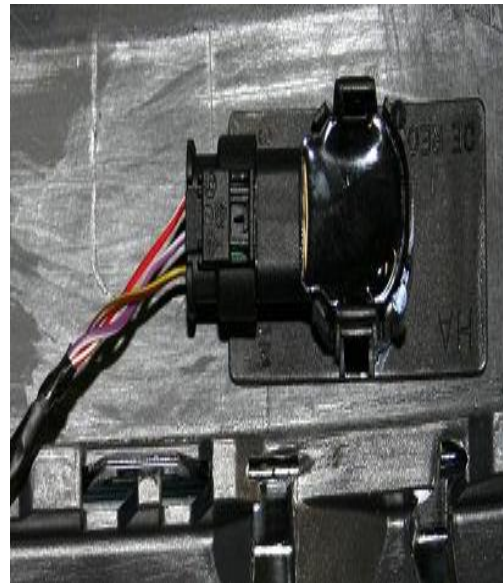
**Figure 13.** A sensor cable with insufficient length.

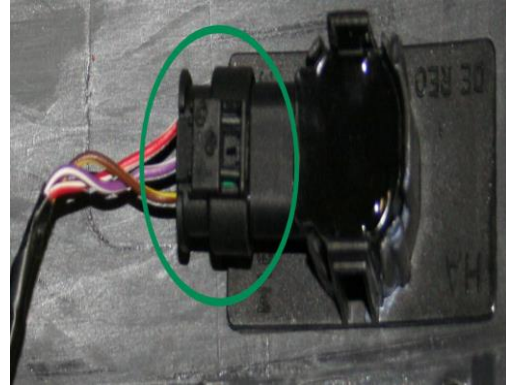
**Figure 14.** A correctly installed parking aid sensor connector.

13. Check the connectors on the parking sensors and the socket box for correct installation (Figures 14 - 15). If the connectors are not installed properly, reinstall.

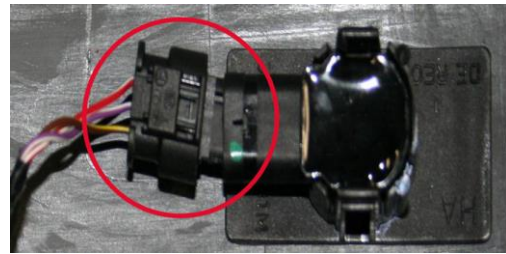
**Figure 15.** A parking aid sensor connector that is not seated correctly.
