Technical Service Bulletin

13 Starter/generator drive belt is noisy or came off, DTC P2BA300 may be stored in the ECM

13 21 14 2061461/3 May 26, 2021. Supersedes Technical Service Bulletin Group 13 number 20-11 dated December 17, 2020 for reasons listed below.

Model(s)	Year	VIN Range	Vehicle-Specific Equipment
A6	2019 - 2021	All	2.0TFSI Hybrid
A4, A5, and Q5	2021	All	2.0TFSI Hybrid

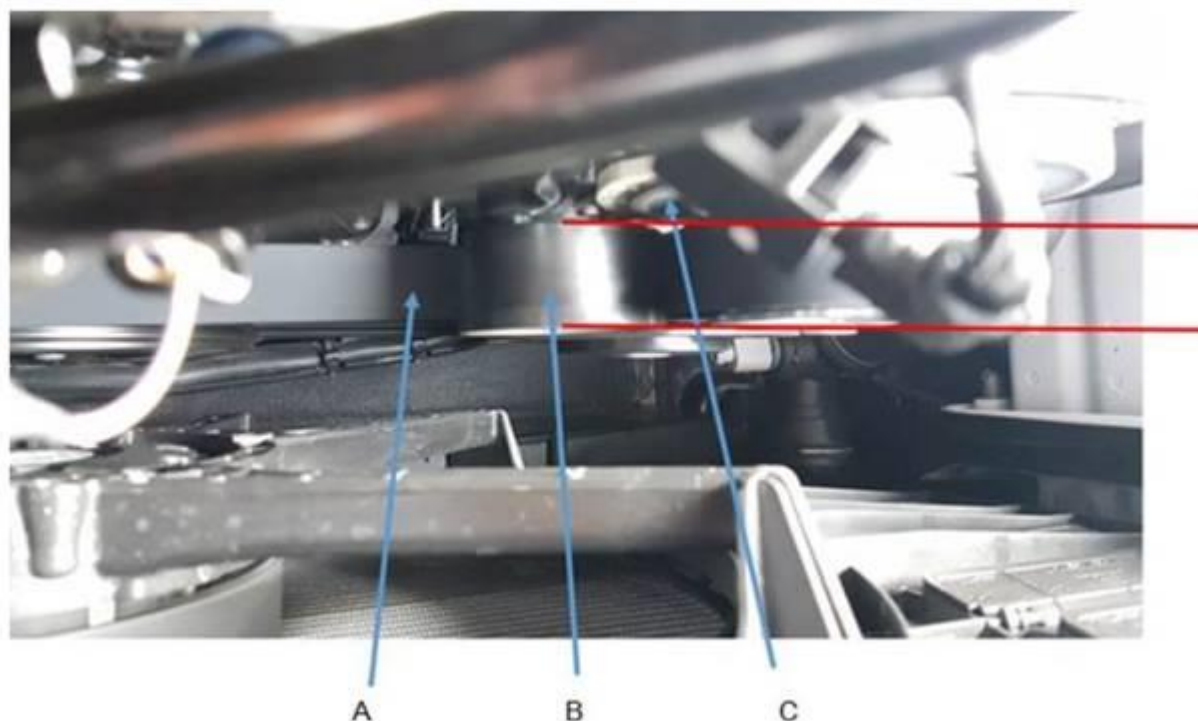
1. Run the engine at idle speed.
2. The belt must not protrude forward or backward over the roller edge of tensioner (Figure 2, red marks).

Figure 2. Check to ensure that the poly V-belt is not protruding in either direction.

Explanation of Figure 2 (view from above into the engine compartment):

A = poly V-belt.

B = tensioning roller of belt tensioner.

Check for correct belt running alignment after poly V-belt and tensioner replacement as follows:
