Subject: ELECTRICAL CONCERN AND/OR MULTIPLE DTC'S DUE TO AFTERMARKET DEVICE	M-Tips No.: MT-001/21
	Last Issued : 05/05/2021

APPLICABLE MODEL(S)/VINS

2011-2014 Mazda2	2007-2021 Mazda6	2013-2021 CX-5	2007-2021 MX-5
2007-2021 Mazda3	2016-2021 CX-3	2007-2012 CX-7	2007-2011 RX-8
2007-2015 Mazda5	2020-2021 CX-30	2007-2021 CX-9

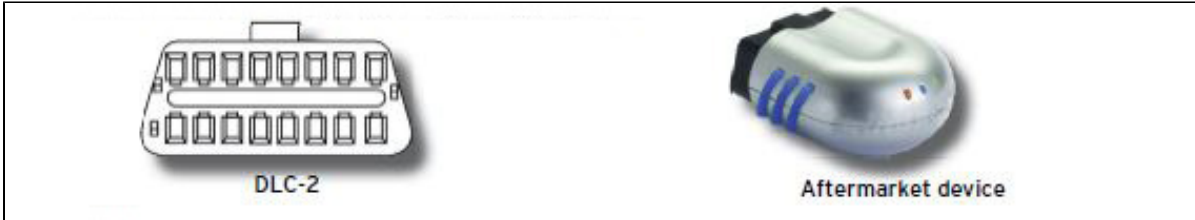
Example 1

Some electrical devices connected to the DLC-2 connector by insurance or mobile phone companies may cause:

- Battery discharge. The device may disrupt the CAN system battery saver mode.
- IDS/MMDS will not communicate with the vehicle due to poor DLC-2 connection. The aftermarket device may cause DLC-2 female terminals to spread open.
- DTCs
 - B1041:54 - ADAPTIVE FRONT LIGHTING SYSTEM (AFS) CONTROL MODULE
 - **B108E:04 - CENTER DISPLAY INTERNAL MALFUNCTION**
 - C0061:54 - DSC HU/CM

- C1001:92 - FORWARD SENSING CAMERA (FSC)
- C1001:97 - FORWARD SENSING CAMERA (FSC)
- U300A:62 - ELECTRIC PARKING BRAKE (EPB)
- **U3004:17 - ACC RELAY CIRCUIT MALFUNCTION**
- U0415:00 - MAZDA RADAR CRUISE CONTROL (MRCC)/SMART BRAKE SUPPORT (SBS)
- U0420:00 - MAZDA RADAR CRUISE CONTROL (MRCC)/SMART BRAKE SUPPORT (SBS)
- Multiple DTC's (U0XXX:00 COMMUNICATION ERROR)

- If an aftermarket device is found connected to DLC-2, take a photo and attach it to the RO. Advise the customer to remove it.
- If you determine that no aftermarket devices have been installed, continue with normal Workshop Manual diagnosis.

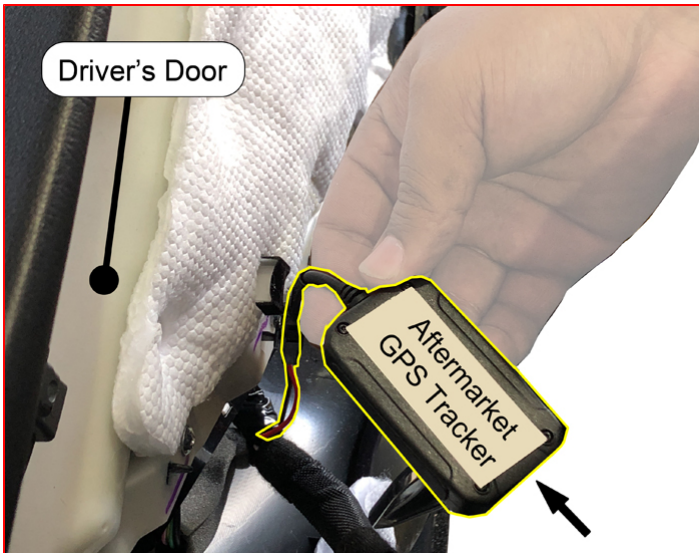
Below are examples of concerns due to an aftermarket GPS tracking device wired to the power window main switch:

- Engine no start
- Battery discharge
- Main relay buzzing

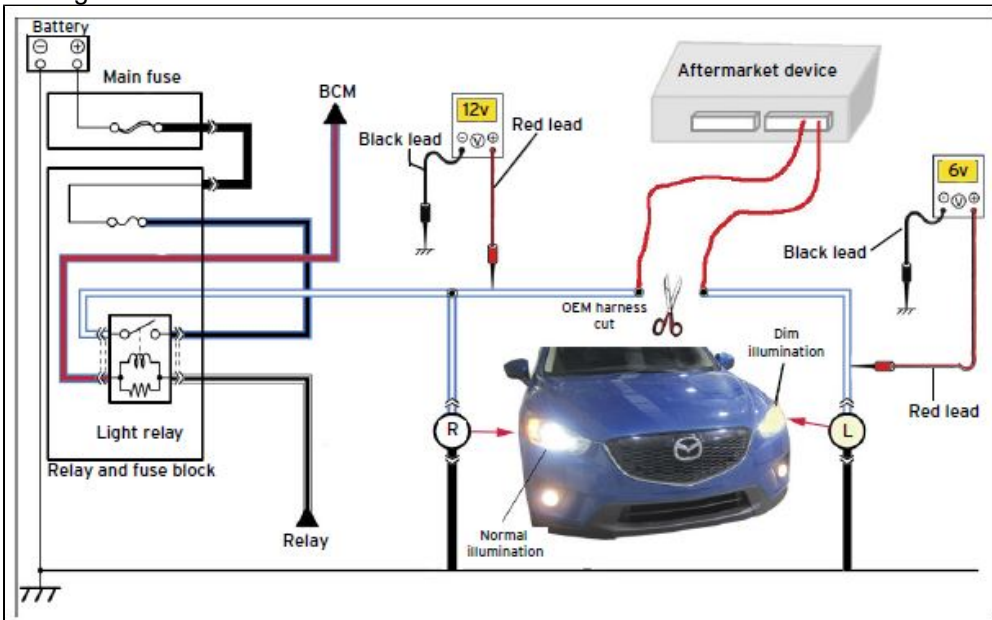
Below is an example of a dim headlight. The aftermarket device changed the headlight circuit resistance, causing a dim headlight.

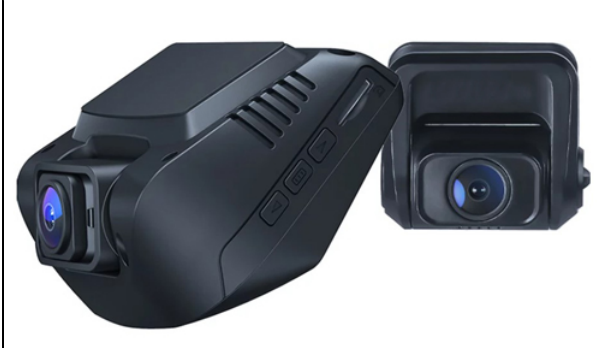
Example 4

DTC B119F:01 (TEL antenna No.1 malfunction) stored. This may be caused by an aftermarket dash cam. The aftermarket device may cause electrical noise disturbing the reception of GPS signals.
