Location: Electrical

Topic: Possible communication issue between IBS and MDS after upgrading to Generation 3 battery

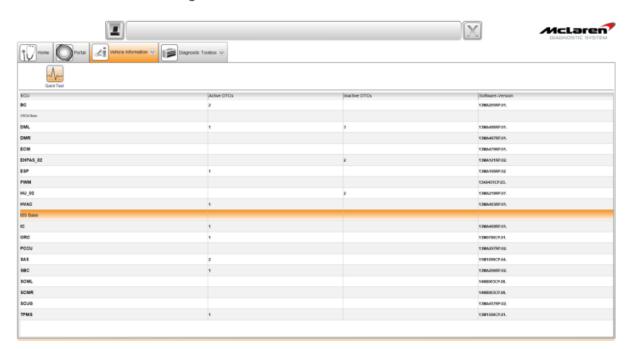
This will result in the IBS displaying as "**IBS Base**" and missing the software version number, as shown in the below image.

This symptom is the result of a communication error between the MDS and the vehicle. It does not alter the operation of the battery or vehicle.

Currently this situation requires no action and will be rectified within a later software version.
