Complaint – Warning Message "E-Power Not Available" Appears in the Instrument Cluster: Observe Specified Procedure (53/21)

Vehicle Type: **Cayenne E-Hybrid (9YA/9YB)**

Model Year: **As of 2019 up to 2020**

Concerns: **DME control unit**

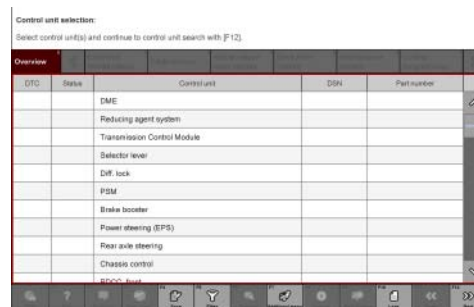
Control unit selection

The fault memories of the control units are read out.

- 2.1 In the control unit selection screen (**'Overview'** menu), press **•F7** to call up the **'Additional menu'** (⇒ *Control unit selection*).
- 2.2 Select the function **'Read all fault memories and erase if required'** and press **•F12** ('Next') to confirm ⇒ *Erasing fault memories*.

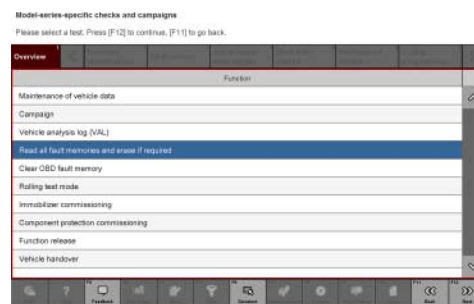
Erasing fault memories

The faults stored in the fault memories of the various control units are deleted.

- 2.3 Once you have read out the fault memories, delete the fault memory entries by pressing **•F8**.
- 2.4 Press **•F12** ('Yes') in response to the question asking whether you really want to delete all fault memory entries.
