| REFERENCE: | Nova Bus Manuals |
| RS N°: | MQR 7621-2280 |

| SUBJECT: | Alternator fail light coming on in service. |
| JUSTIFICATION: | A 12V relay is installed instead of a 24V relay for the alternator output status signal. |

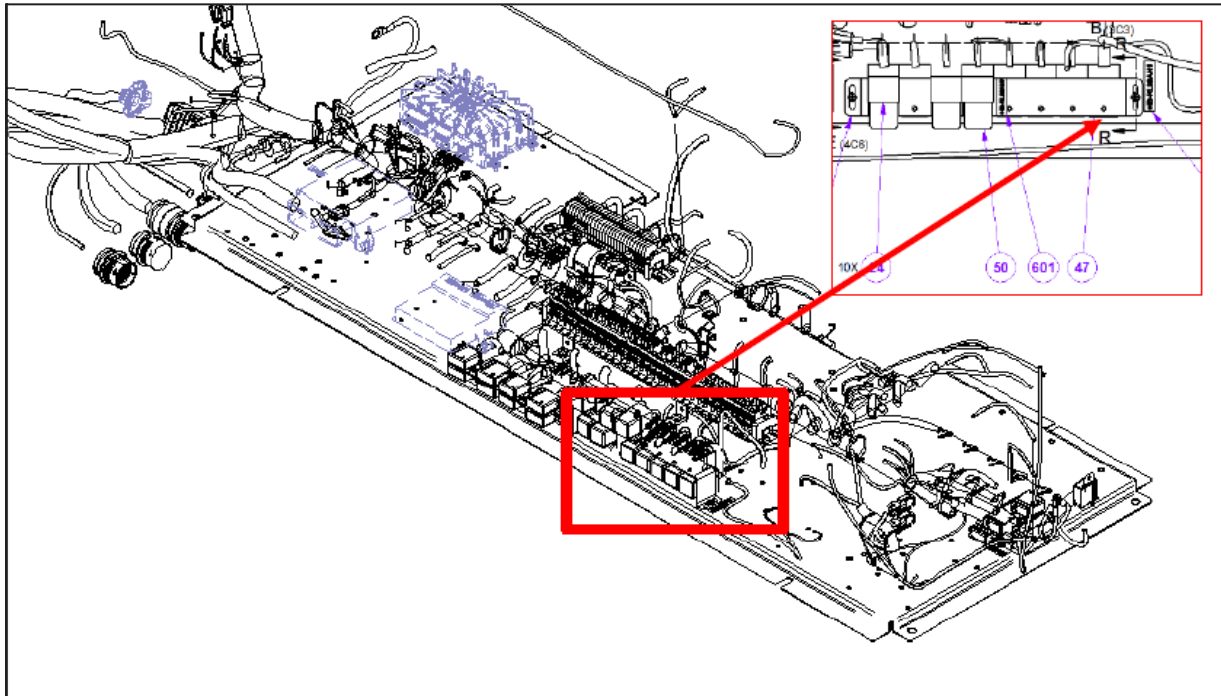
Figure 3 - Interior Back Panel

- 1.5. Locate the 12V relay at position +IB RL99AH1 inside the interior back panel (see figure 3).

- 1.6. Remove the 24V relay N82209 and replace it with a N11613 relay.
- 1.7. Close the rear panel and test the bus (the alternator tell tale light should not be lit).
- 1.8. Return the bus to service.❖
