SERVICE BULLETIN

APPLICABILITY: 2020MY Legacy and Outback
2019-2020MY Forester

NUMBER: 07-176-20R

SUBJECT: DTCs B118B, B11E5, B11E6 in Driver Monitoring System (DMS)

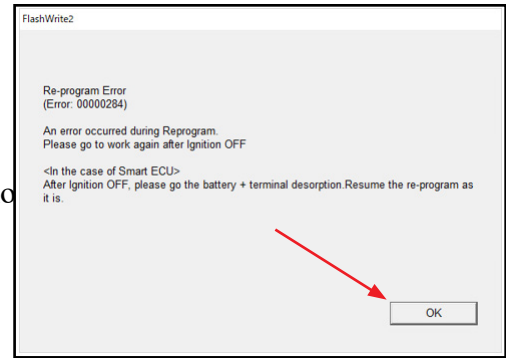
NOTE: If during the reprogramming, the **Error** screen shown here is displayed, ignore it and select OK. If no error screen is displayed, select OK.

Step 7) Proceed with reprogramming. Install the **FIRST** of **TWO** DMS update files using FlashWrite.

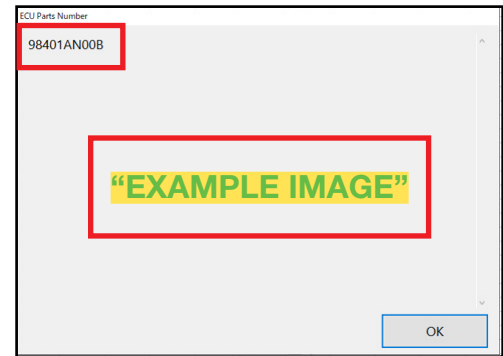
Confirm the update has been performed successfully by comparing the (NEW) ECU Parts Number with the chart provided above. Select **OK** to complete the procedure.

Step 11) Using the SSM4, confirm the DMS **ECU** Part Number to confirm the update was successful. Go to: Diagnosis > Confirm VIN > Each System > Driver Monitor (scroll down) > Work Support > ECU Parts Number.
