Noise Symptom/Jerking or Spare Parts Requirements - Clicking Noise/Rough-Running Engine/Jerking Under Load With Respect to Transfer Gear: Programming All-Wheel Drive Control Unit/Checking Transfer Gear (SY 84/17)

Vehicle Type: **Cayenne (VR6 - 92A)/Cayenne S (92A)/Cayenne GTS (92A)/Cayenne Turbo (92A)/Cayenne Turbo S (92A)/Cayenne S Diesel (V8 - 92A)**

Model Year: **As of 2011 up to 2017**

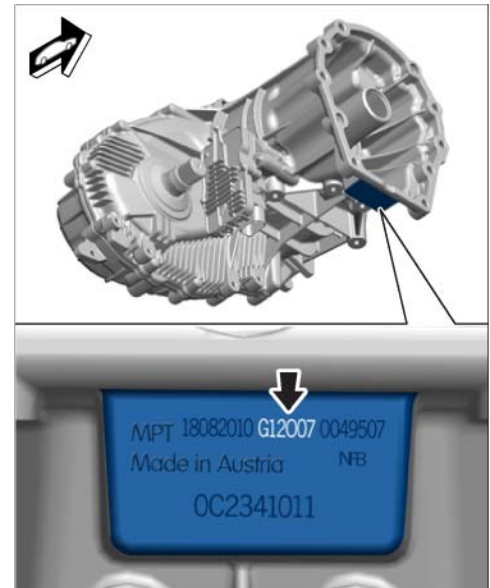
Classification data for transfer case

- If the transfer case with servo motor (control unit) is replaced, there is no need to reload data (classification data).
- This data is already contained in the control unit for servo motor and transmission bundle replacement.
- Classification data can be read out of the control unit using the PIWIS Tester (see "Actual values" tab)
- If only the servo motor is replaced, the classification data must be re-written into the control unit.
- Classification data can be found on the transfer case housing.
